**RE: Assessment of Identified Trees at Beale Park**

# *Assessment of Identified Trees at Beale Park*

*City of Cockburn*

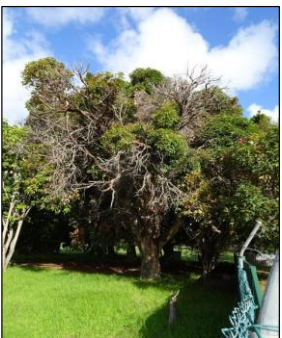
Marri Canker (*Quambalaria coyrecup*) was noted in the Red Flowering Gum (*Corymbia ficifolia*), and its presence looks to be impacting the health of that Tree with large parts of its canopy showing indications of decline. As a result, that tree may also have fairly limited life span remaining as at this time there are no documented methods of control for this fungal disease.

| Ref. No | Species | Height (m) | DIA (DBH) mm | Image | Management |
|---|---|---|---|---|---|
| 61 | Red Flowering Gum<br>( <i>Corymbia ficifolia</i> ) | 8.5 | 900 | | Suggest remove the dead sections.<br>No canopy thinning required. May need to be removed should further decline occur |
