1 Forrest Rd, Hamilton Hill

Structural Inspection Report

M15819

BPA Engineering were requested, by Dwayne Rowland of Kardan Construction, to undertake a structural audit of the existing buildings at 1 Forrest Rd, Hamilton Hill.

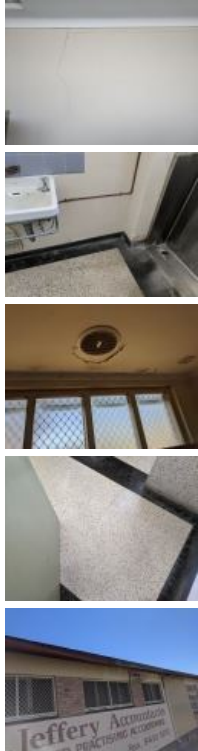
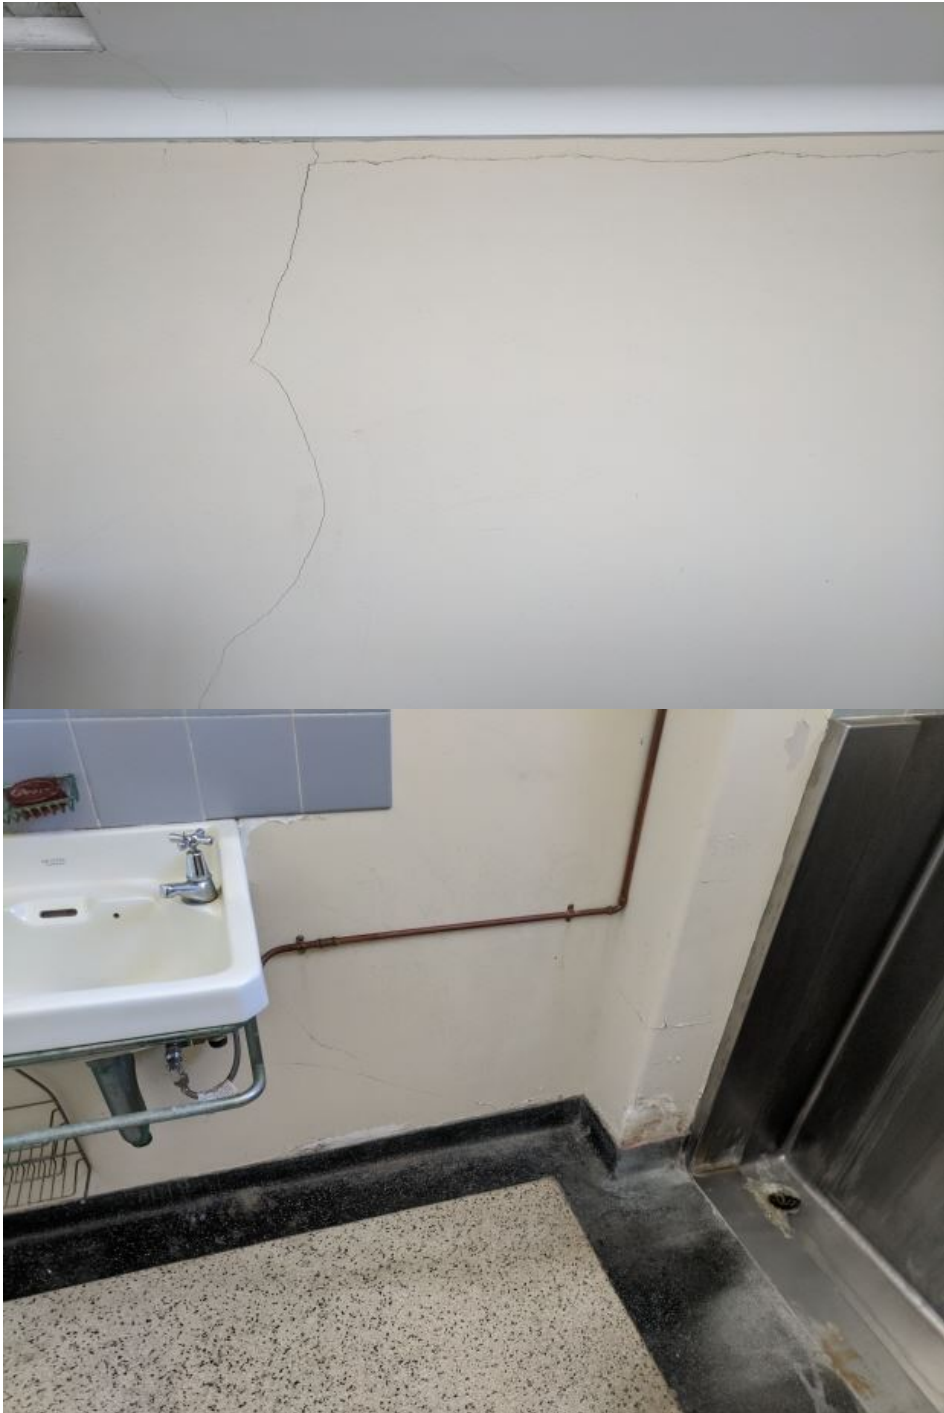
| 001-001 | Cracks observed to various walls and one across the floor. Moisture damage to ceiling paintwork. The external wall has a significant crack over the window opening. | <ul style="list-style-type: none"> <li>Most of the cracks observed were cosmetic. They do indicate that some movement has occurred in the foundations; however, most are not of structural significance.</li> <li>The vertical cracks over the window in the external brick should be stitched using the Helifix Crack Repair System.</li> </ul> | |

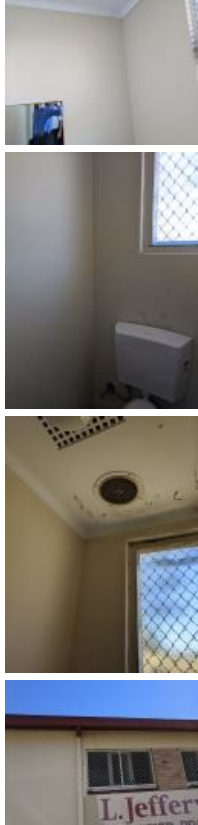
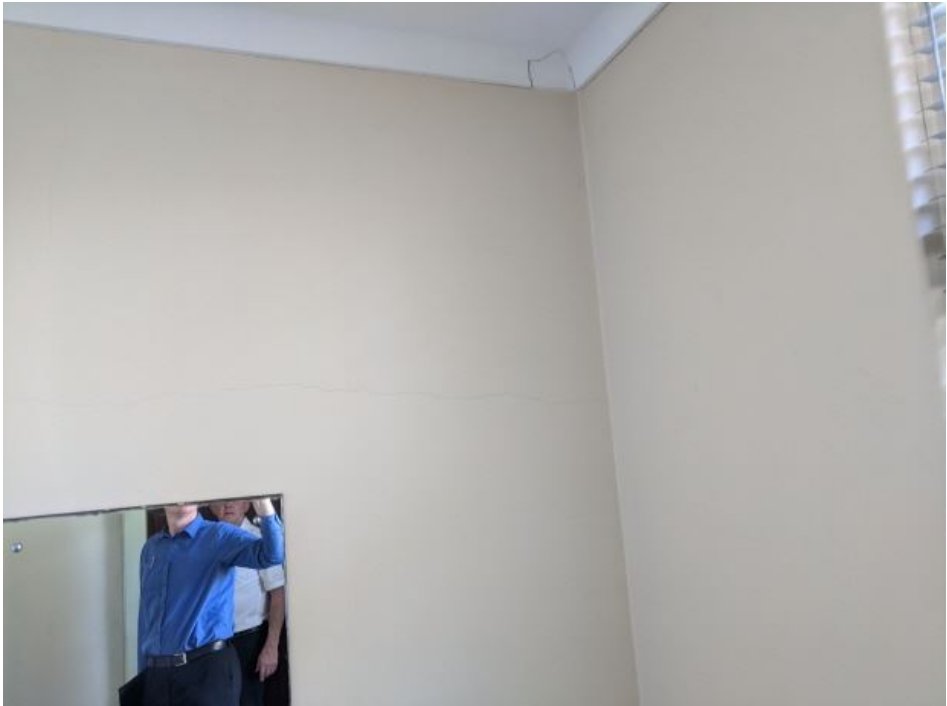
| 001-002 | Cracks in wall above window, near toilet. Moisture damage to ceiling paintwork. The external wall has a significant crack over the window opening. | <ul style="list-style-type: none"> <li>Most of the cracks observed were cosmetic. They do indicate that some movement has occurred in the foundations; however, most are not of structural significance.</li> <li>The vertical cracks over the window in the external brick should be stitched using the Helifix Crack Repair System.</li> </ul> | |

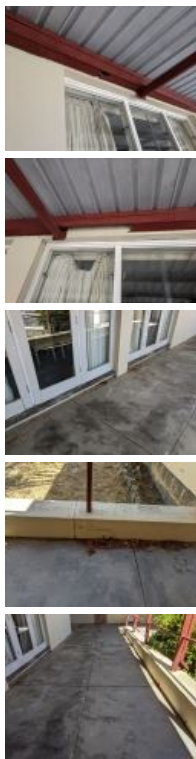
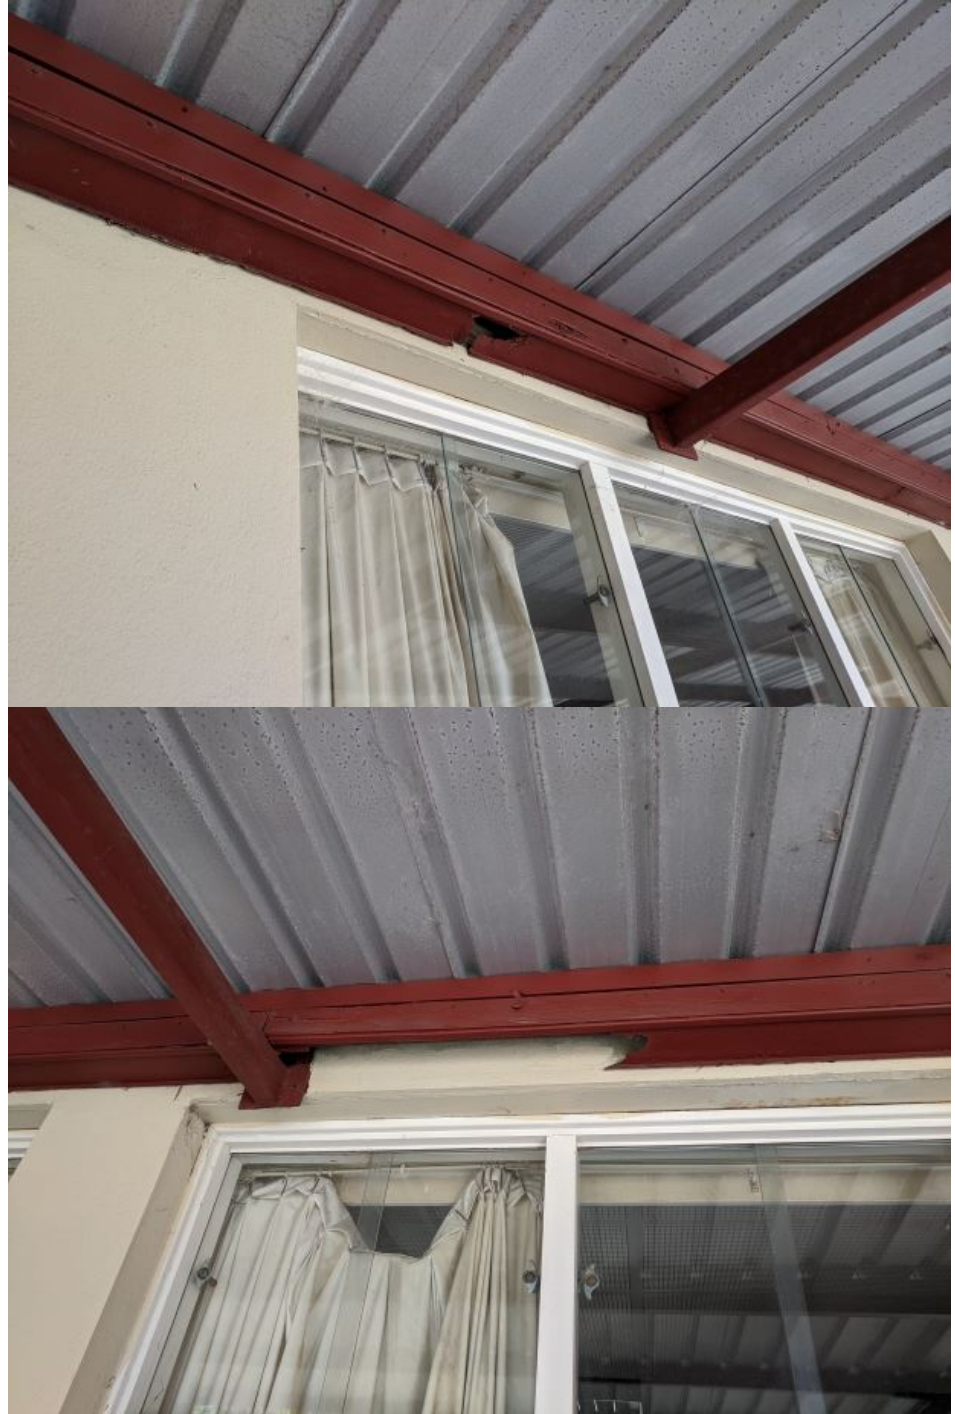
| 001-009 | <p>Metalwork above the north entry and windows to the hall was corroded through.</p> <p>The timber threshold step is weathered and does not appear to have been painted in some time.</p> <p>The verandah post base is embedded in the brickwork upstand and is corroding, resulting in cracking.</p> <p>The concrete verandah slab has cracked.</p> <p>It was also noted that there are no downpipes off the verandah gutter.</p> | <ul style="list-style-type: none"> <li>The metalwork above the door appeared to be cosmetic, to hide the end of the sheeting; however, it was also clear that water has run over the top ends of the roof sheets.</li> <li>Ensure that the top end of the roof sheets are correctly turned up.</li> <li>Remove the damaged flashing. Replace if desired.</li> <li>The timber step should be sanded back and painted or varnished.</li> <li>The brickwork around the verandah post should be removed. Prop the verandah, cut off the post at the top of the brickwork level and weld on a new base plate; reinstate the brickwork, then bolt the new base plate down with drilled and epoxied anchors. Anchors should have at least 200mm embedment.</li> </ul> | |

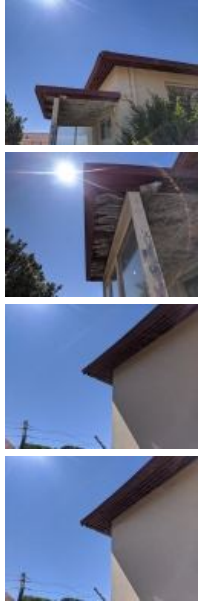
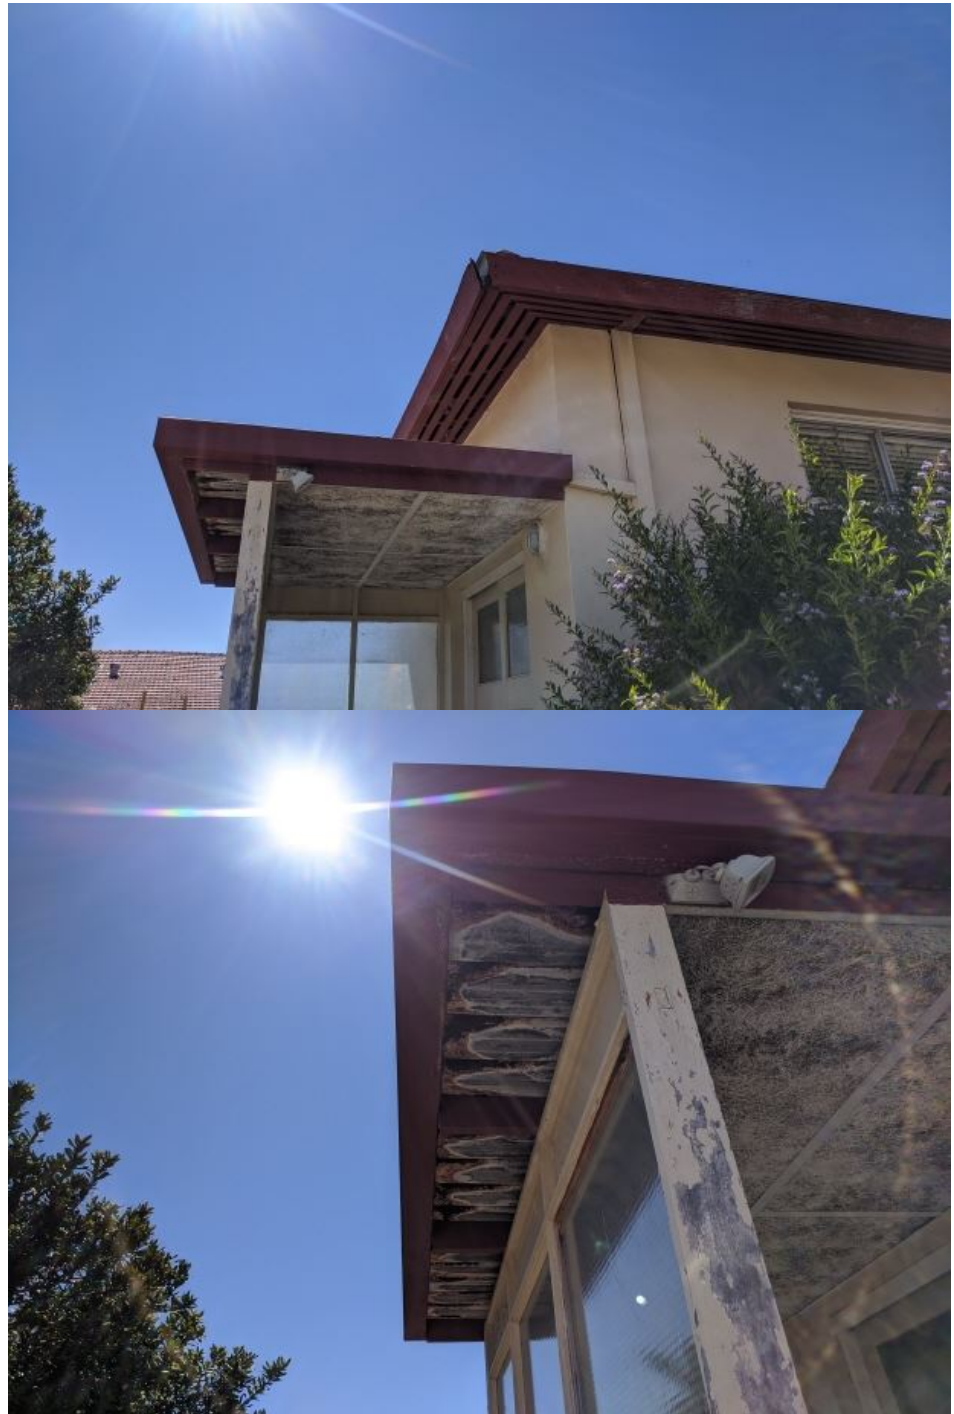
| 001-014 | Timber lining to eaves of main roof and lining to stair roof have deteriorated. | <ul style="list-style-type: none"> <li>• Replace missing timber lining.</li> <li>• Paint existing timber lining to provide protection.</li> </ul> | |

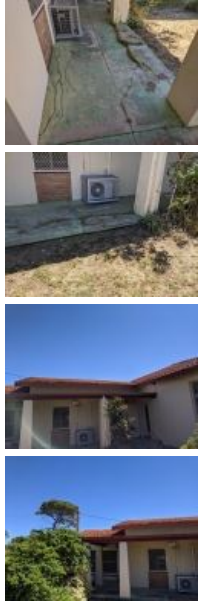
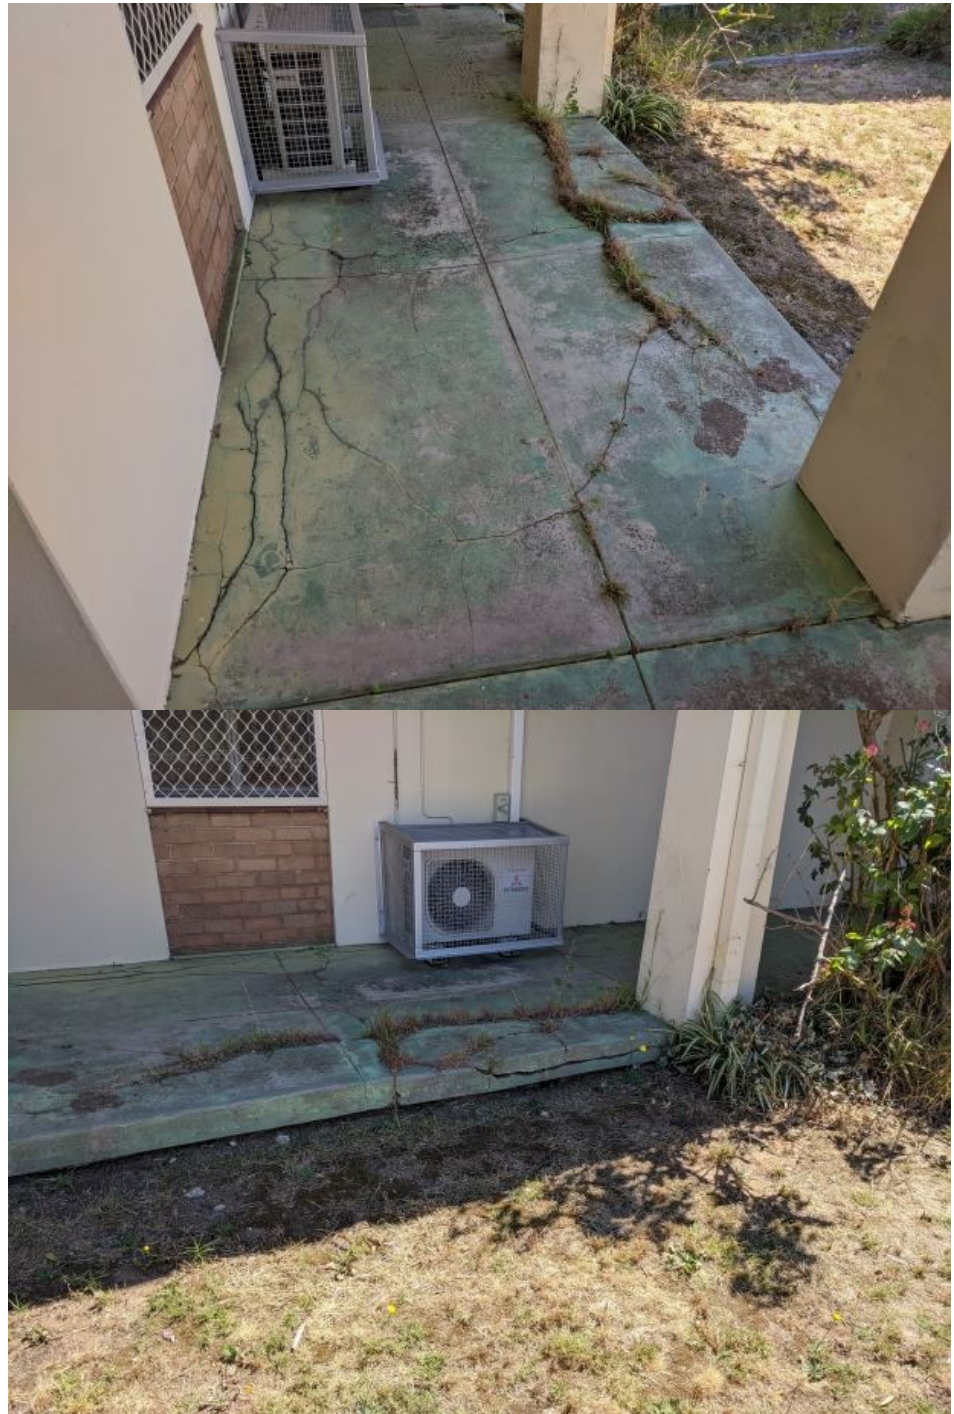
| 001-021 | The SW verandah has cracked and subsided. The roof over shows considerable sag. | <ul style="list-style-type: none"> <li>The cause of the subsidence is unknown.</li> <li>Remove the slab and investigate the cause. This may include water leaks or poor compaction.</li> <li>Roof is likely to have saged as a result of moisture and long term loads. Review with internal ceiling moisture damage. Repair any leaks or re-seal tile roof.</li> </ul> | |

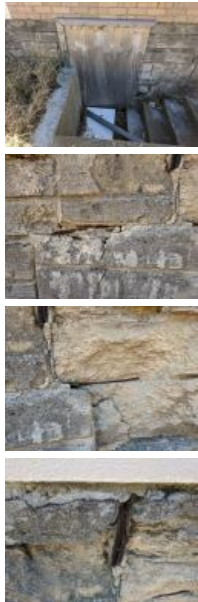
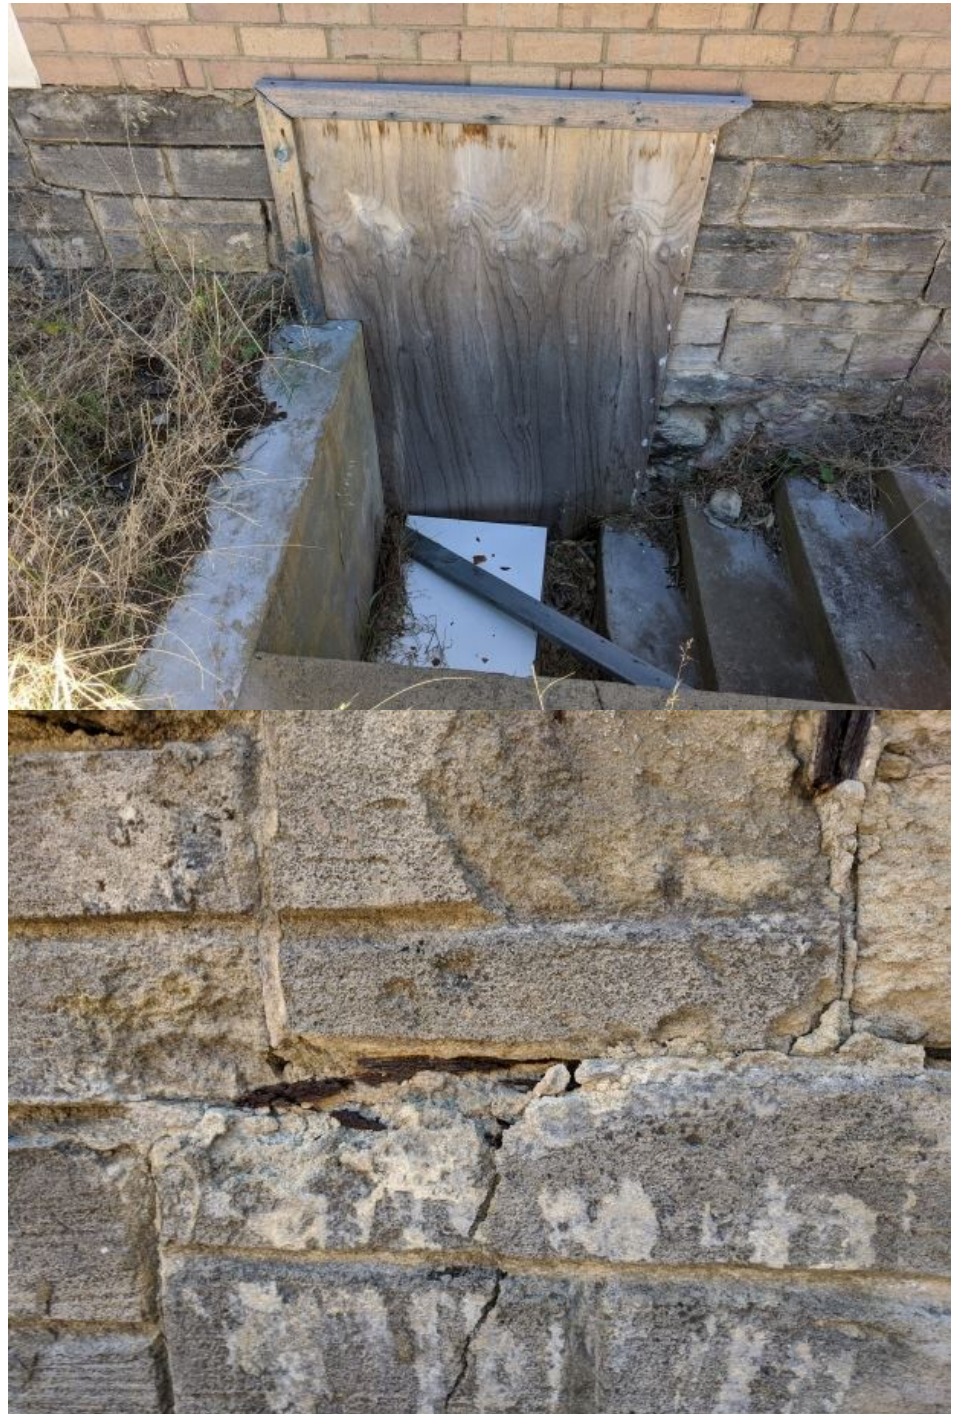
| 001-022 | The basement was not accessible. There was some deterioration of the limestone blockwork and mortar around the basement entry. Embedded steel in the blocks has corroded and expanded. | <ul style="list-style-type: none"> <li>The basement should be accessed for a termite inspection.</li> <li>Remove corroded steel from the limestone blocks.</li> <li>Re-point the joints with lime mortar or similar to prevent damage to the limestone blocks.</li> </ul> | |

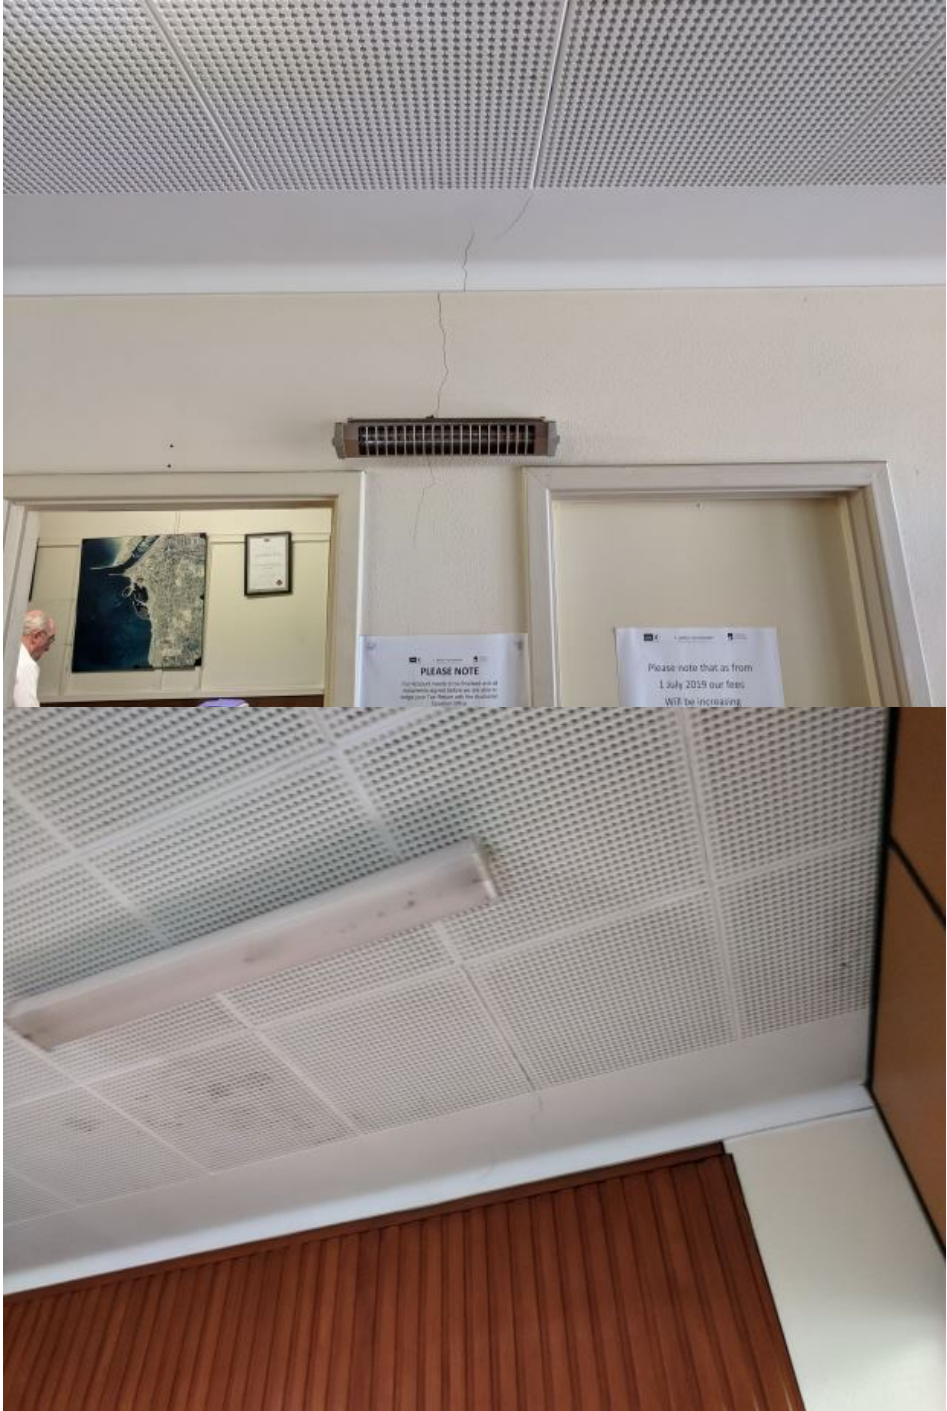
| ITEM: | PHOTO: |
|---|---|
| 001-004 | |

| 001-004 | Crack in wall between doors, and some ceiling cracks | <ul style="list-style-type: none"> <li>The crack between the doors is indicative of some foundation movement. This crack should be stitched at every second course using the Helifix Crack Repair System.</li> </ul> | |

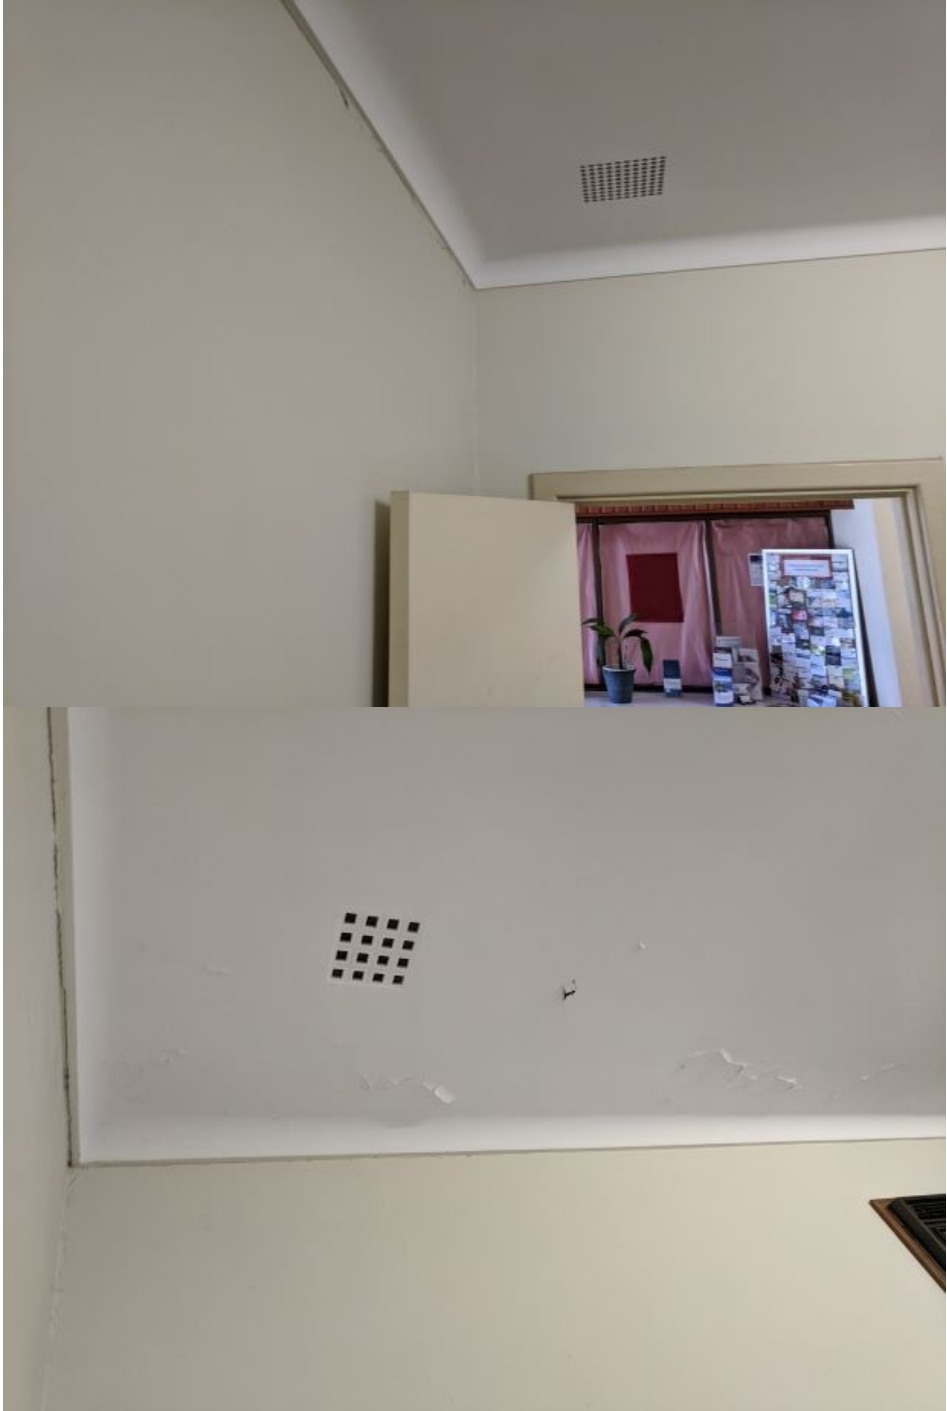
| ITEM: | PHOTO: |
|---|---|
| 001-005 | |

| 001-005 | Cracking around top of wall / cornice. Some moisture damage to ceiling paintwork | <ul style="list-style-type: none"> <li>Cracking along the cornice can be a symptom of a number of things. Commonly, the roof timbers expand and contract with variations in temperature and moisture. This can lead to minor movements that crack the brittle plaster.</li> <li>Externally, some sag was noticeable in the roof; likely due to moisture and long term loads.</li> <li>Where leaks occur, they should be traced and repaired to avoid damage to ceilings. As it was summer (and dry) at the time of inspection, the ceiling was not wet at the time of inspection.</li> </ul> | |

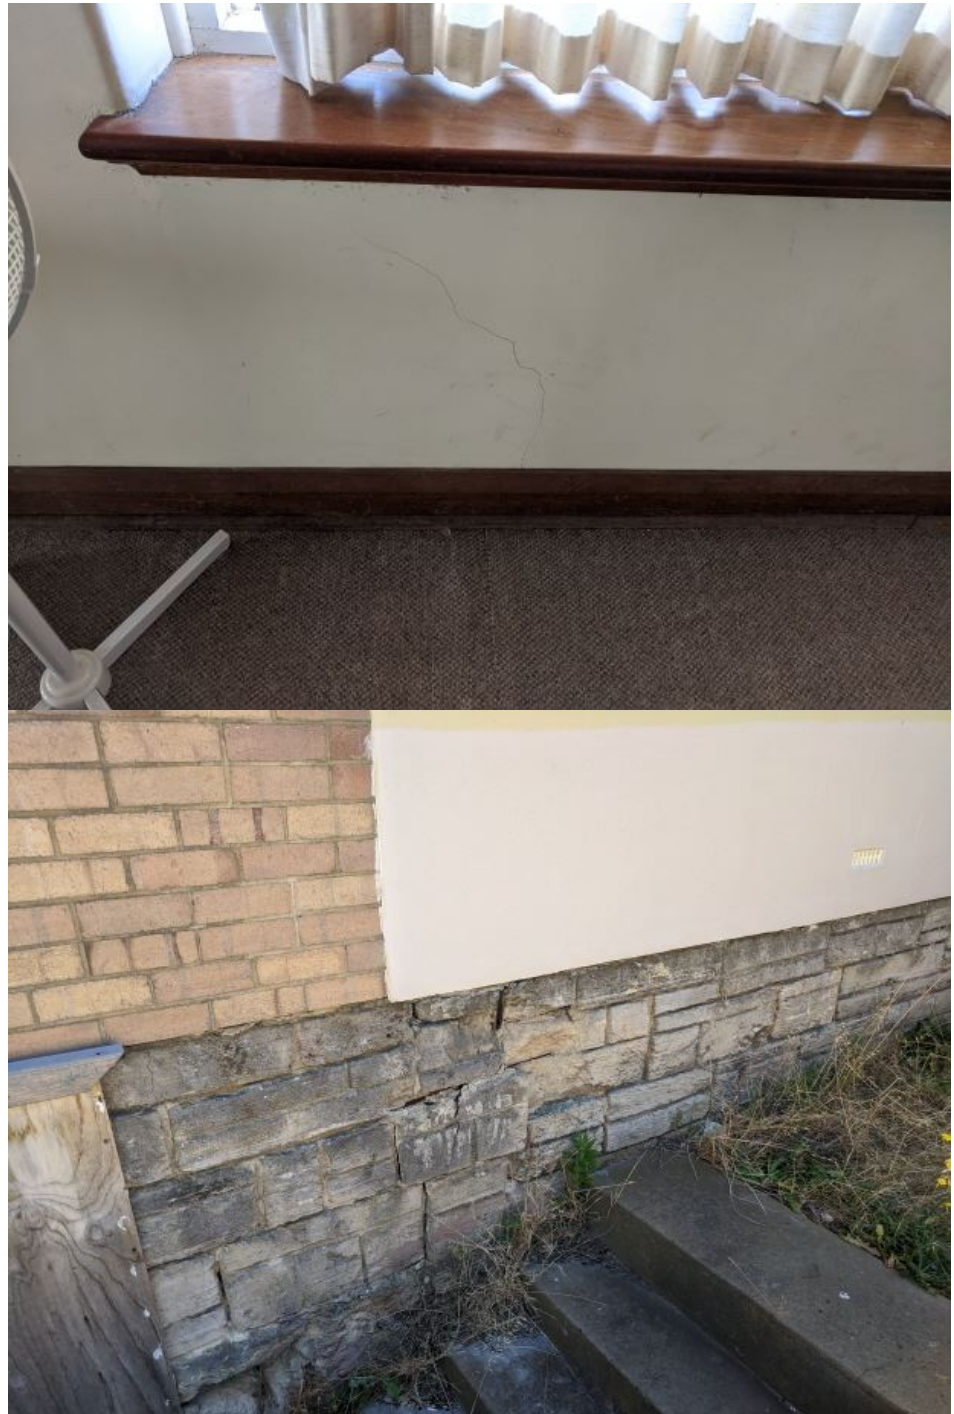
| 001-006 | Crack in the brickwork below the window in the meeting hall. This appeared to above the entry to the basement. Externally, there was some deterioration of the foundation limestone; and the embedded steel was corroded. | <ul style="list-style-type: none"> <li>The crack should be repaired using the Helifix Crack Repair System.</li> <li>The crack is likely due to the condition of the supporting wall. As there was no access to inspect within the basement, we can only go on the condition of the external wall, which was deteriorating.</li> <li>The external basement wall should have the corroding steel removed and the mortar joints re-pointed. As the wall appears to be limestone, it will likely require lime mortar for repair works. (Cementitious mortar may cause further damage to the limestone blocks)</li> </ul> | |

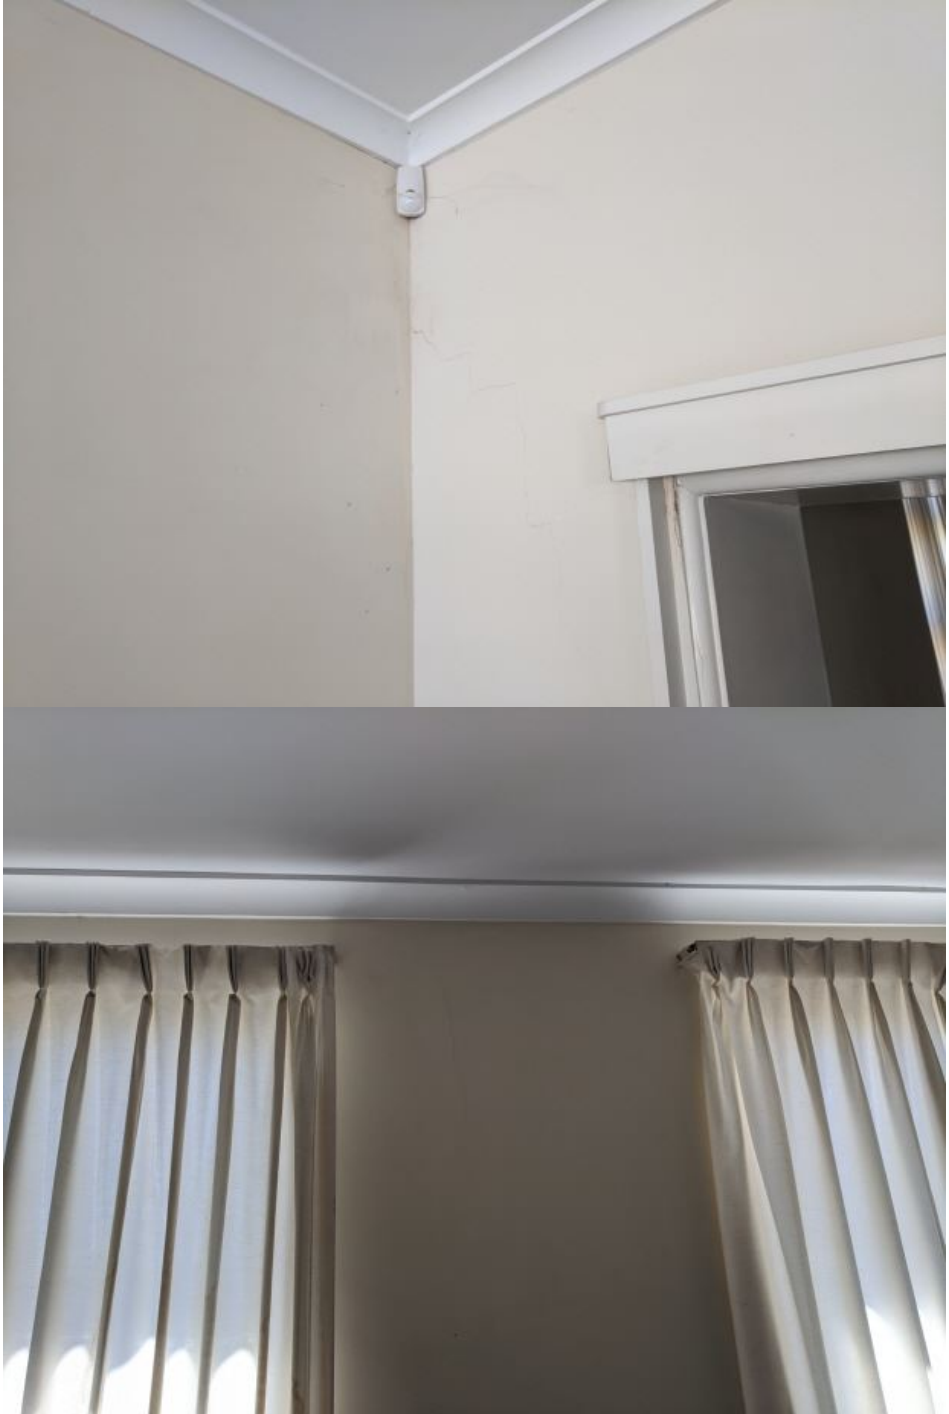
| ITEM: | PHOTO: |
|---|---|
| 001-007 | |

| 001-007 | The wall beside the door to the meeting room has stepped cracking from the top of the door. The East side piers between the windows were cracked vertically. | <ul style="list-style-type: none"> <li>• Repair the crack using the Helifix Crack Repair System. Reinforce at two course centres.</li> <li>• The vertical cracks in the piers should be repaired using the Helifix Crack Repair System.</li> </ul> | |

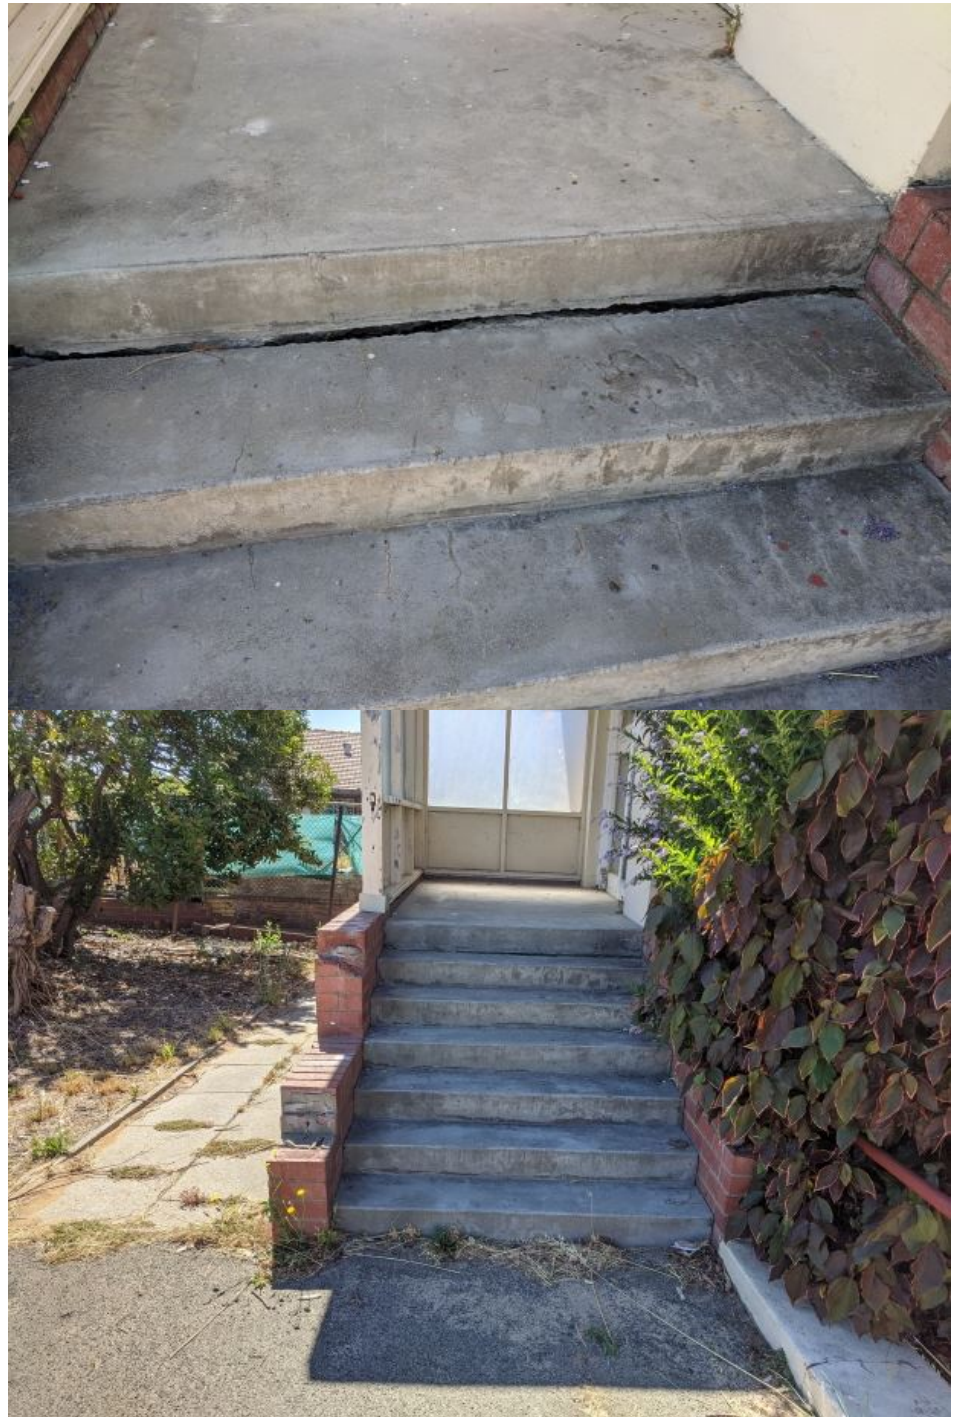
| 001-013 | Stair has subsided. Outer handrail has been removed. Inner handrail may have been impact damaged. It has also corroded and spalled the brickwork surrounding it. | <ul style="list-style-type: none"> <li>Seal the horizontal crack in the stair and monitor for further subsidence.</li> <li>Repair brickwork and replace handrails.</li> </ul> | <br><br><br> |

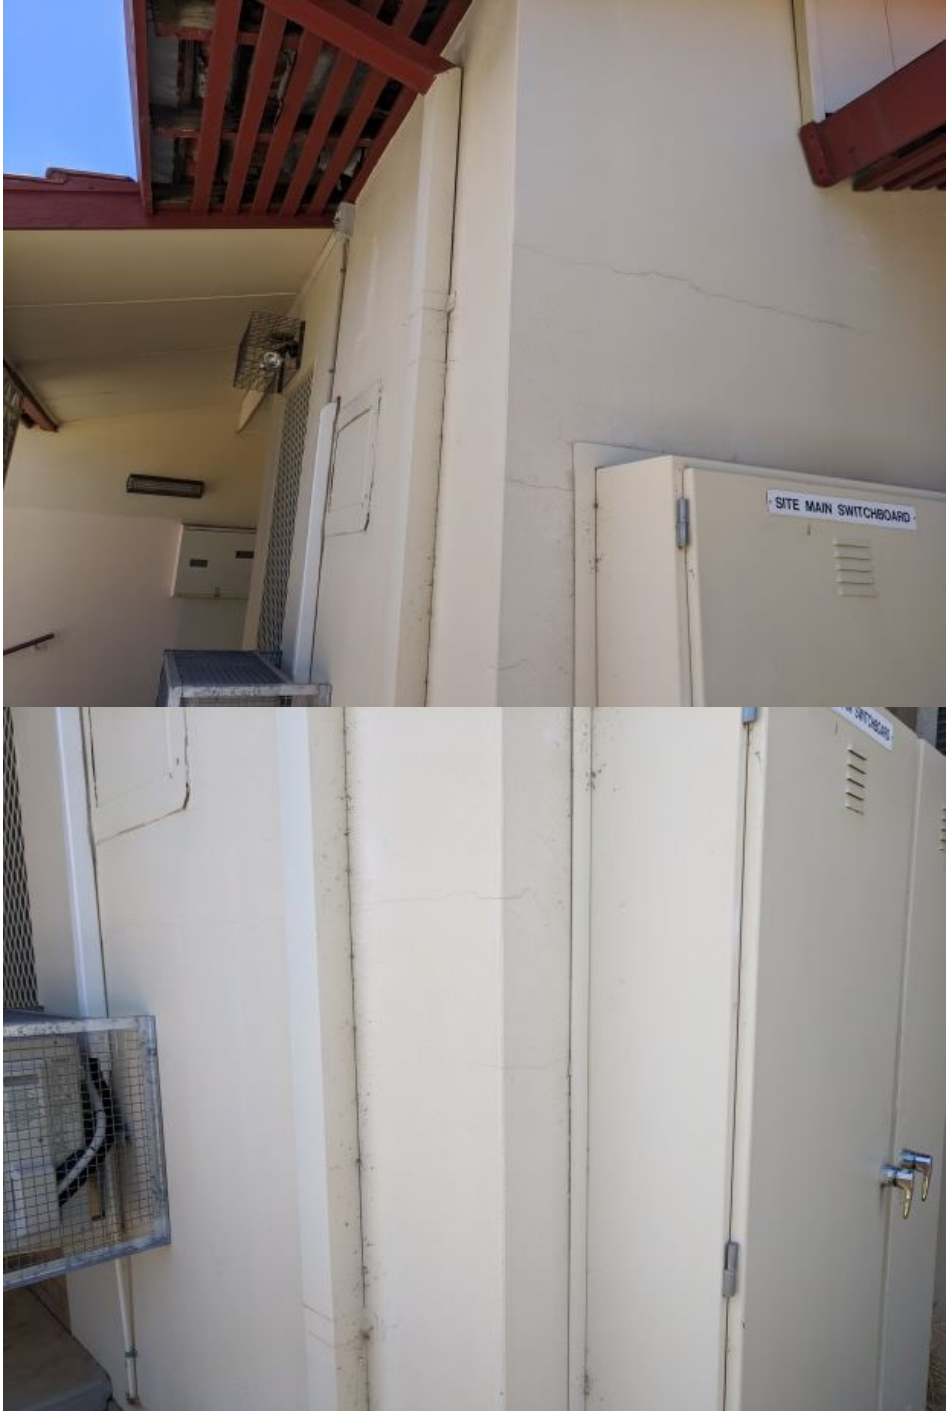
| 001-017 | Horizontal cracking at corner near switch board. | <ul style="list-style-type: none"> <li>Repair the cracks using Helifix Crack Repair System. For horizontal cracks this does not involve reinforcement.</li> </ul> | |

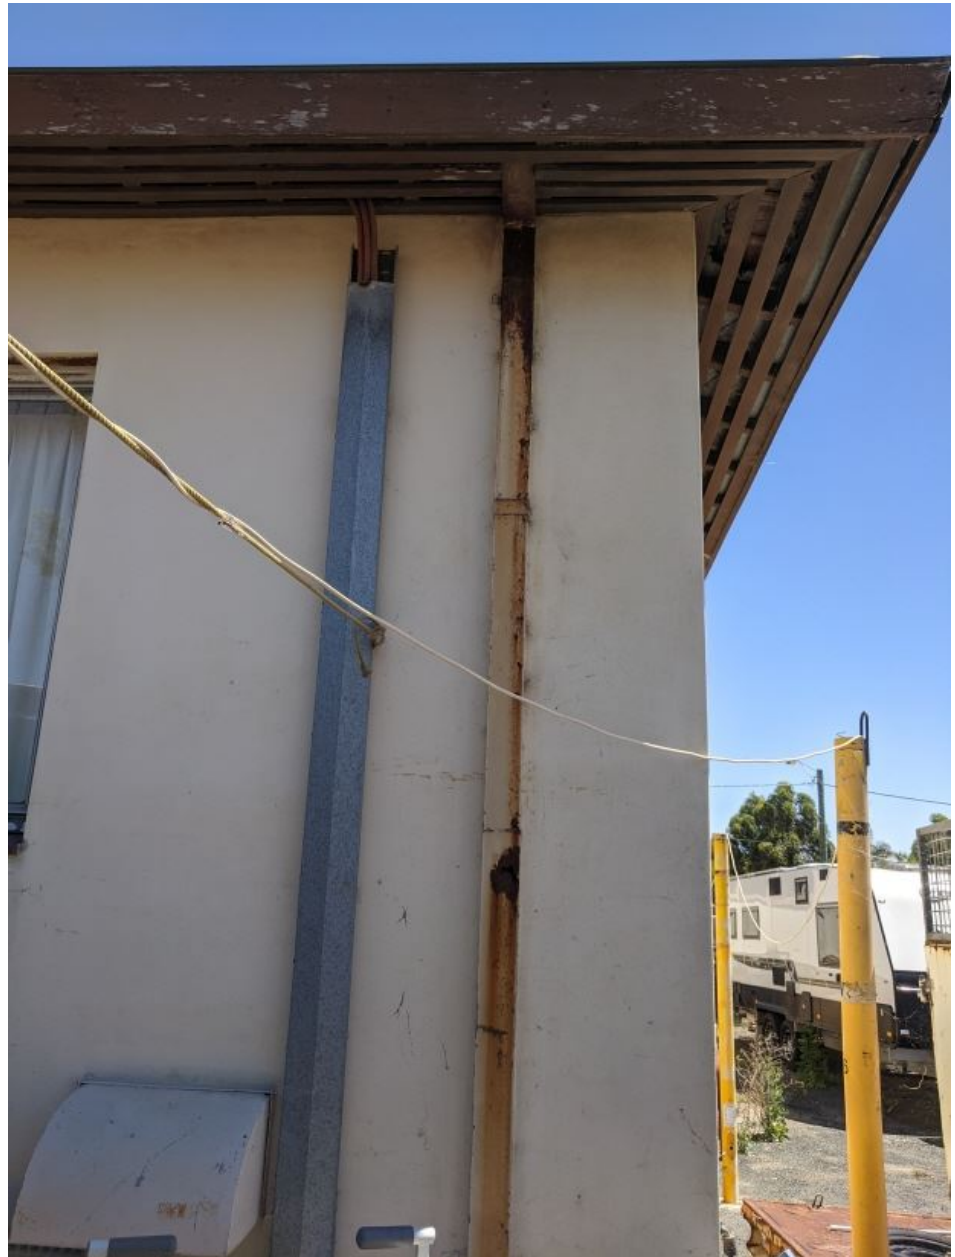
| 001-024 | The downpipe on the South face of the SE corner of the building is severely corroded. | <ul style="list-style-type: none"> <li>Replace this downpipe. Ensure stormwater is directed away from the base of the wall.</li> </ul> | <br> |

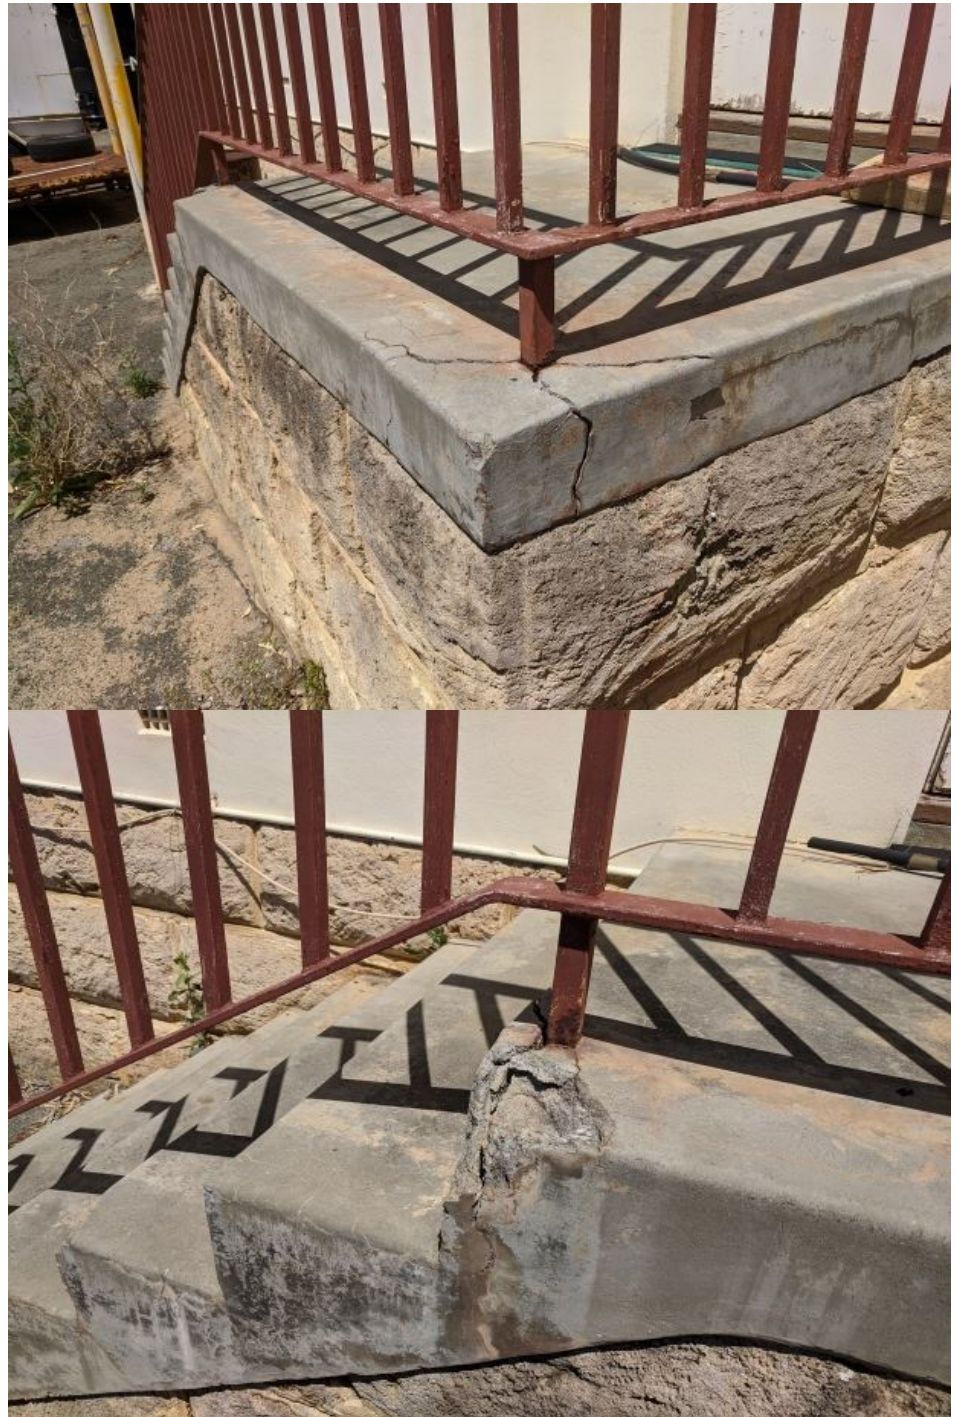
| 001-025 | The stair up to the unused kitchen door had spalled around the embedded handrail posts. | <ul style="list-style-type: none"> <li>Remove the handrail and embedded steel.</li> <li>Repair the stair and replace the handrail.</li> <li>Alternatively, if not required for escape, demolish the stairs and brick up the door to the kitchen.</li> </ul> | <br> |

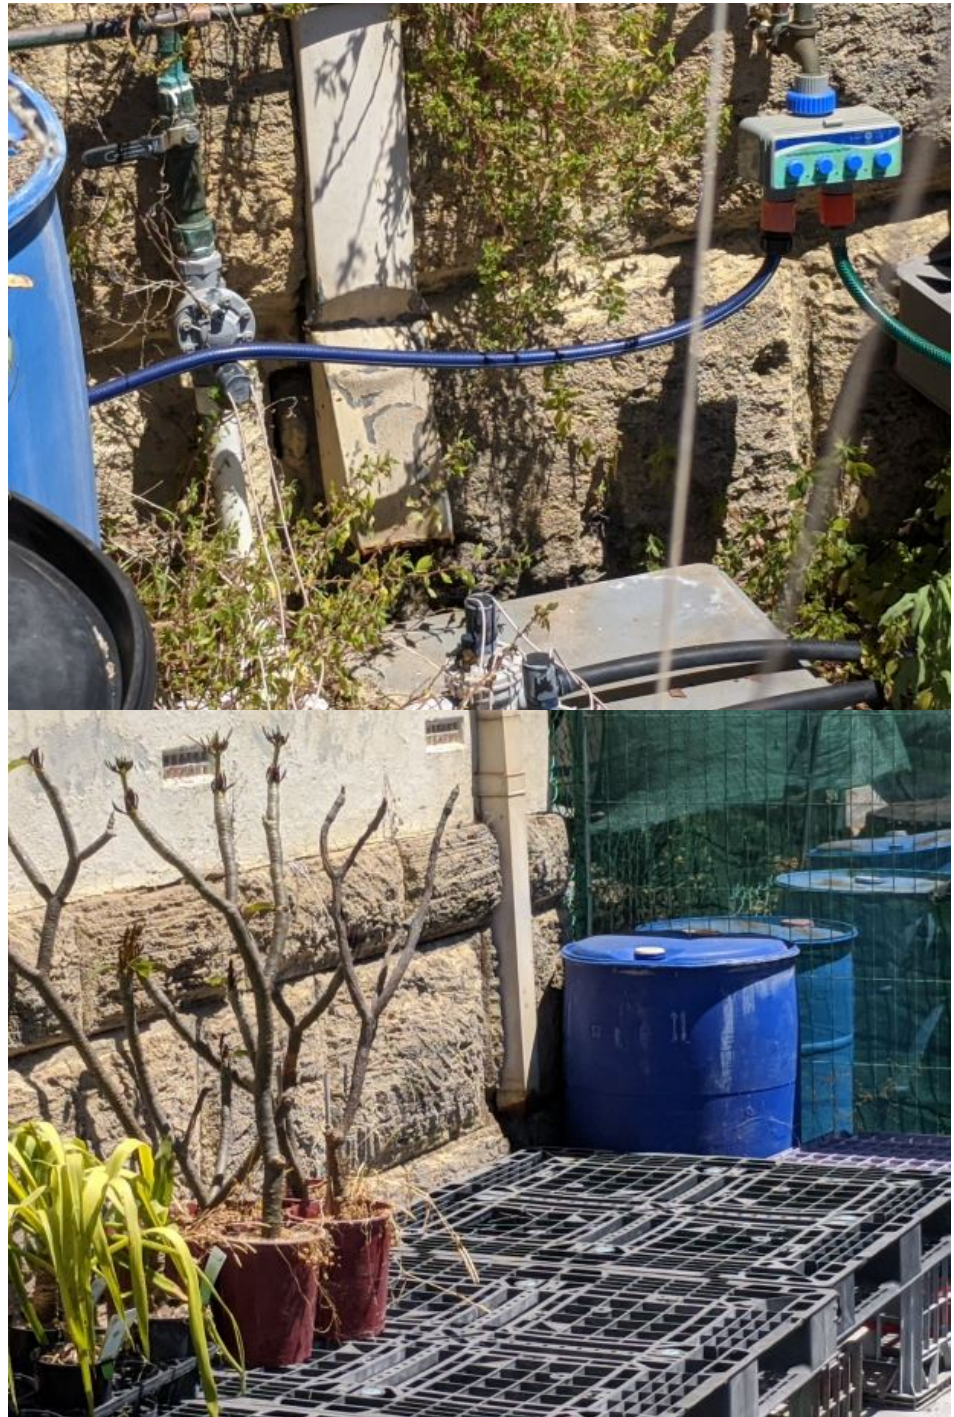
| 001-026 | Downpipes were corroded away near their base with one also being partially crushed. | <ul style="list-style-type: none"> <li>Trim the corroded portions of the downpipes and replace the bottom portion, redirecting water away from the footings. If no garden beds are available for this disposal, then install a soakwell.</li> </ul> | |
