1 Forrest Rd, Hamilton Hill

Structural Inspection Report

M15819

BPA Engineering were requested, by Dwayne Rowland of Kardan Construction, to undertake a structural audit of the existing buildings at 1 Forrest Rd, Hamilton Hill.

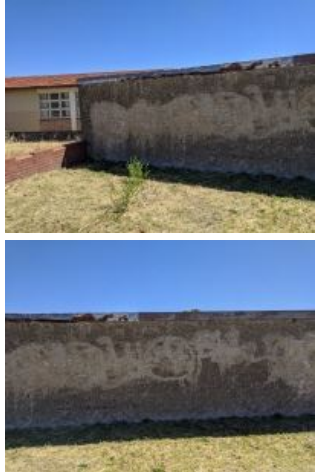
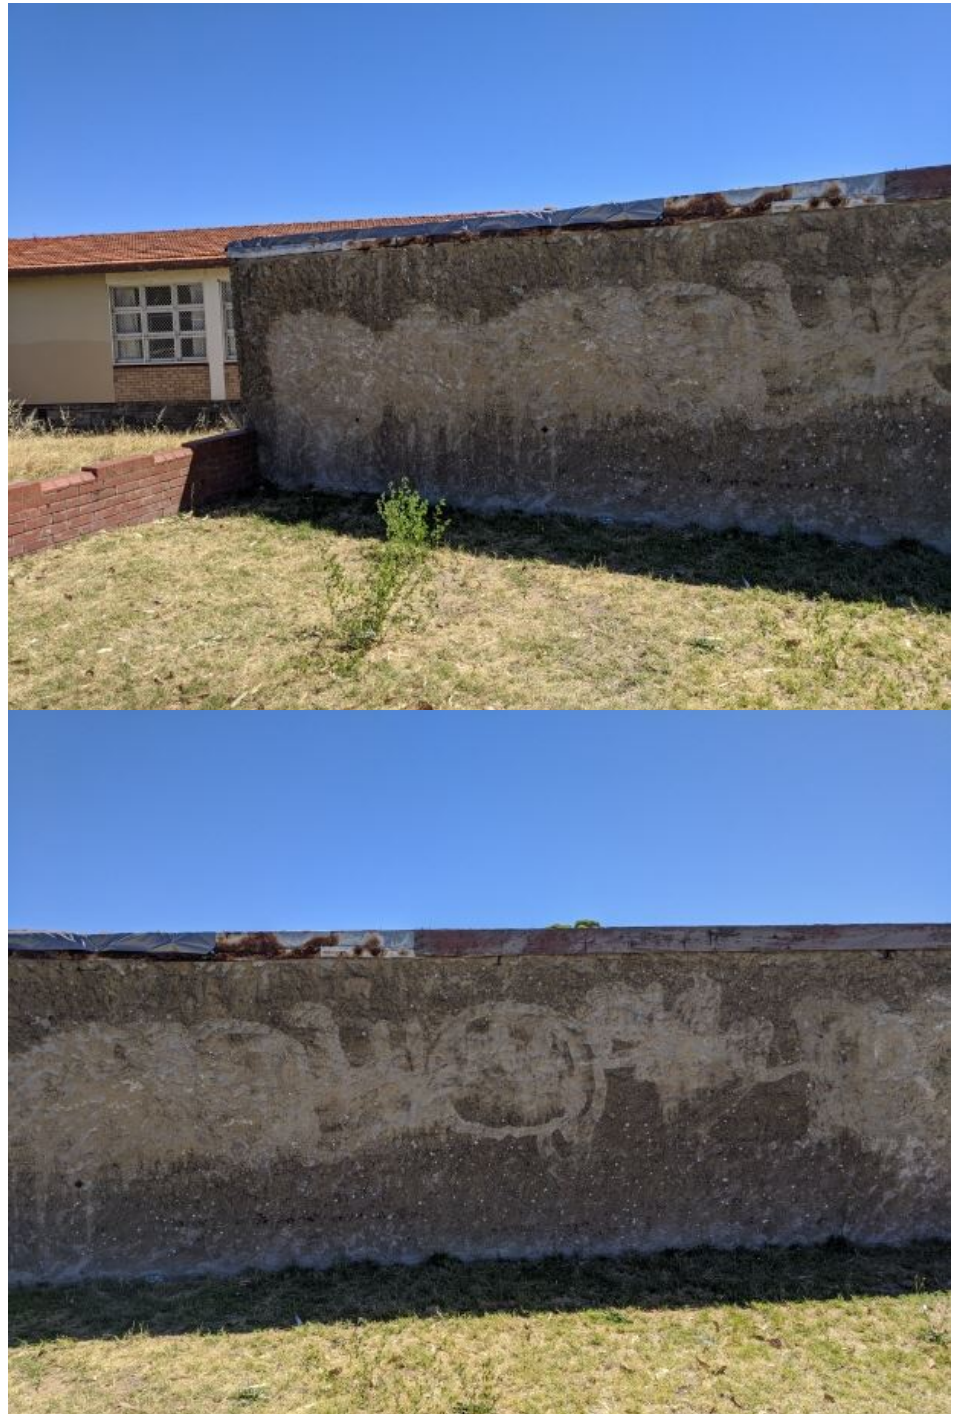
| 002-002 | The South West corner of the building has a flashing that has severely corroded. The remainder has a timber barge board. | |

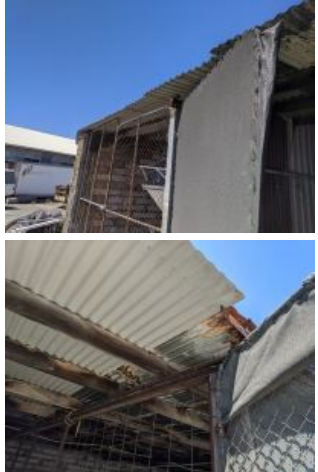
| 002-005 | The edge purlin was missing in the first two bays. The sheeting had been replaced. The remaining purlin (back from the edge) in the end bay had been deeply notched. | |

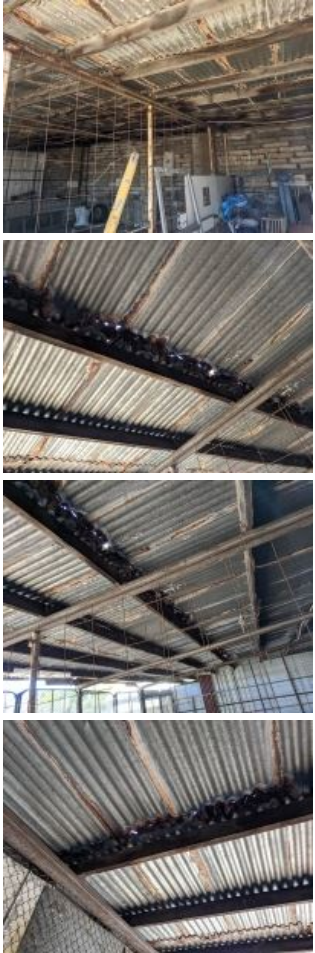
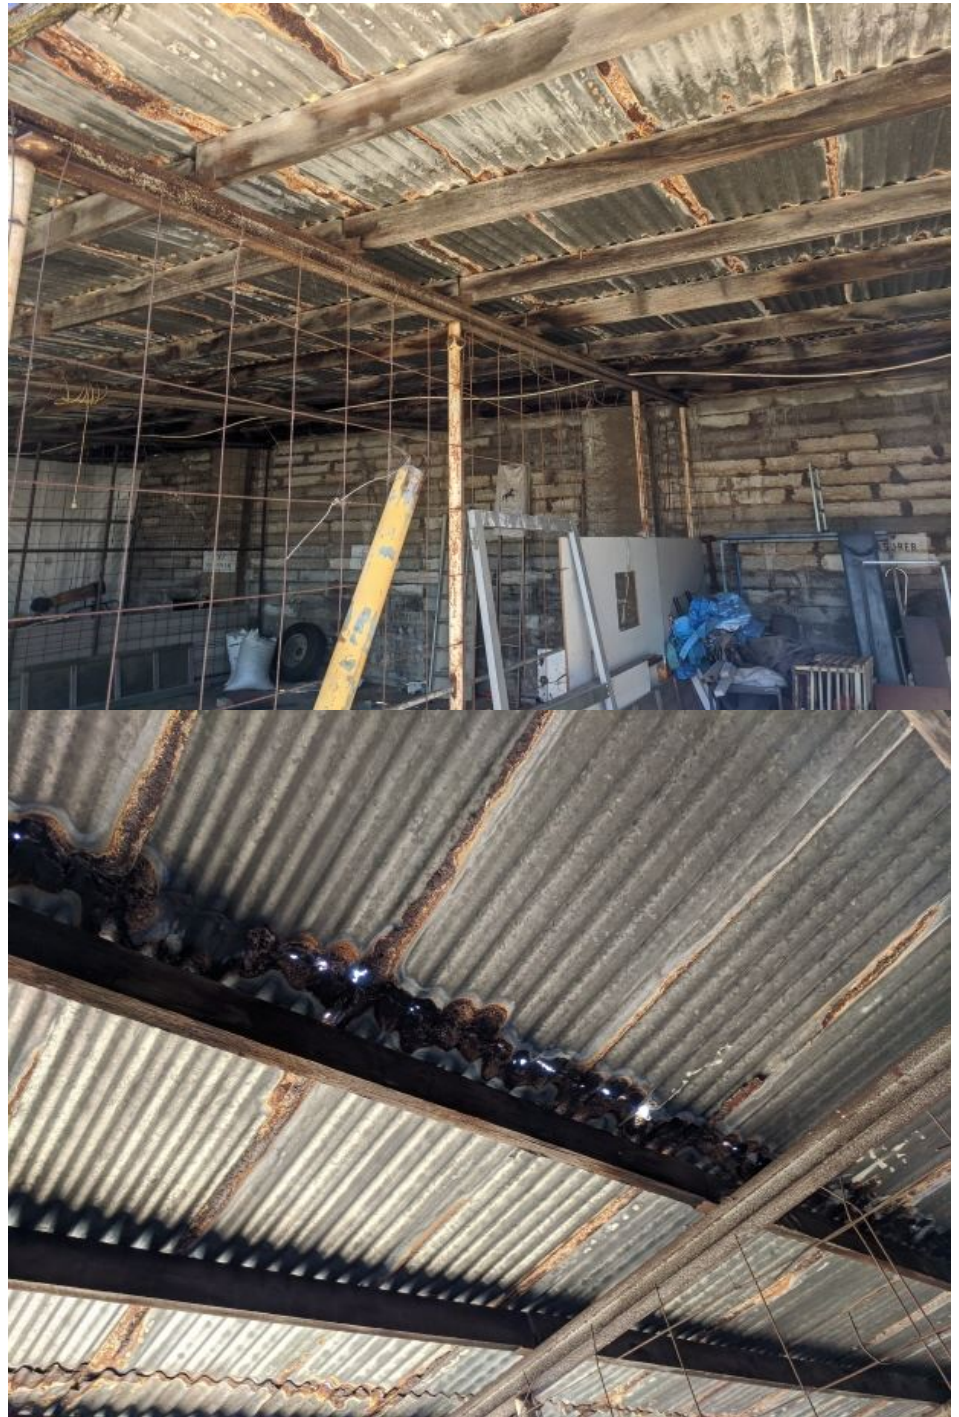
| 002-007 | Generally the roof sheeting was in very poor condition, with extensive corrosion and many holes. | |

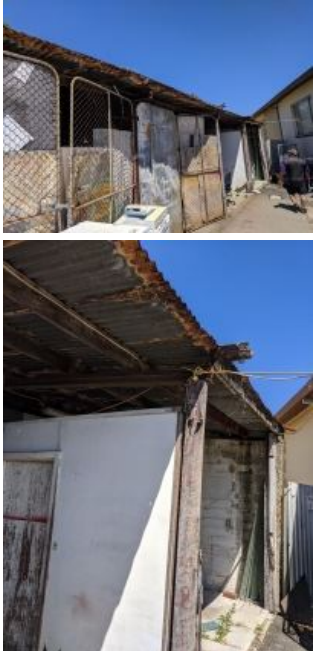
| 002-008 | The edge purlin is missing along the North face near the West end of the building. | |

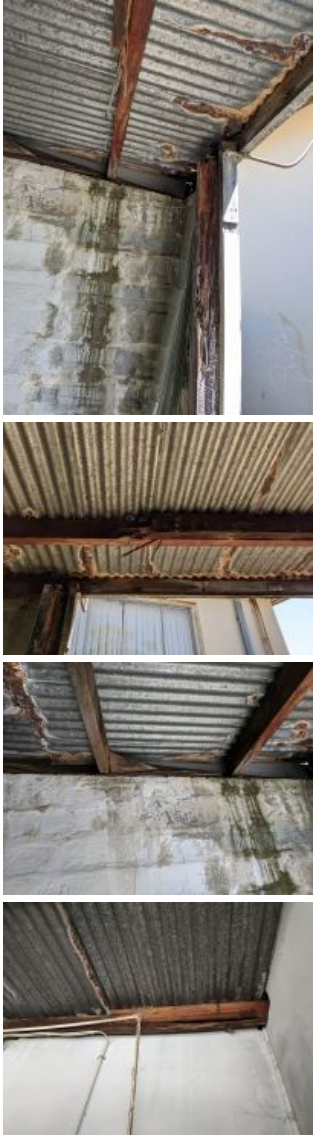
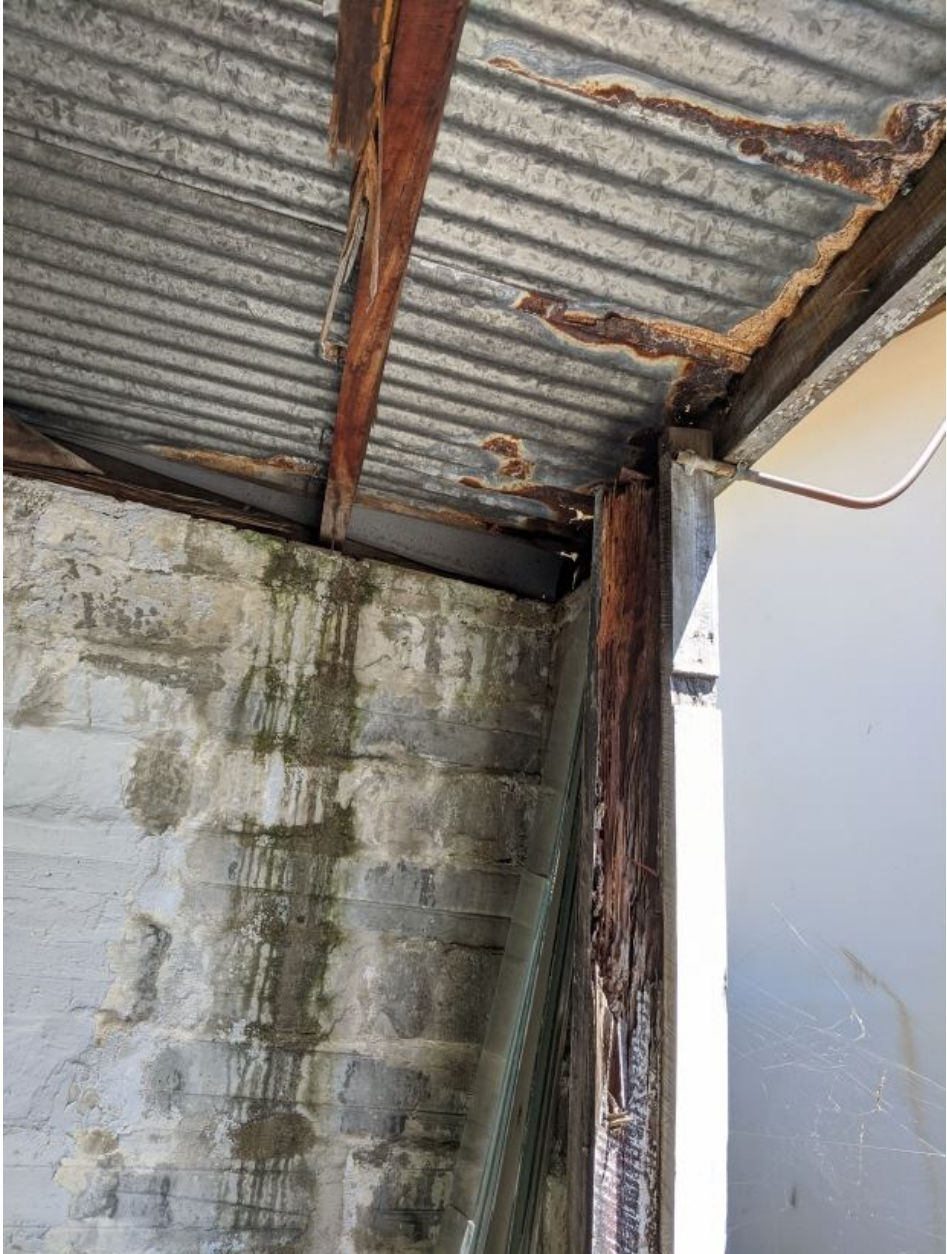
| 002-009 | The West end of the building has comprehensive termite damage. | |

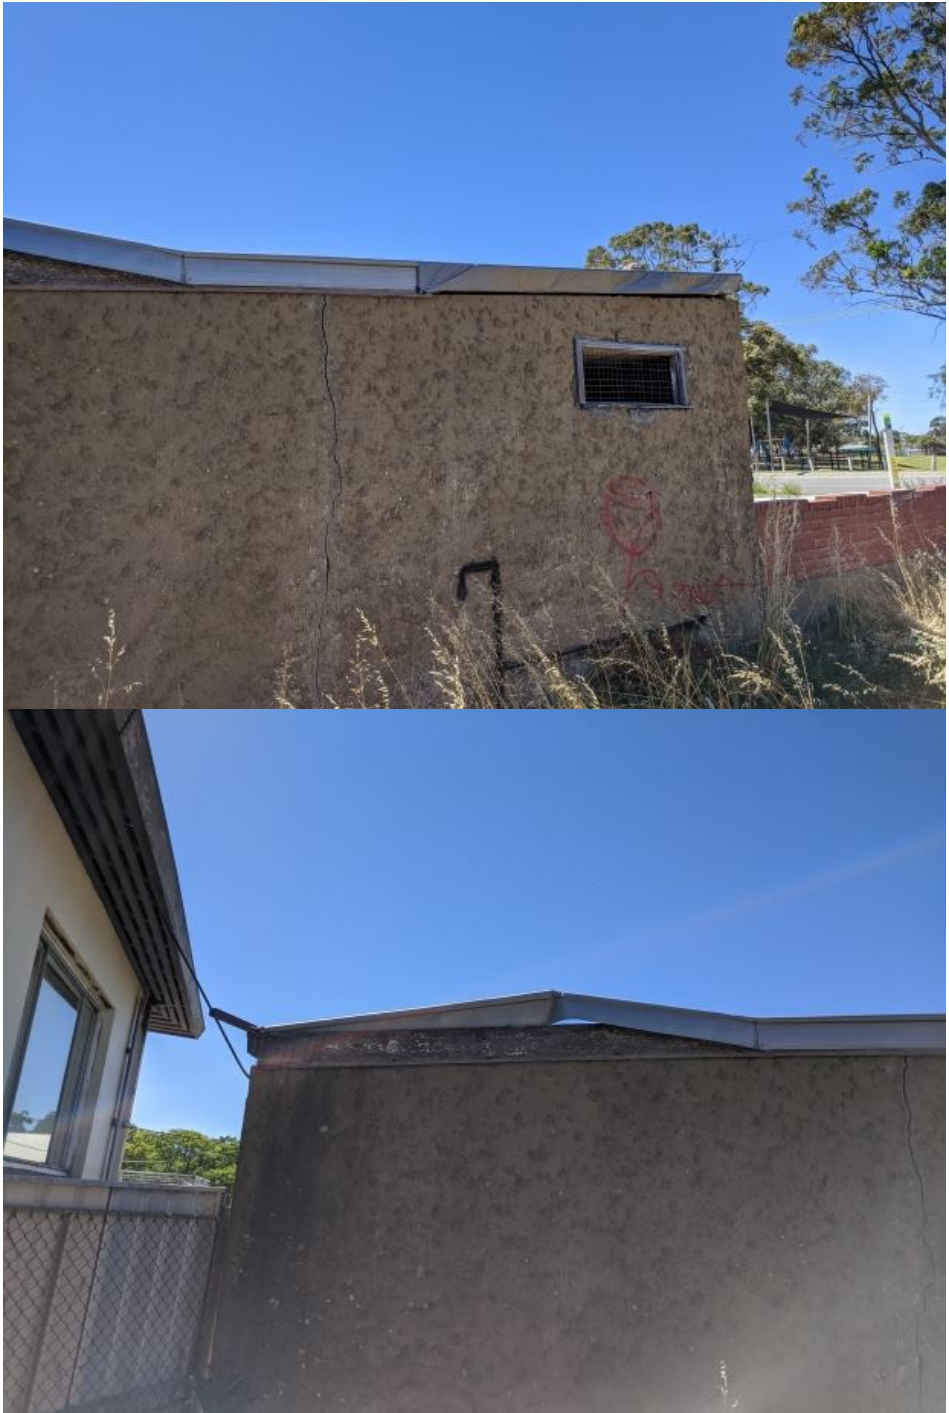
| LOCATION: | B2 - West End (Ext) | |
|---|---|---|
| 002-001 | A large vertical crack was evident in the end wall of the building. The flashing on the NW corner was partially detached. On the SW corner, a tarp had been placed over the roof. The opening in the wall to the toilet has a timber surround that has deteriorated. | |

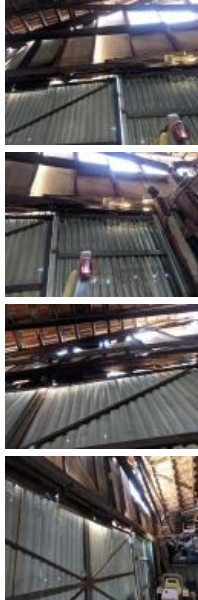
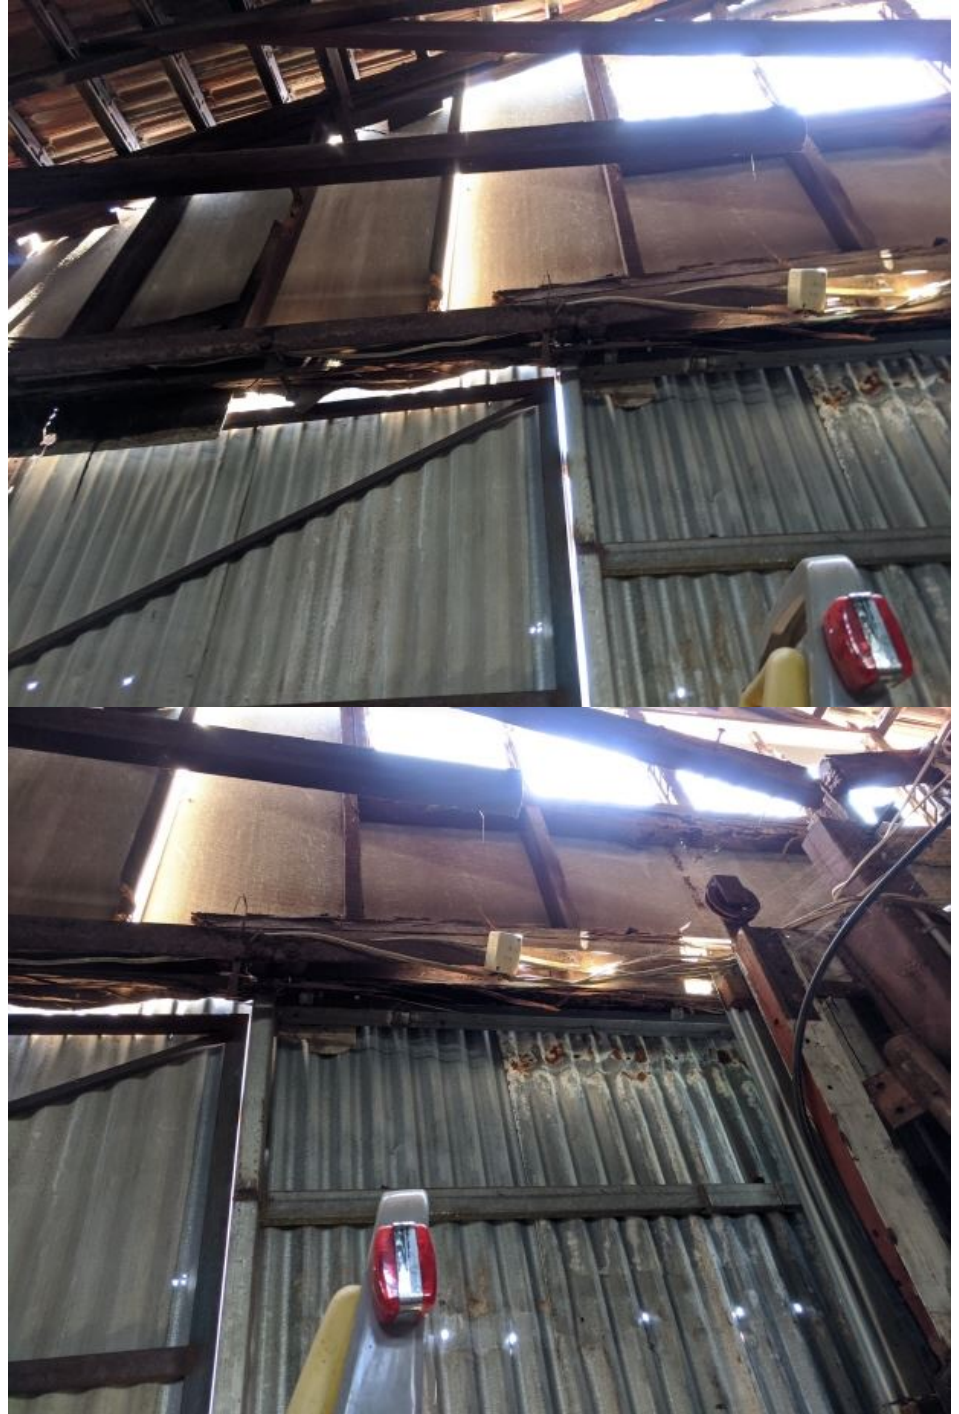
| LOCATION: | B4 - North | | |
|---|---|---|---|
| 004-002 | The timber structure supporting the north face of the building is severely damaged by termite activity. Timber members providing lateral support over the doors have also been compromised. | <ul style="list-style-type: none"> <li>The north face of the building requires demolition and re-construction.</li> <li>Note that the facade cladding may be asbestos.</li> </ul> | |

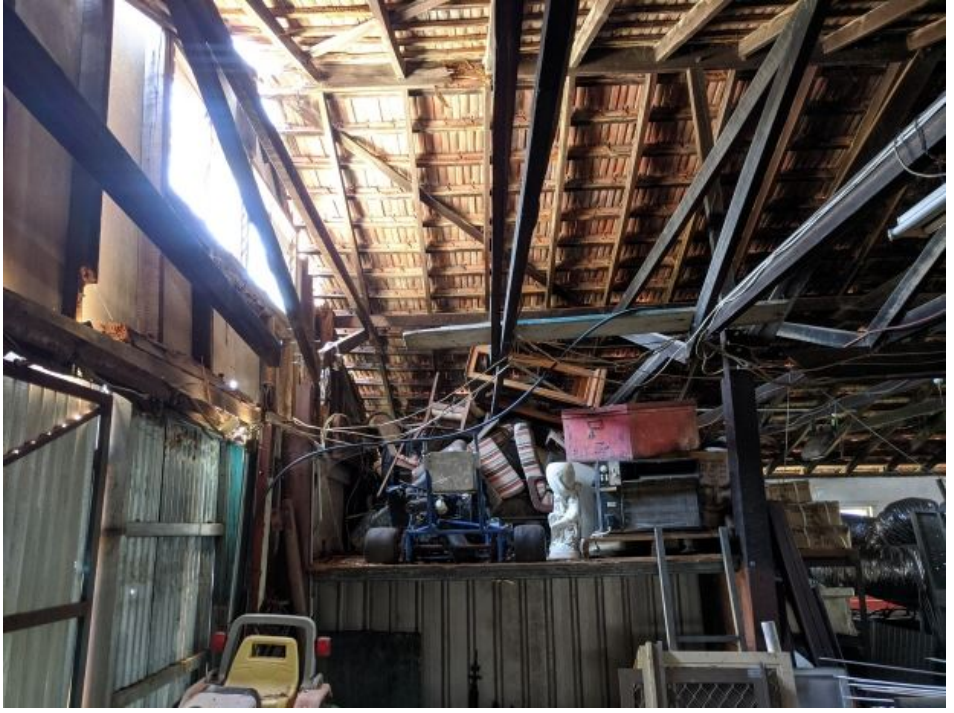
| ITEM: | PHOTO: |
|---|---|
| 004-005 | |

| 004-005 | Beyond the North bay of the building, the majority of the timber structure appeared to be in acceptable condition. | | |
