**BEALE PARK REDEVELOPMENT**  
Traffic Impact Statement

15 November 2024

# *Tree Survey – Beale Park, Prepared for City of Cockburn*

*Tree Survey – Beale Park, Spearwood – March 2021*

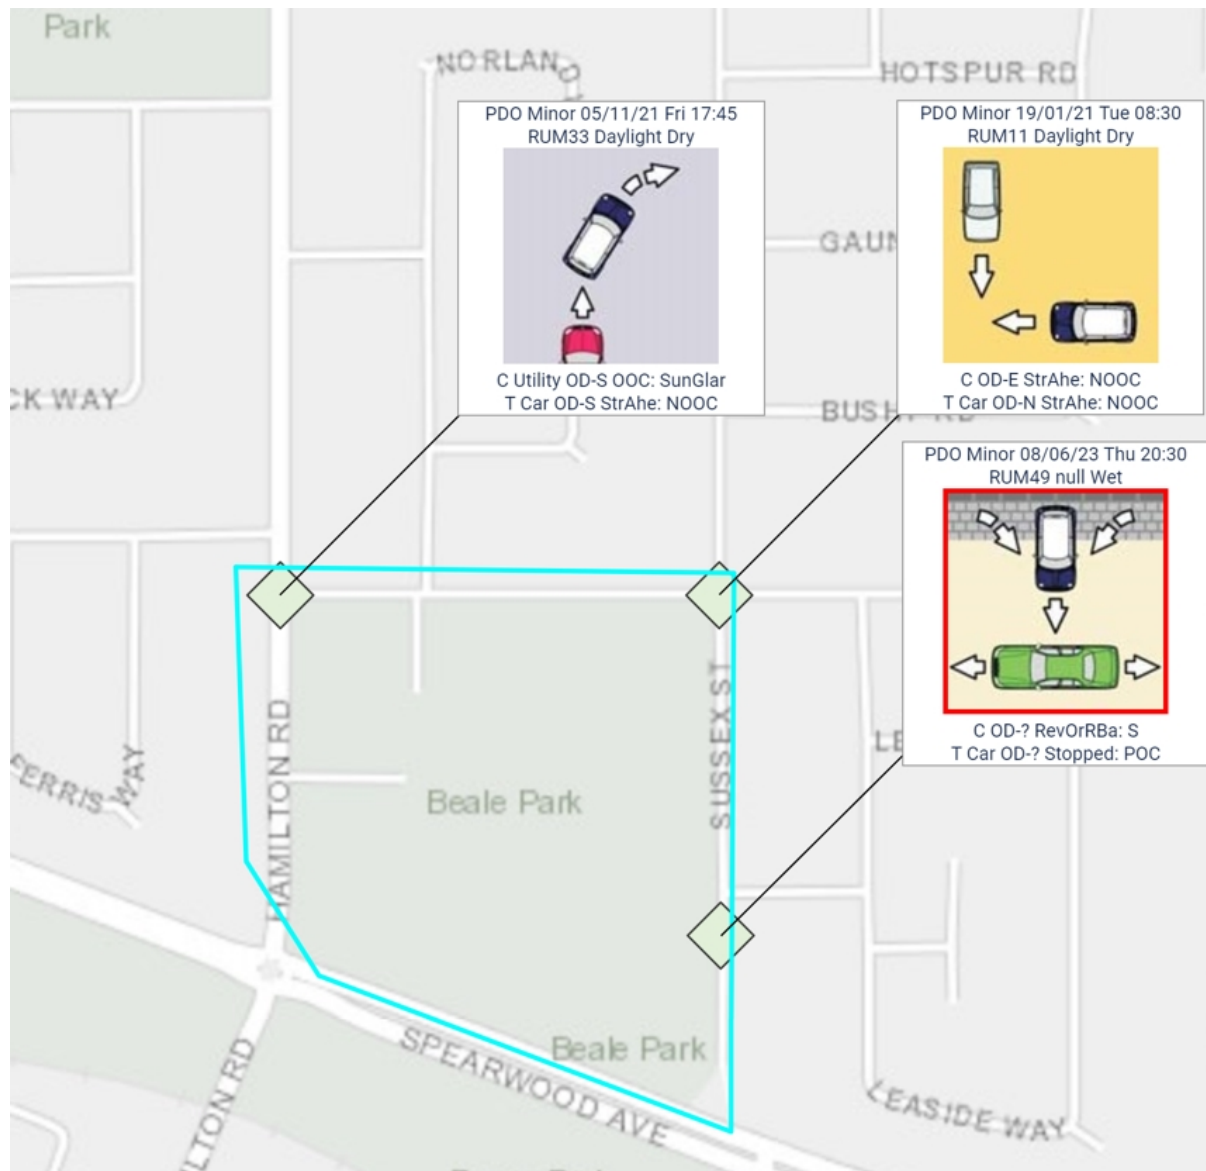
**Figure 12-1: Crash Data for Beale Park Surrounding Roads**

As shown from the figure, there were only three (3) recordings of crash, where two happened at intersections. As the proposed redevelopment does not involve relocating accesses, it is not expected to increase the likelihood of this trend as identified from the crash analysis.

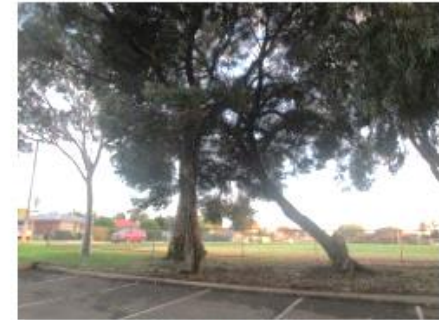
Tree 3

| Tree tag n. | Botanical name | Age Class | Height (m) | Canopy spread (m) | DBH (mm) | DRF (mm) | Health and condition | Recommended Works | QTRA Risk of Harm | Evidence of Cockatoos Yes/No | TPZ (m) | SRZ (m) |
|---|---|---|---|---|---|---|---|---|---|---|---|---|
| 3 | <i>Eucalyptus gomphocephala</i> | Mature | 11 | 8 | 680 | 740 | Found in good health and fair structural condition displaying a full coverage of foliage supported by codominant stems. Main union and branch attachments appear sound at this time. Minor deadwood. | No works recommended at this time. | 1/50,000 | No | 8.16 | 2.92 |
