# Manning Park Trails Rehabilitation Plan 2027–2031

The Manning Park Trails Rehabilitation Plan provides a coordinated five-year program to protect the park's natural and cultural values while maintaining safe, high quality recreational access. The plan has been informed by a comprehensive trails audit, and recent flora, vegetation, fauna and heritage assessments, which together provide a detailed understanding of current trail impacts and actions required to manage and remediate those impacts.

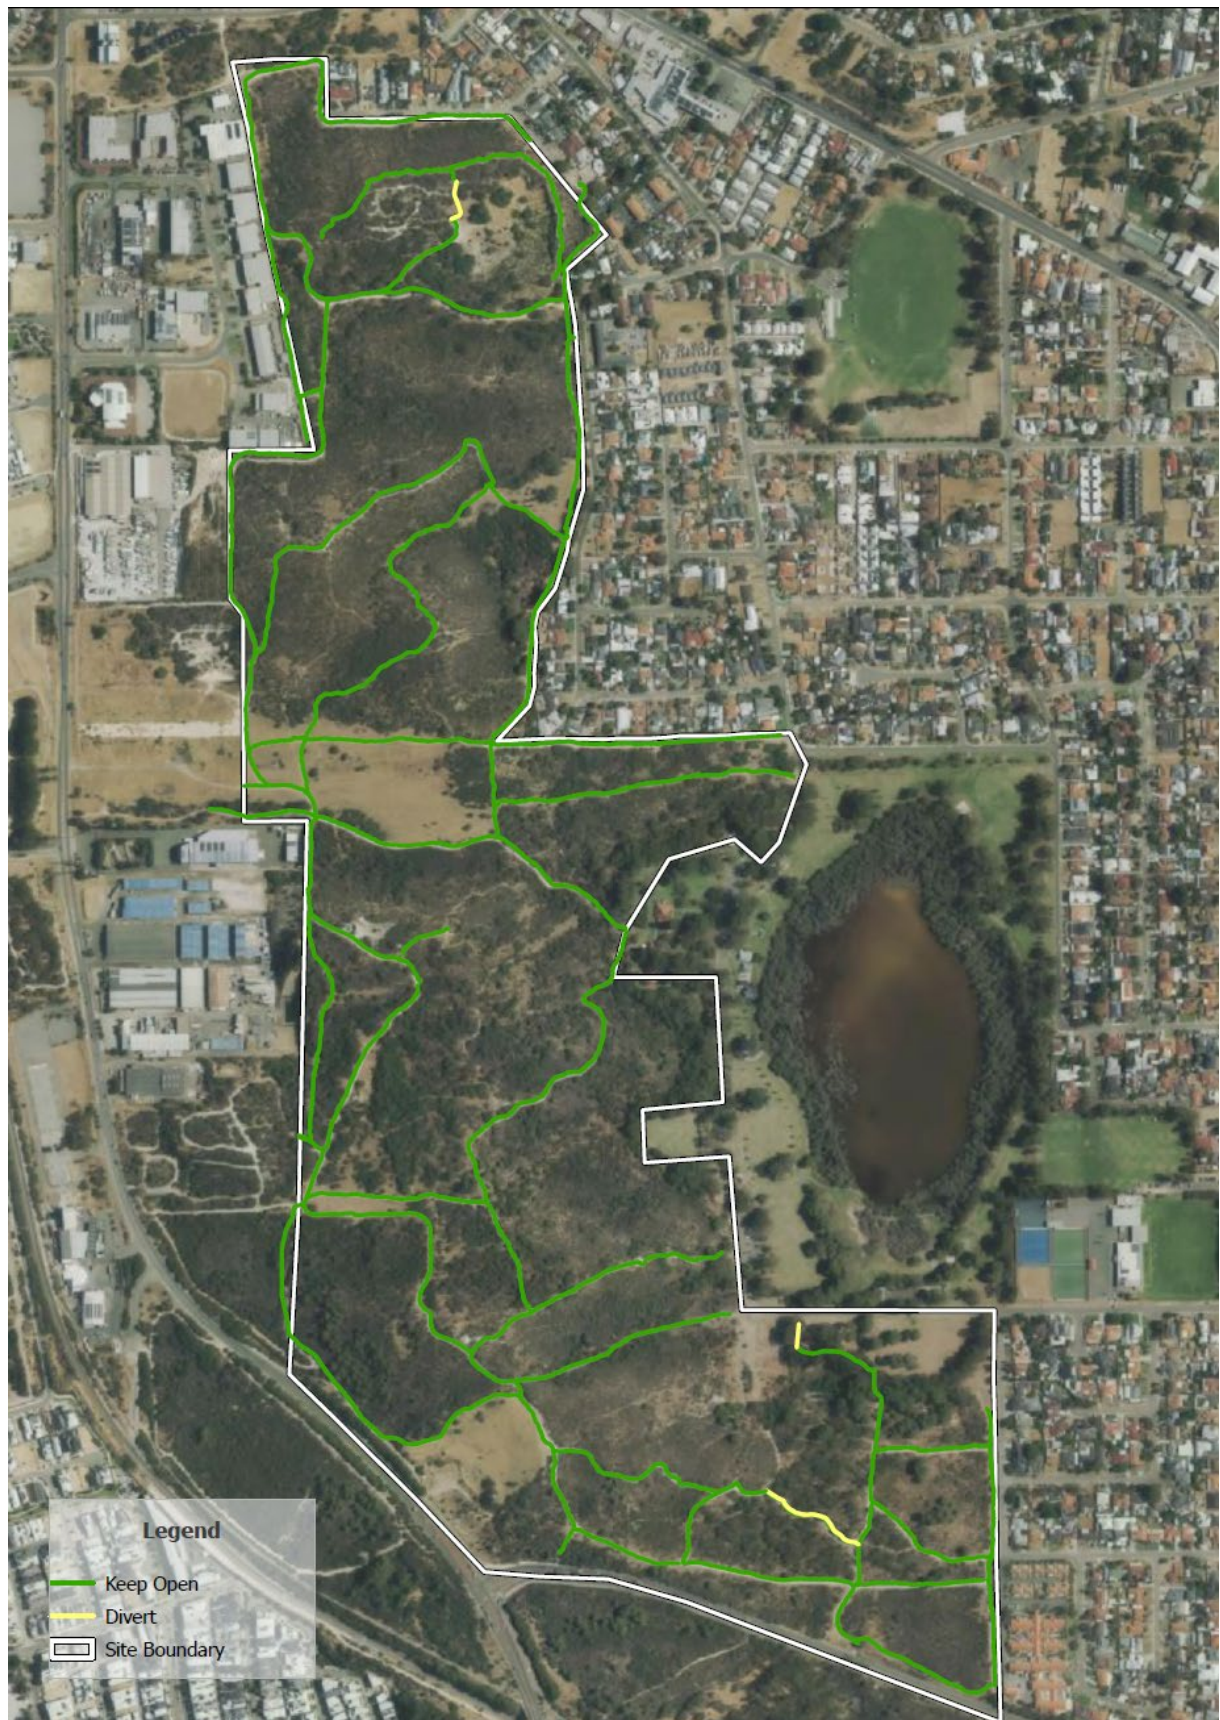
Figure 3: Trails remaining open and trail diversions

Four trails are recommended for partial closure, with a combined length of 780 m. These trails were identified because sections intersect sensitive environmental or heritage areas, while other portions provide important connectivity or safe access. Diversions are recommended where applicable to redirect access between two existing tracks and prevent degradation of adjacent areas. Trails recommended to be partially closed or diverted are shown in Figure 3.

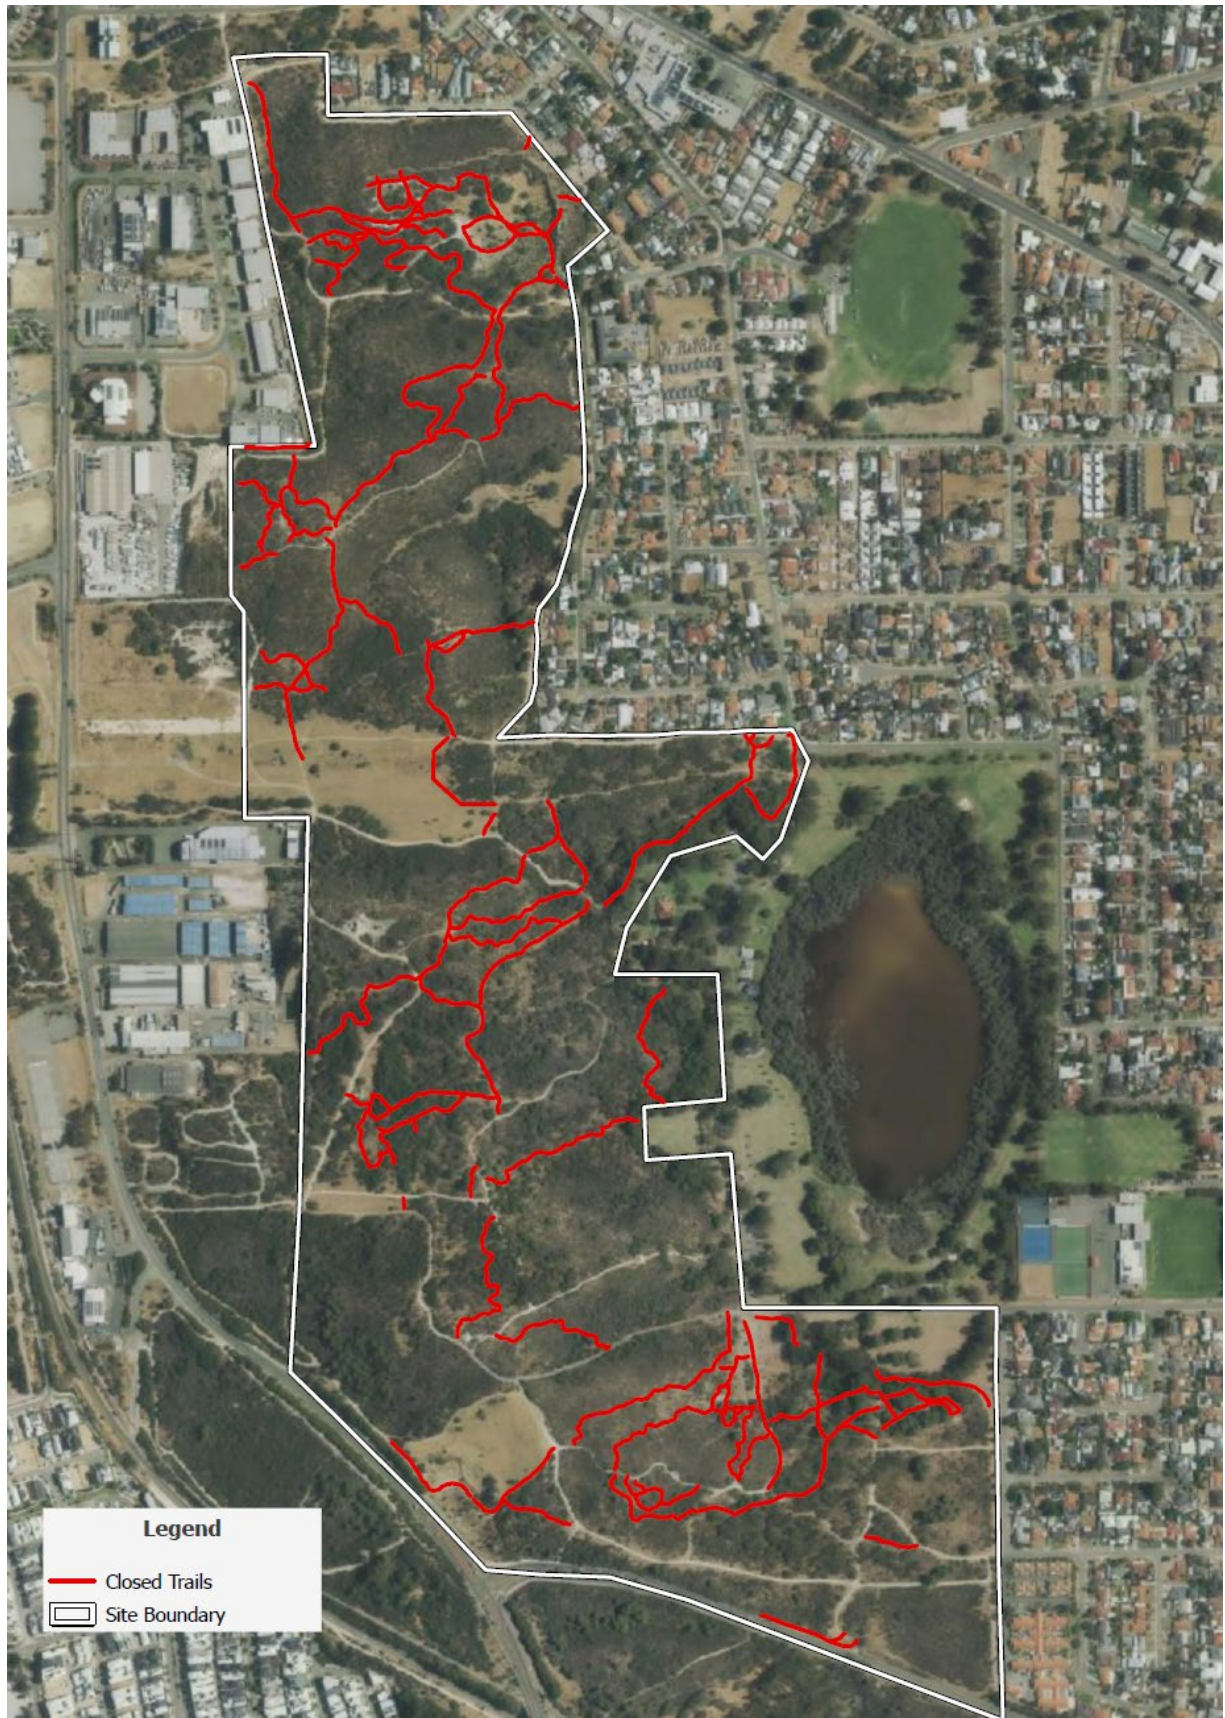
Figure 4: Trail closures

66 trails are recommended for closure, representing 11 km of informal tracks within Manning Park. These trails vary in width from 0.3 m to 1.0 m and equate to approximately 1.06 hectares of land.

A map of the trail closures is shown in Figure 4.

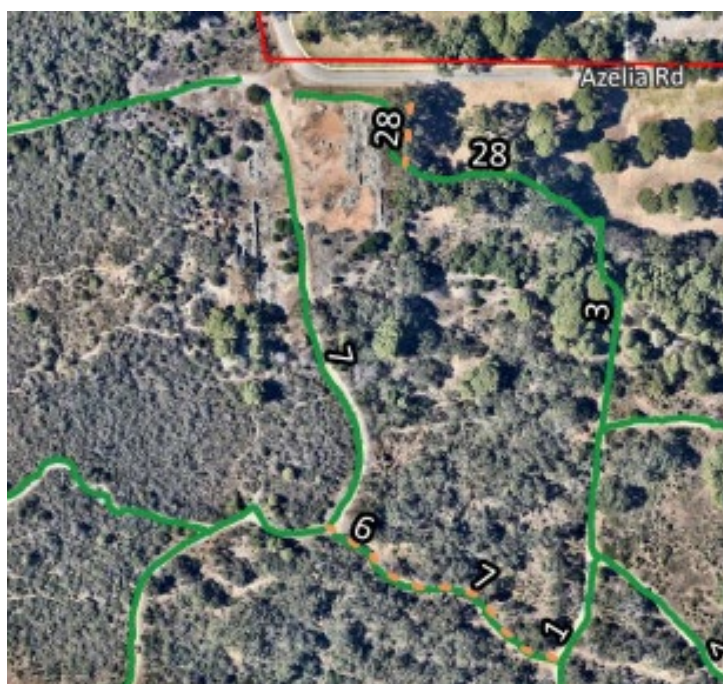
*Figure 6: Trail management at the Davilak Ruin site*

To address this, it is recommended that the north-south trail (Trail 7), which currently passes through the centre of the ruins, is diverted away. The same applies to Trail 28, which provides access to the ruins from the east.

In line with the Davilak Ruins Archaeological Management Strategy (Bush, 2014), bollards should be installed at both the northern and southern entrances to the ruin site along Trail 7 to deter entry. At the northern entry point, bollards should be positioned behind the existing educational signage. The existing vehicle access gate is to remain in place to allow the City continued access for management.

The eastern gate and associated pedestrian access point should be removed and replaced with fencing consistent with the existing fencing around the site. The large educational sign at this location should also be relocated outside the fenced area to allow visitors to appreciate the ruins from further back.
