**RE: Assessment of Identified Trees at Beale Park**

# *Assessment of Identified Trees at Beale Park*

*City of Cockburn*

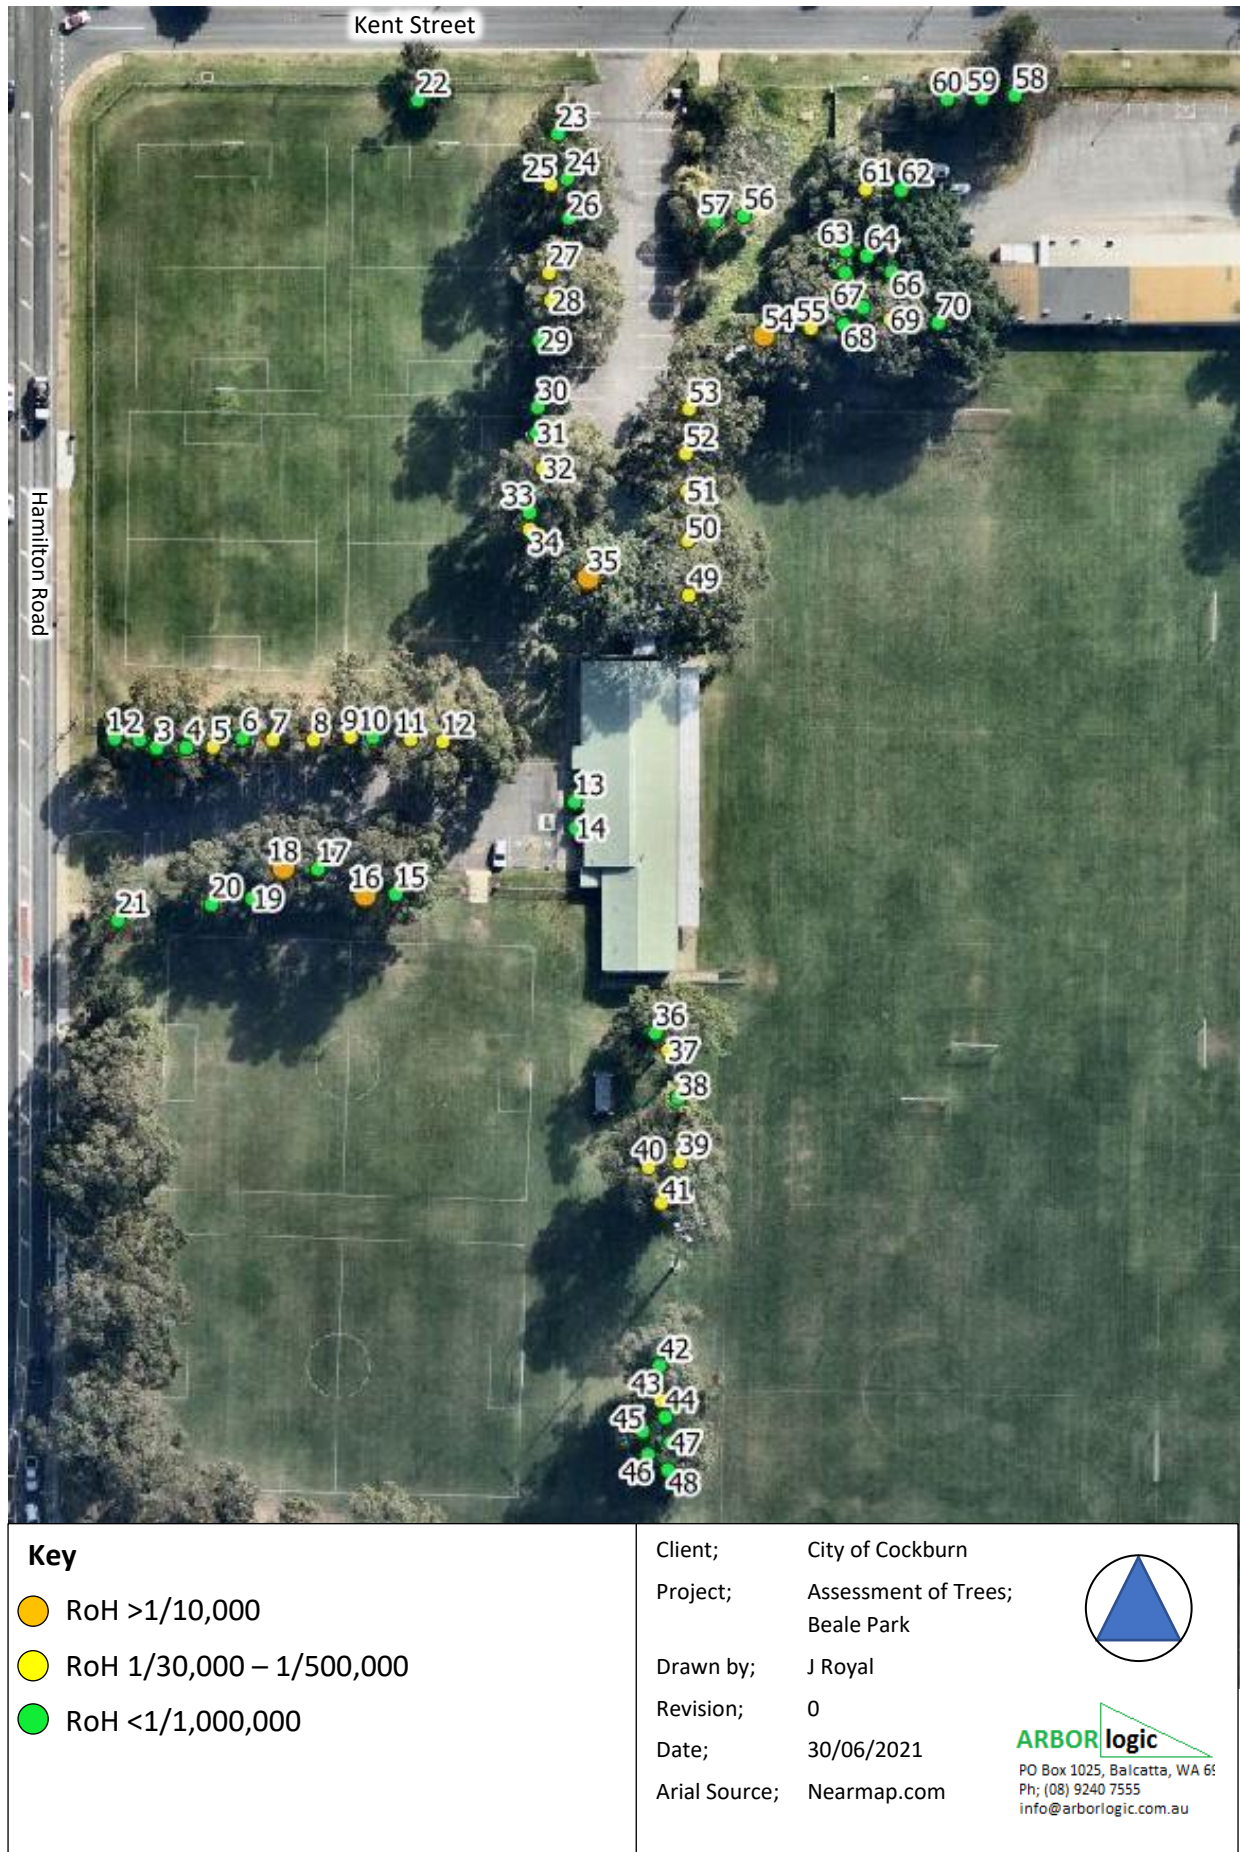
The risk of harm assessed from the Trees has been overlaid onto an aerial of the Site overleaf for reference, and an attachment to this report provides a table of information on each of the Trees included in this assessment.

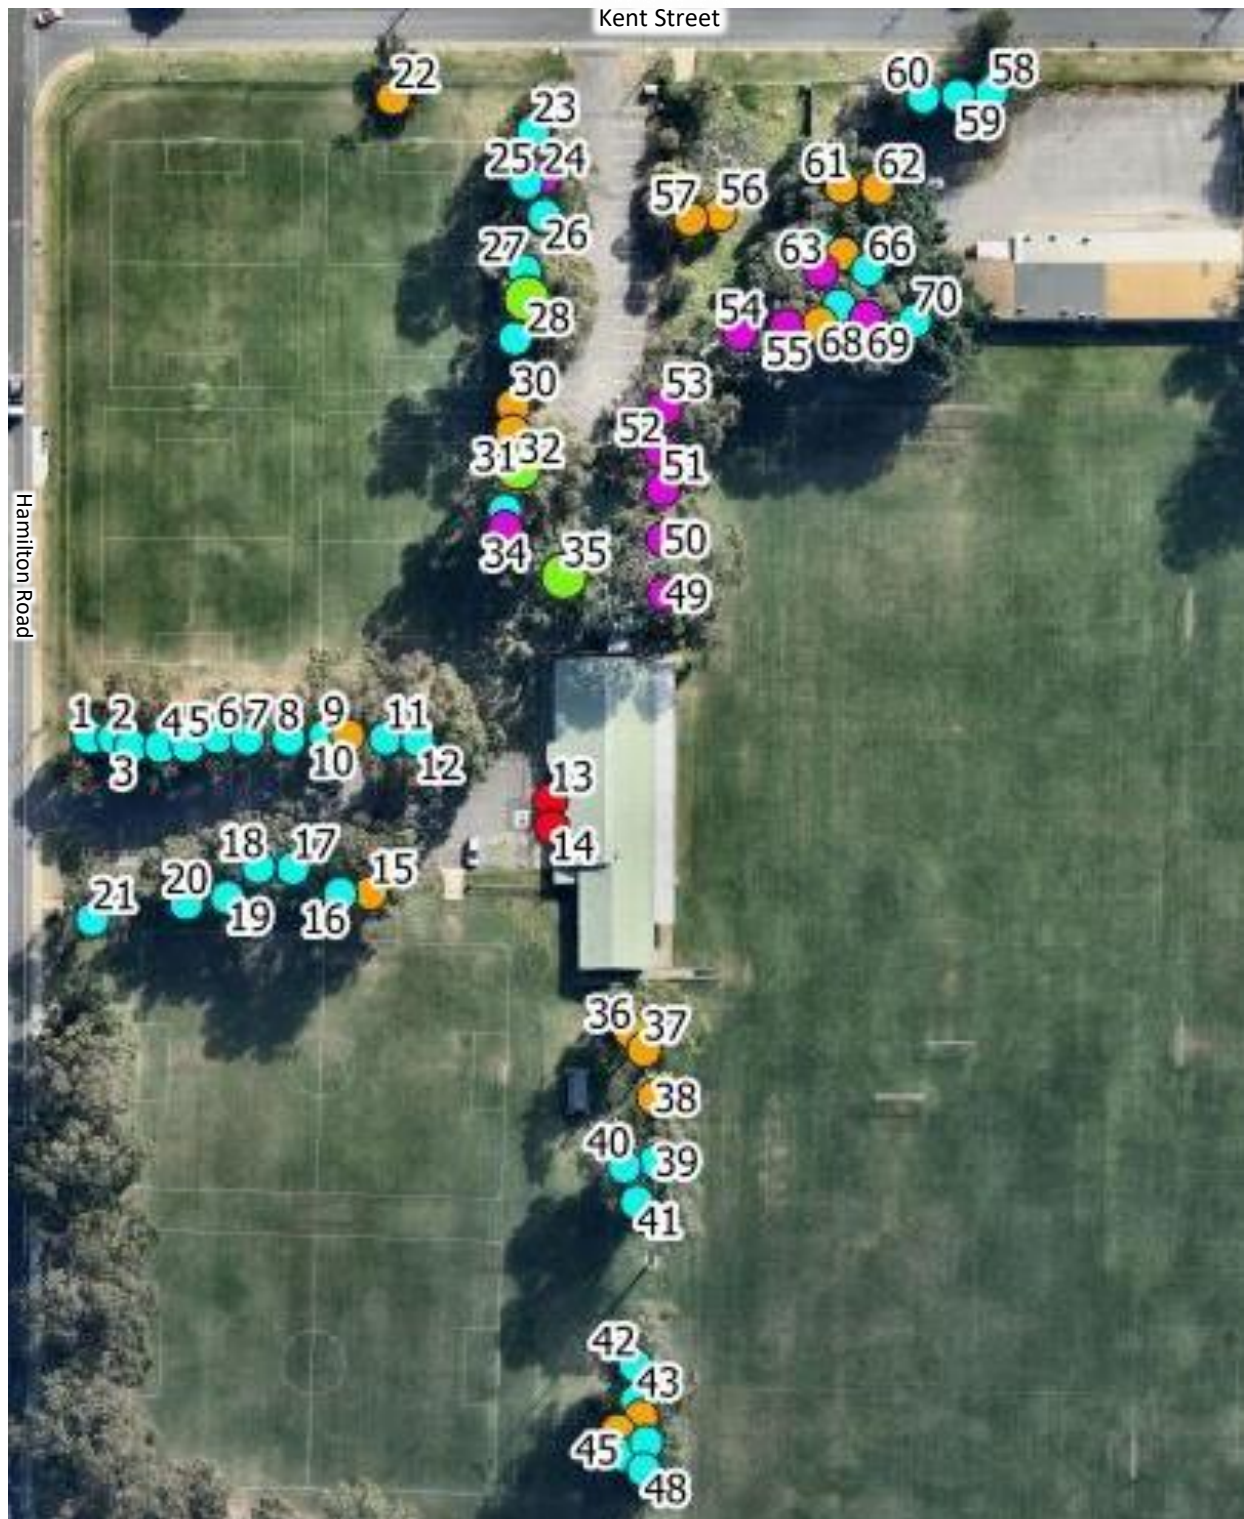
The aerial overleaf provides an overview of the Site with the retention value of each Tree overlaid and colour coded for ease of reference.

- High Retention Value Trees
- Suitable Trees
- Trees that may have higher risks/management requirements
- Low retention value trees (mostly declining trees)
- Very Low retention value trees (small trees insignificant to the landscape)
