1 Forrest Rd, Hamilton Hill

Structural Inspection Report

M15819

BPA Engineering were requested, by Dwayne Rowland of Kardan Construction, to undertake a structural audit of the existing buildings at 1 Forrest Rd, Hamilton Hill.

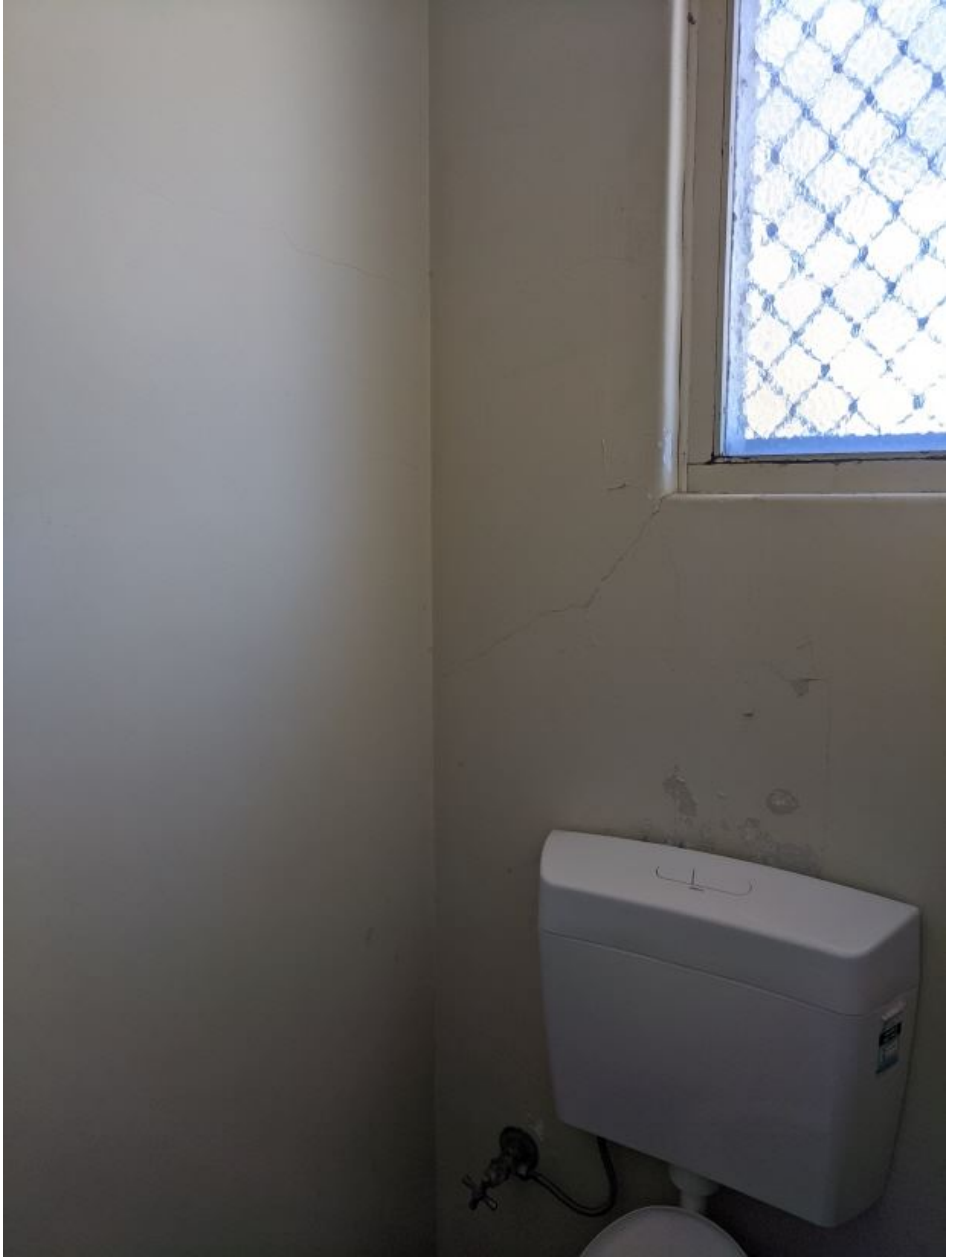
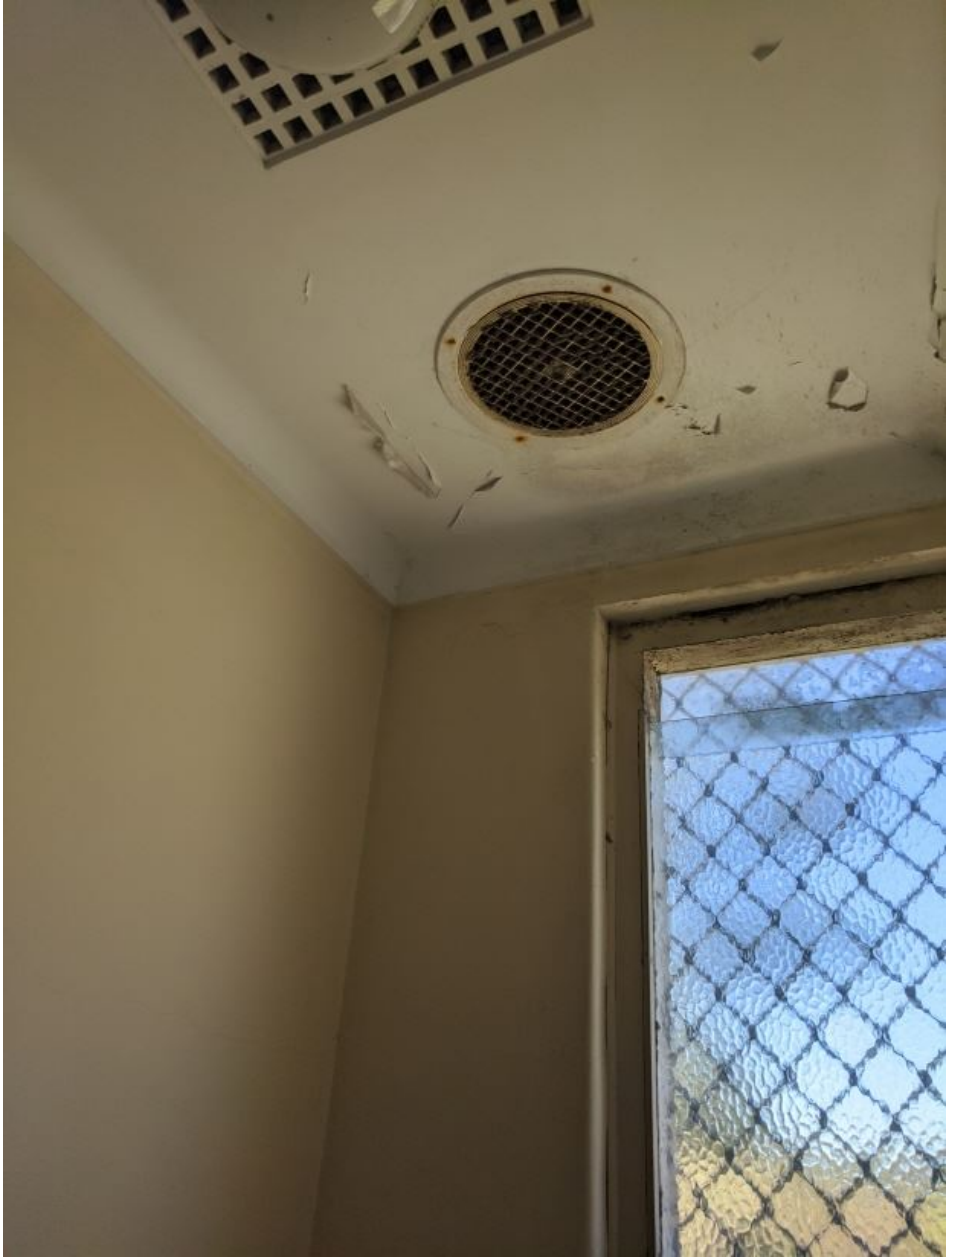
| 001-002 | Cracks in wall above window, near toilet. Moisture damage to ceiling paintwork. The external wall has a significant crack over the window opening. | <ul style="list-style-type: none"> <li>Most of the cracks observed were cosmetic. They do indicate that some movement has occurred in the foundations; however, most are not of structural significance.</li> <li>The vertical cracks over the window in the external brick should be stitched using the Helifix Crack Repair System.</li> </ul> | |

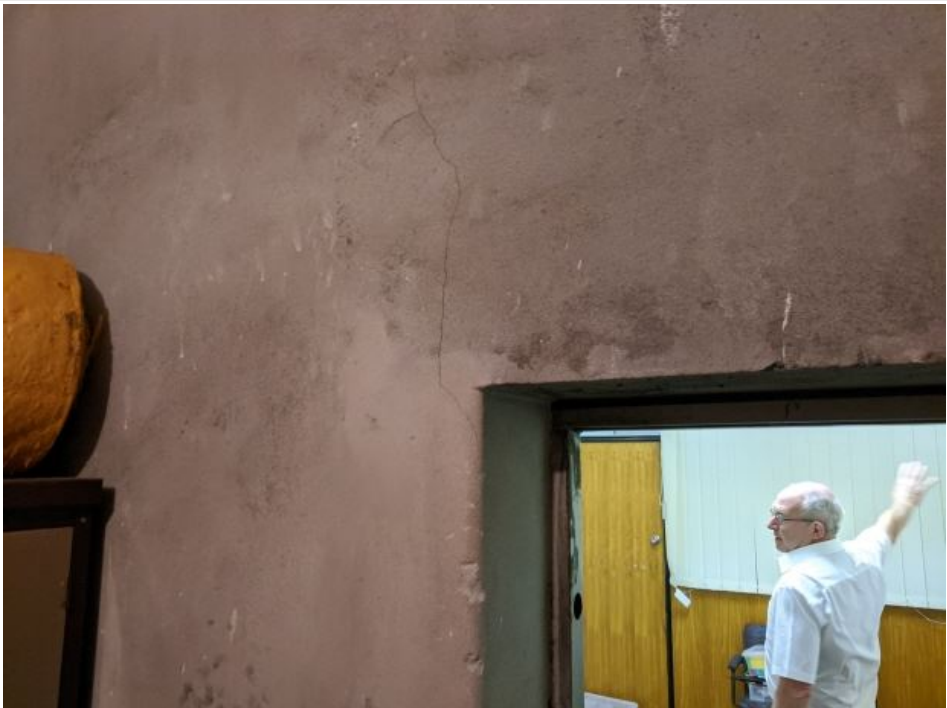
| 001-003 | Small crack above side of door opening | <ul style="list-style-type: none"> <li>The crack appears to be cosmetic and may be patched if required.</li> </ul> | |

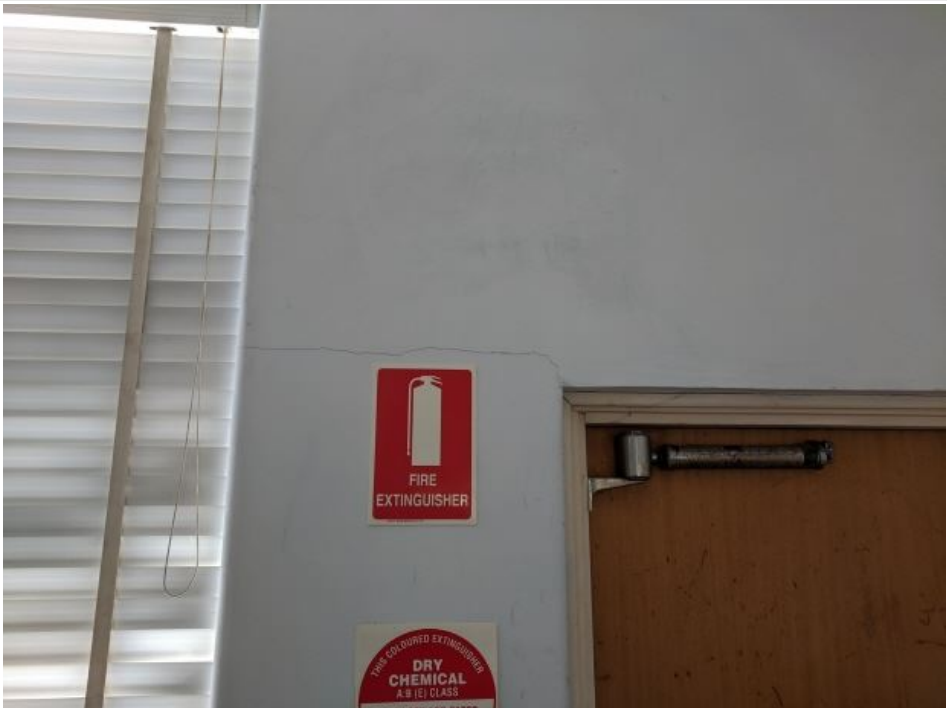
| 001-008 | Horizontal crack from top of Eastern door in kitchen. | <ul style="list-style-type: none"> <li>• This crack is in a weakened portion of the wall due to the position of the door and window. Patch and monitor for future movement.</li> </ul> | |

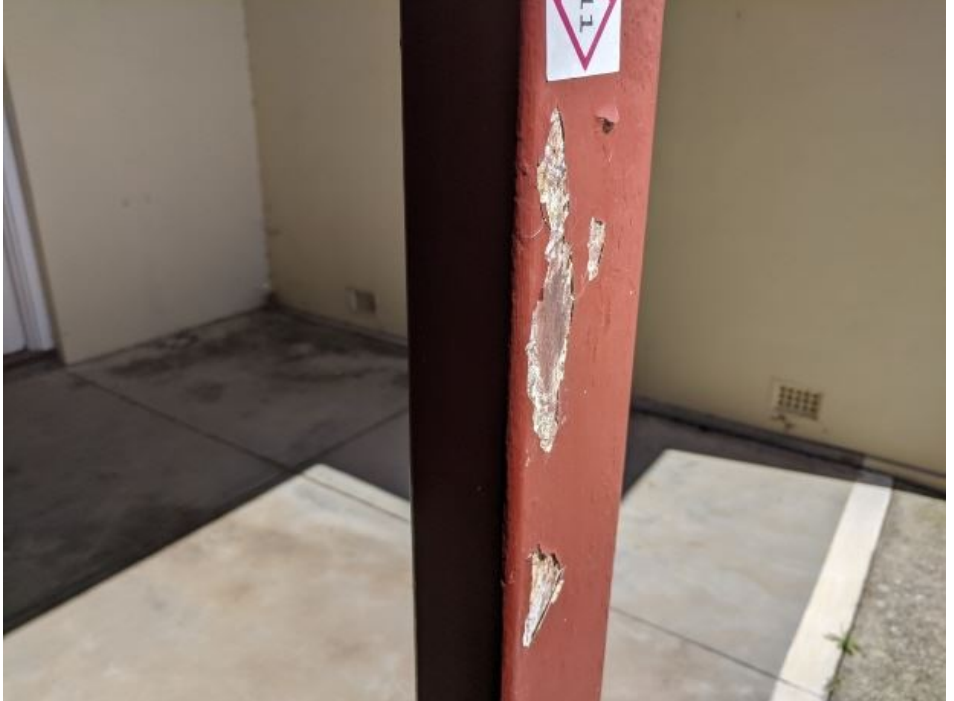
| 001-010 | <p>Post near the West end of the hall verandah has peeled paint.</p> <p>Corrosion deposits stain the West wall - indicating that the gutter is leaking and causing corrosion of the fixings.</p> <p>The steel beam below the gutter appears to have significant corrosion.</p> | <ul style="list-style-type: none"> <li>The paint on the verandah post appears to be an incompatible paint applied over galvanising. Clean back the outer paint coating; etch prime, then re-apply paint treatment using an epoxy based intermediate coat and polyurethane (or similar) finish coat.</li> <li>Investigate the condition of the gutter. Remove and replace the corroded fixings where the gutter has leaked.</li> <li>Further investigate the steel beam (would likely require removal of the gutter). Depending on condition, either replace the beam, or clean it back to steel (bristle blast or power tool clean) and apply a 3 coat paint system.</li> </ul> | |

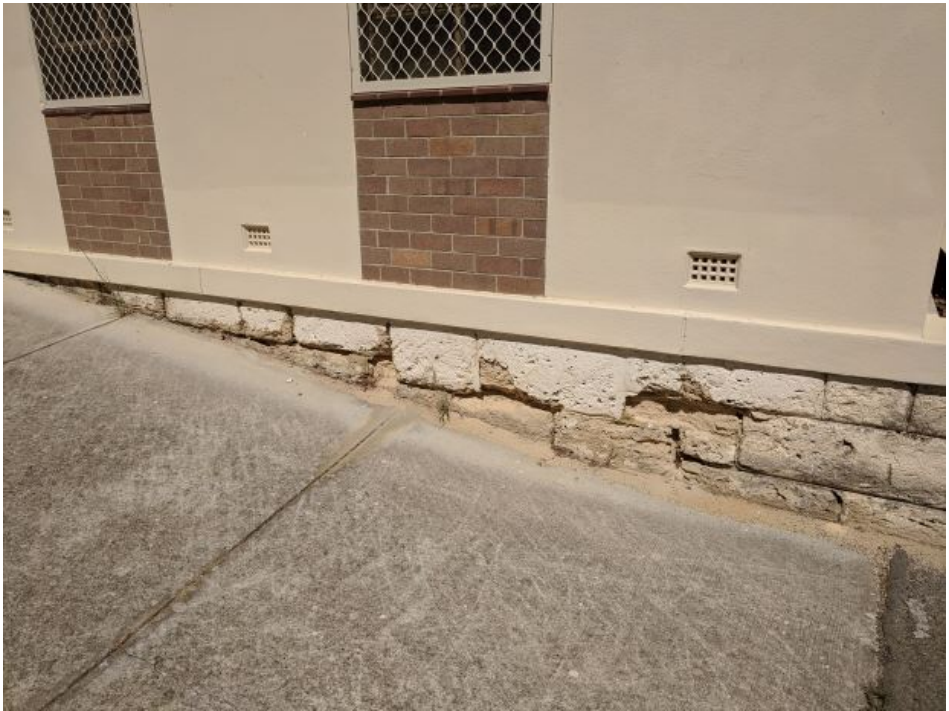
| 001-011 | The limestone foundation on the West side of the driveway has deteriorated. | <ul style="list-style-type: none"> <li>Monitor for future damage. If re-pointing mortar, use lime mortar or similar.</li> </ul> | |

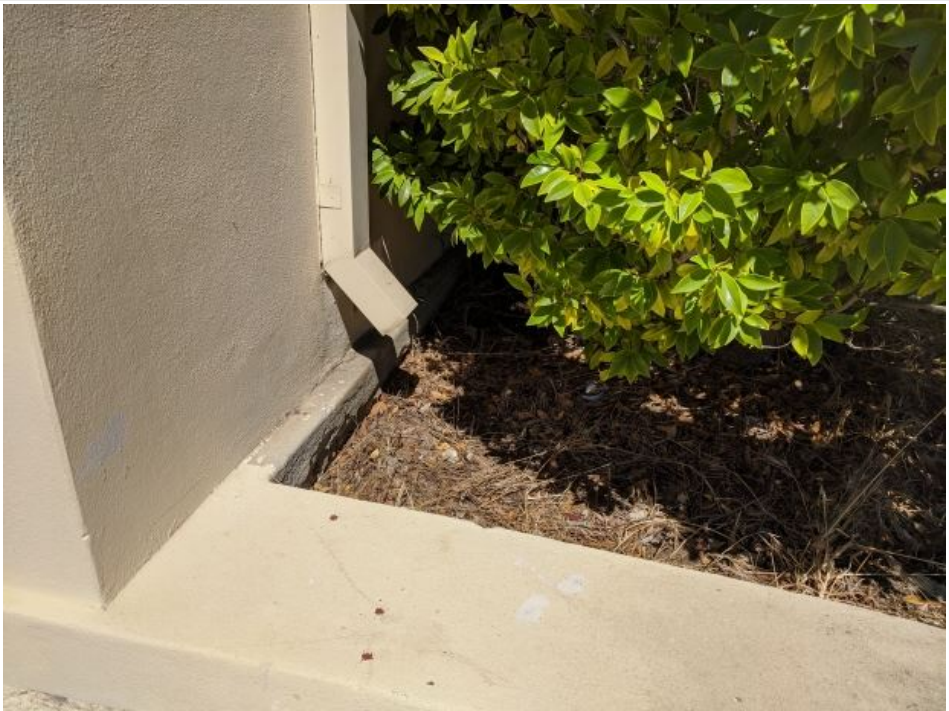
| 001-012 | Downpipe in garden bed adjacent driveway spills onto ground near foundations | <ul style="list-style-type: none"> <li>Re-direct stormwater away from foundations.</li> </ul> | |

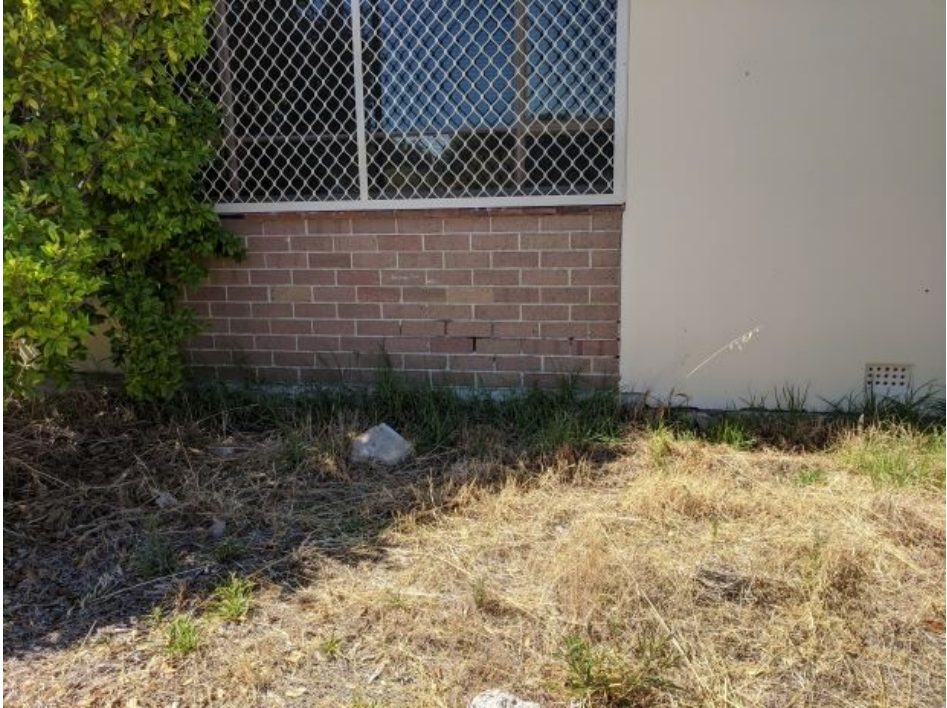
| 001-015 | The north wall (filing room) has some mortar loss. | <ul style="list-style-type: none"> <li>• Re-point missing mortar.</li> </ul> | |

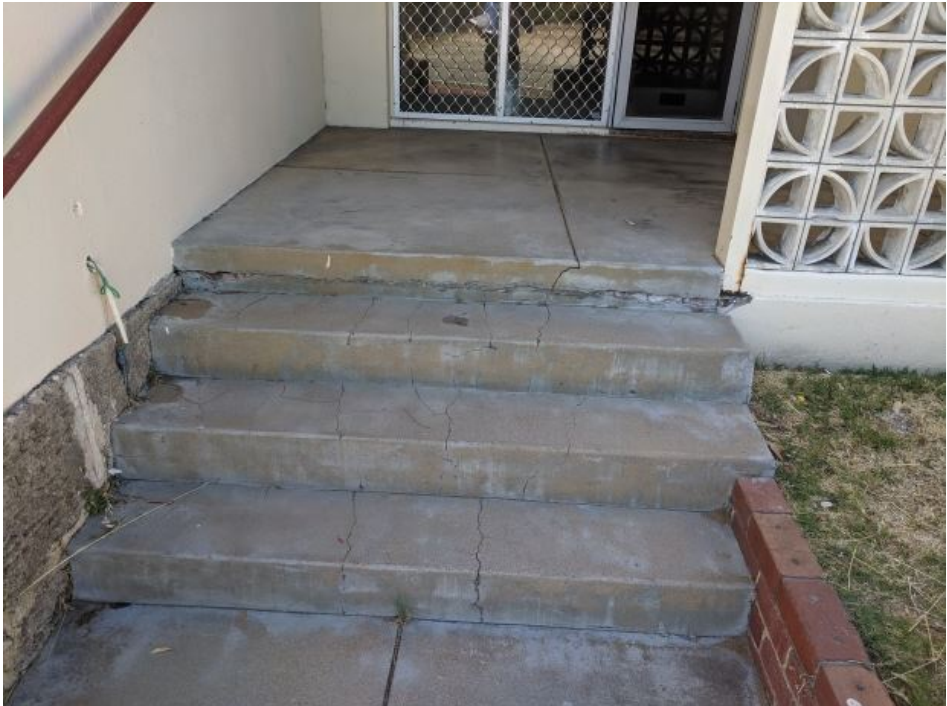
| 001-016 | Entry steps to the accountant's office are cracked. The steel post on the right is embedded in the concrete and has severely corroded. The West end of the porch has a similar embedded post base plate that has corroded resulting in large cracks in the concrete. | <ul style="list-style-type: none"> <li>While in poor condition, the steps are function. Over time, they will deteriorate further. To prolong the life of the stairs, inject cracks with Roadware 10-Minute Concrete Mender; or an epoxy such as Sikadur 52.</li> <li>Break out the concrete around the base of the steel posts; prop the roof structure; cut off the column above the floor level and install a base plate; re-instate the concrete using a bonding agent and keyed in reinforcing bars; Fix down the new base plate. Ensure all steel is treated with a 3 coat system e.g. PUR5 (AS/NZS 2312.1)</li> </ul> | |

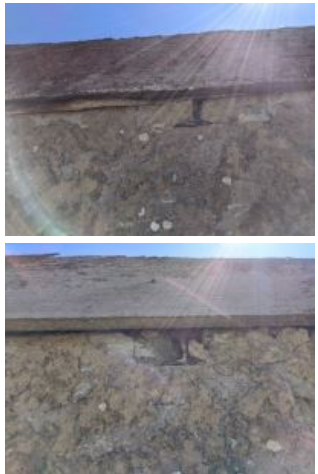
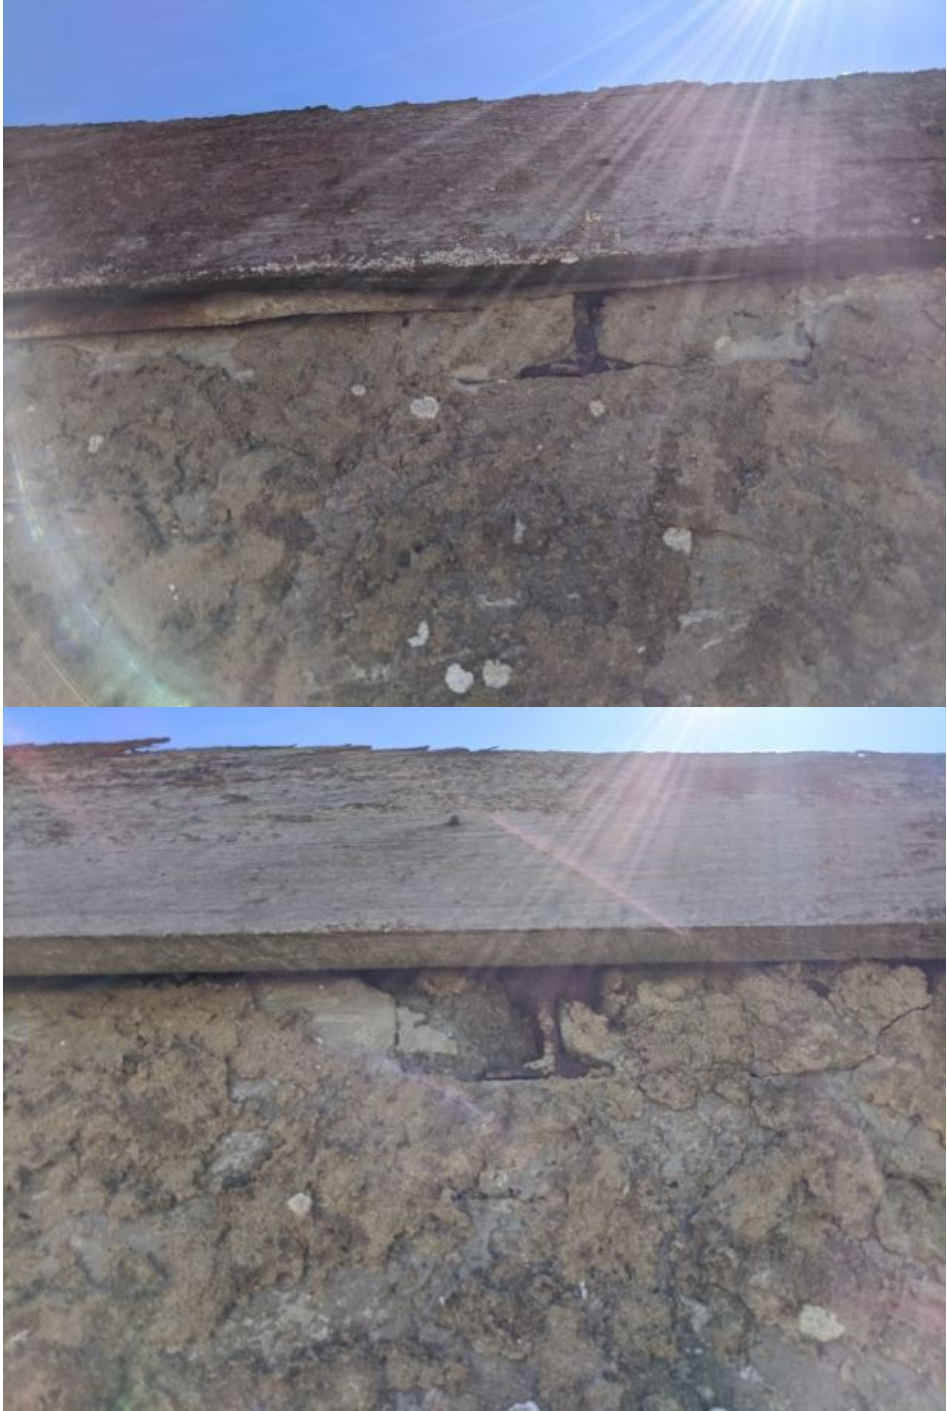
| 002-003 | The steel roof beams were railway irons built | |

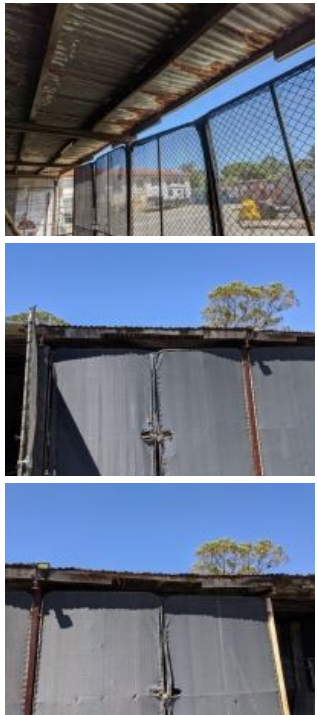
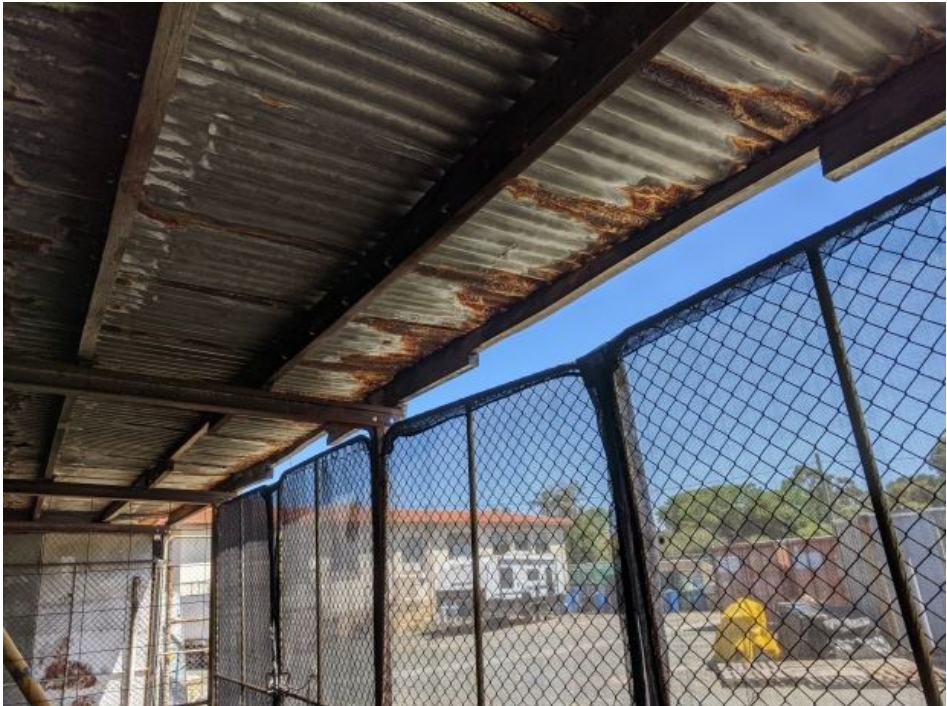
| 002-006 | Timber purlins along the North face have been notched. | |

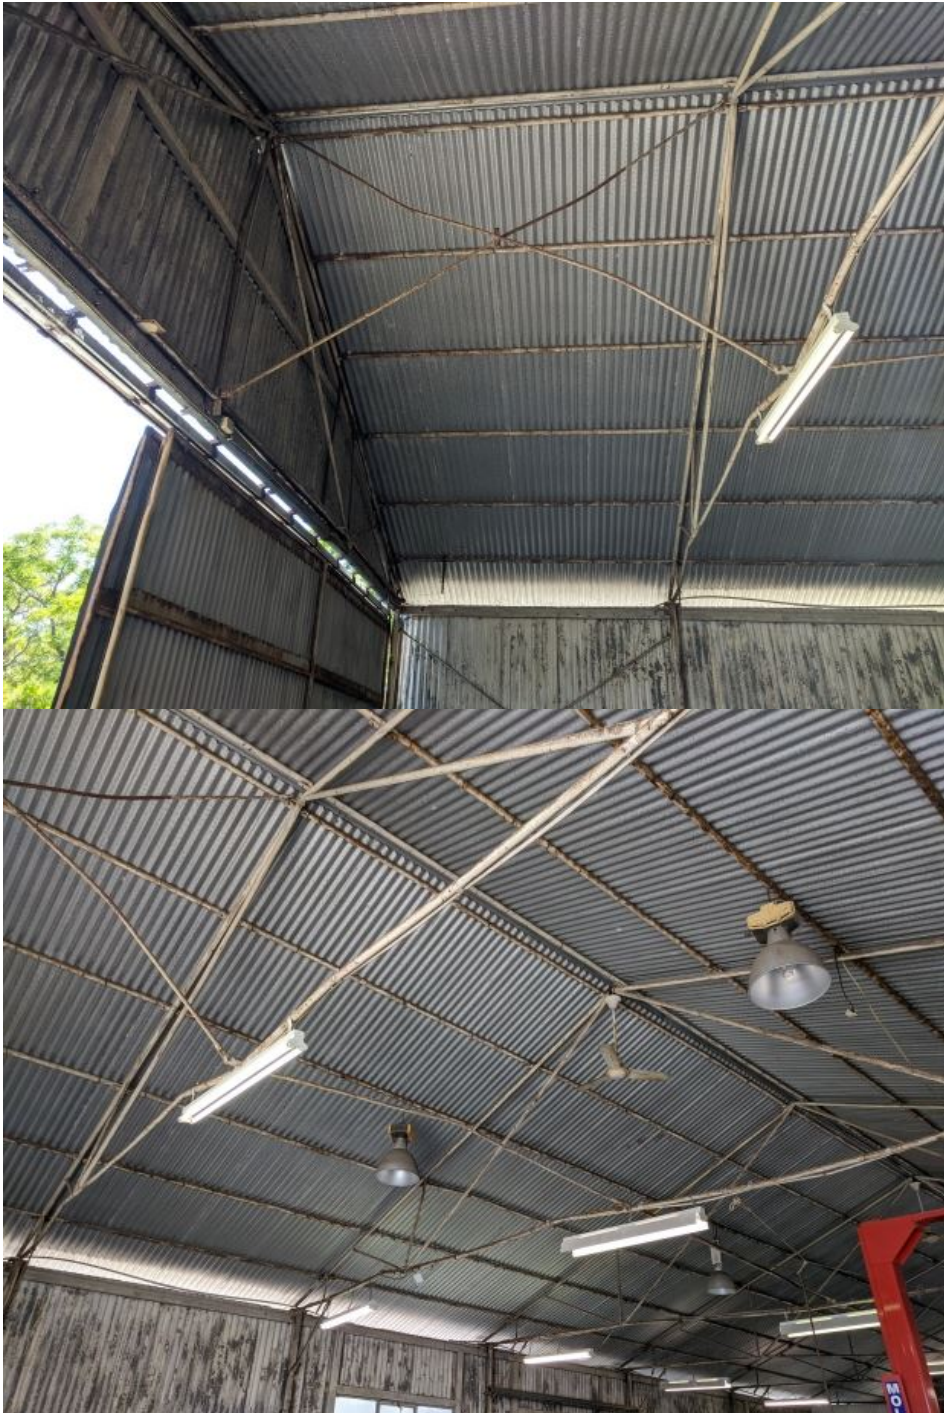
| LOCATION: | B3 - Trusses | | |
|---|---|---|---|
| 003-001 | The roof trusses near the entry to the building and further in are buckled. They appear to have been sustained impacts - we understand that prior to becoming a mechanics workshop, the building was a truck workshop and was likely damaged at that time. The centre of the first bay has cross bracing rods but does not have a horizontal brace, thus rendering them ineffective. | <ul style="list-style-type: none"> <li>The structural capacity of the trusses has been compromised.</li> <li>The spandrel above the entry sliding door is not adequately restrained by the bracing.</li> </ul> | |

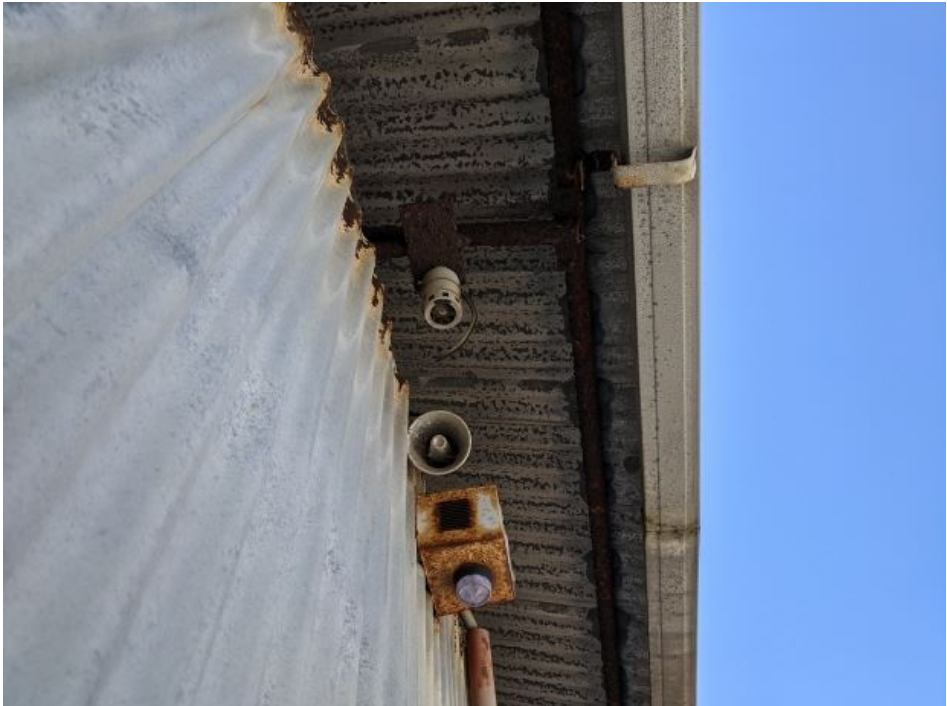
| ITEM: | PHOTO: |
|---|---|
| 003-003 | |

| 003-003 | The purlins are CHS members. The purlin at the eaves and one row in are heavily corroded, particularly on the West side. The roof sheet is also affected where in contact with the purlins. | <ul style="list-style-type: none"> <li>The edge purlins are no longer protected by the galvanising coating that has delaminated.</li> <li>Some material loss has occurred as a result of corrosion. It would be difficult to determine the remaining capacity of the section.</li> </ul> | <br> |

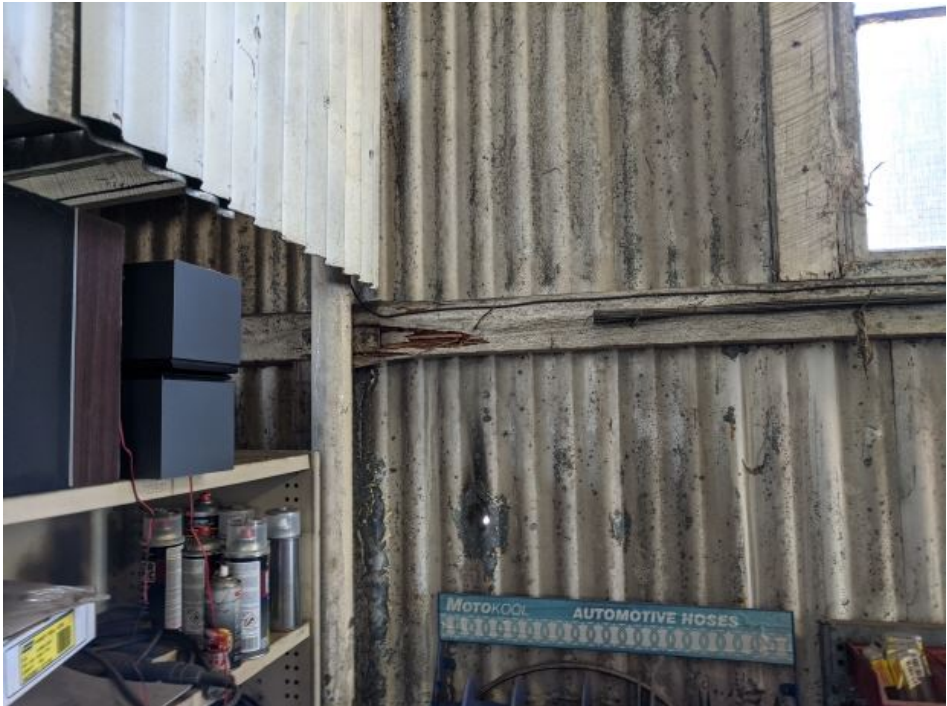
| ITEM: | PHOTO: |
|---|---|
| 003-004 | |

| 003-004 | Timber wall support in the South West corner is termite damaged. | <ul style="list-style-type: none"> <li>Timber requires replacement.</li> </ul> | <br><br><br> |

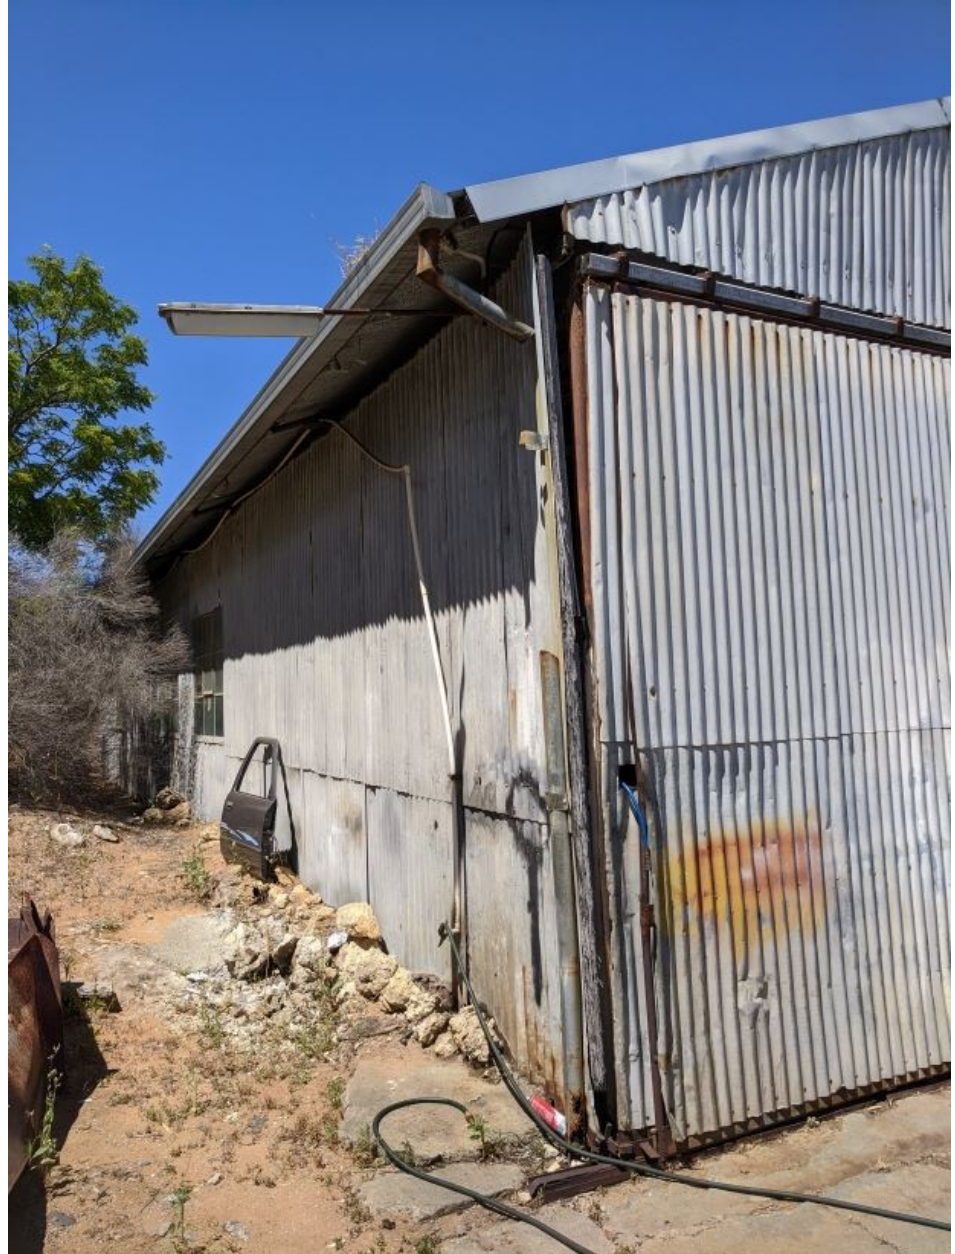
| 003-006 | The downpipe has corroded away. Timber at the corner has deteriorated and pulled away from the structure. Wall sheeting at the bottom of the wall near the tap has corroded away and appears to have been replaced. Rock and soil is built up against the base of the wall. | | |

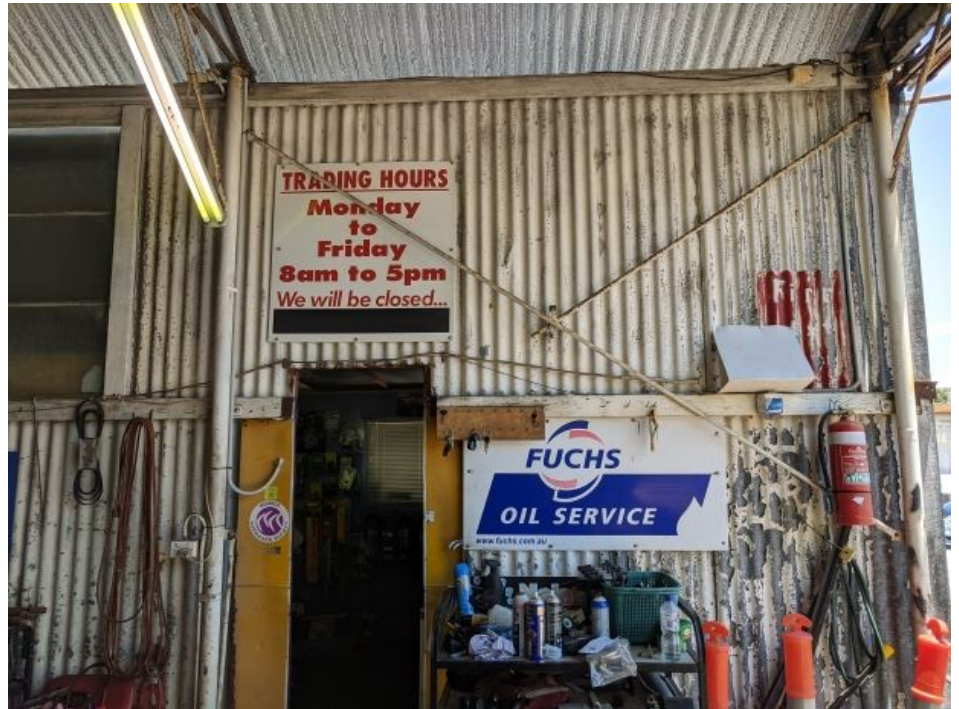
| 003-007 | A cross brace as the entry to the lean-to office has been cut. | <ul style="list-style-type: none"> <li>The brace on the opposite diagonal should be replaced with a compression strut.</li> </ul> | |

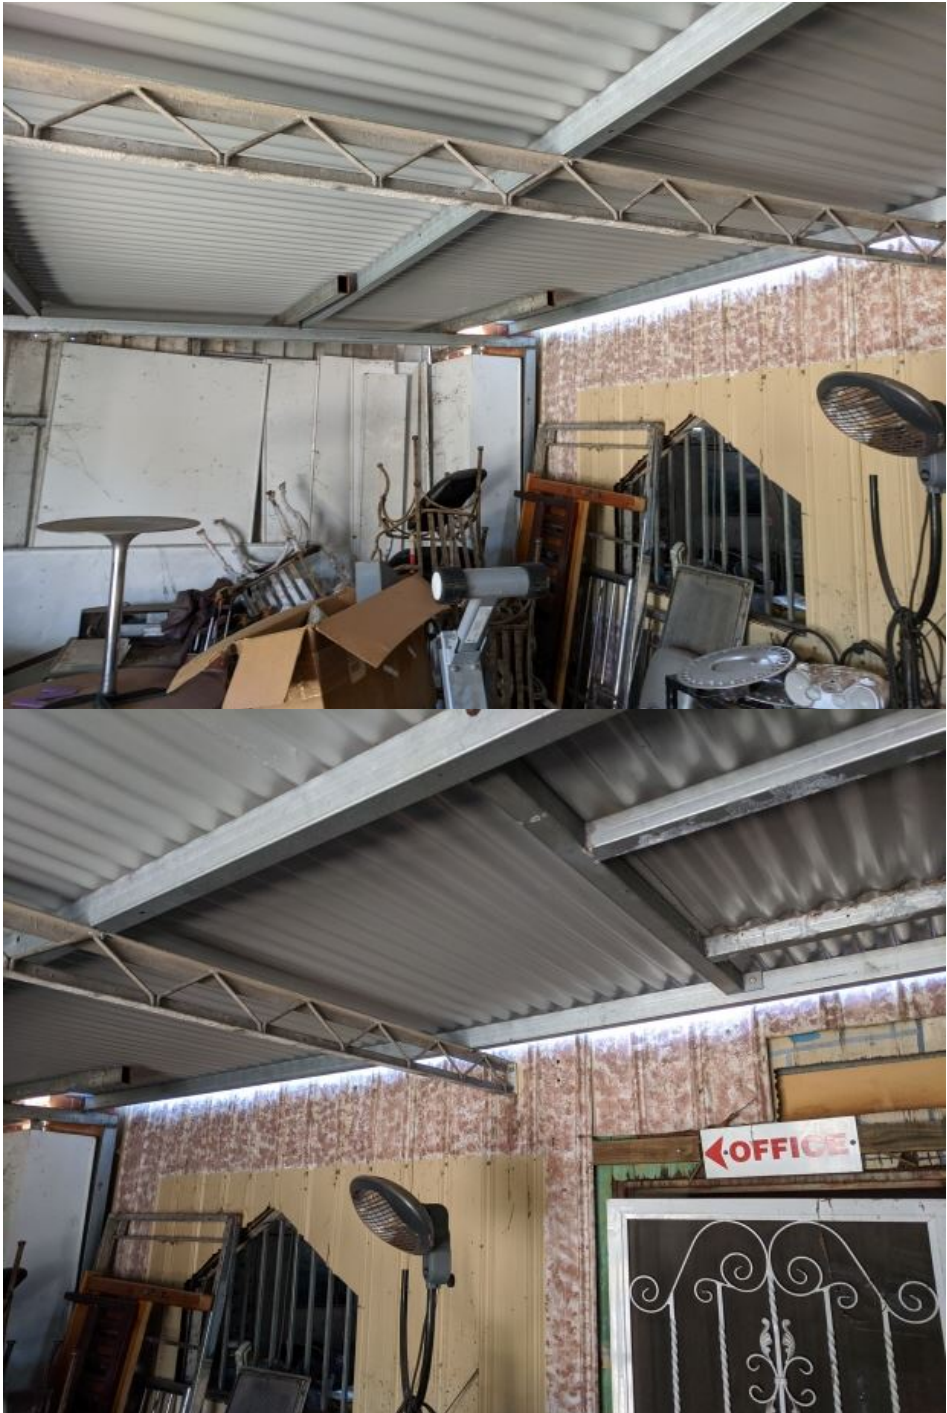
| ITEM: | PHOTO: |
|---|---|
| 004-001 | |

| LOCATION: | B4 - Entry Lean To | | |
|---|---|---|---|
| 004-001 | The lean-to truss is fixed to the wall sheeting using a single bolt. Purlins are improperly lapped | <ul style="list-style-type: none"> <li>At least two fixings should be installed. Ensure there is timber within the wall to fix to.</li> </ul> | |

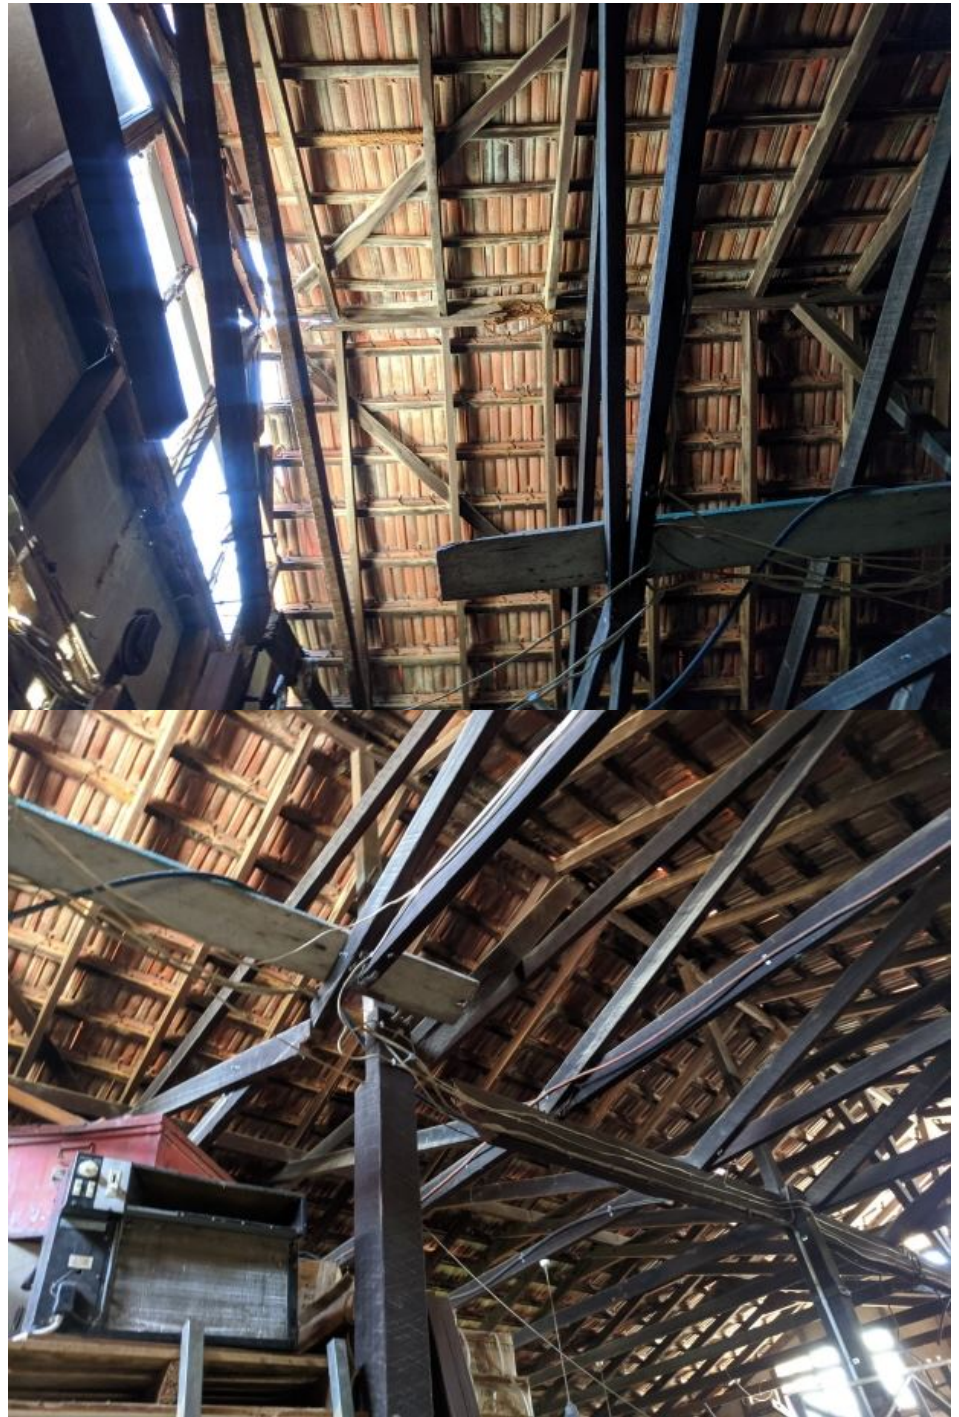
| LOCATION: | B4 - North | | |
|---|---|---|---|
| 004-003 | The ridge beam has disintegrated due to termite activity. The central support beam was removed due to termite damage and not replaced. Struts for the ridge and trusses are unsupported. | <ul style="list-style-type: none"> <li>The roof is not structurally sound.</li> <li>The Northern bay of the building requires demolition and re-construction.</li> </ul> | |

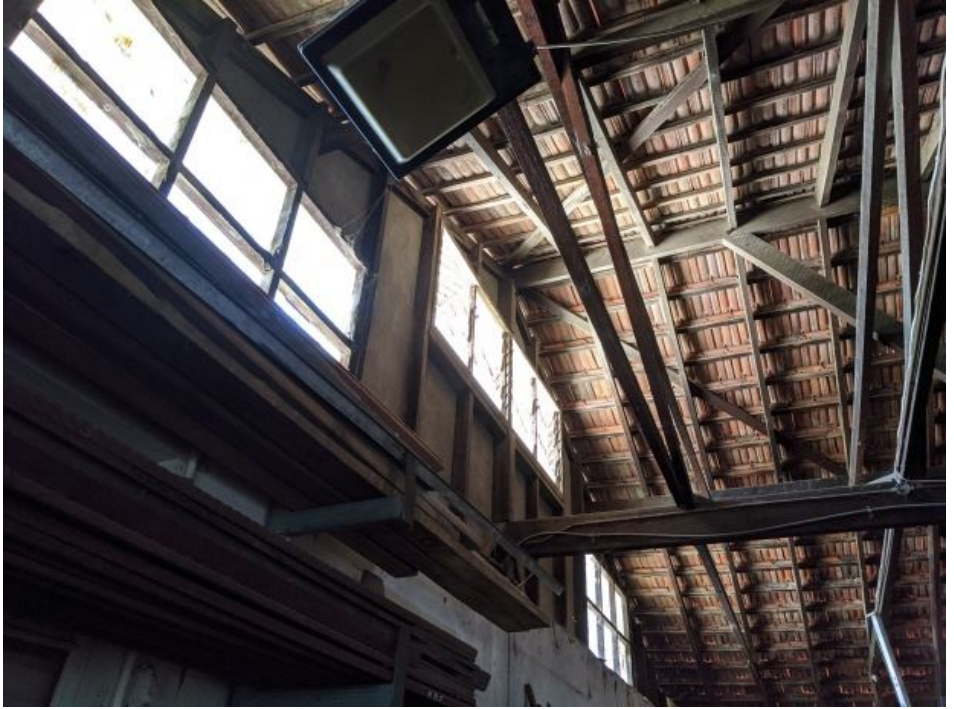
| ITEM: | PHOTO: |
|---|---|
| 004-005 | |

| 004-005 | Beyond the North bay of the building, the majority of the timber structure appeared to be in acceptable condition. | | |

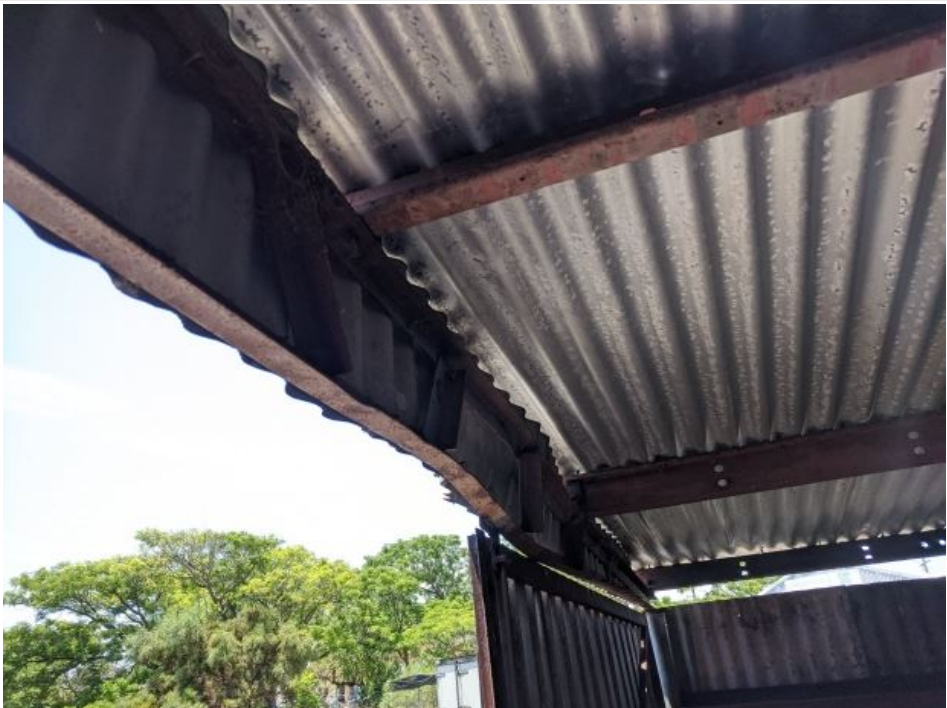
| ITEM: | PHOTO: |
|---|---|
| 004-007 | |

| 004-007 | The entry to the attached shed on the south of the main building had evidence of impact damage. | <ul style="list-style-type: none"> <li>This truss may require replacement.</li> </ul> | |

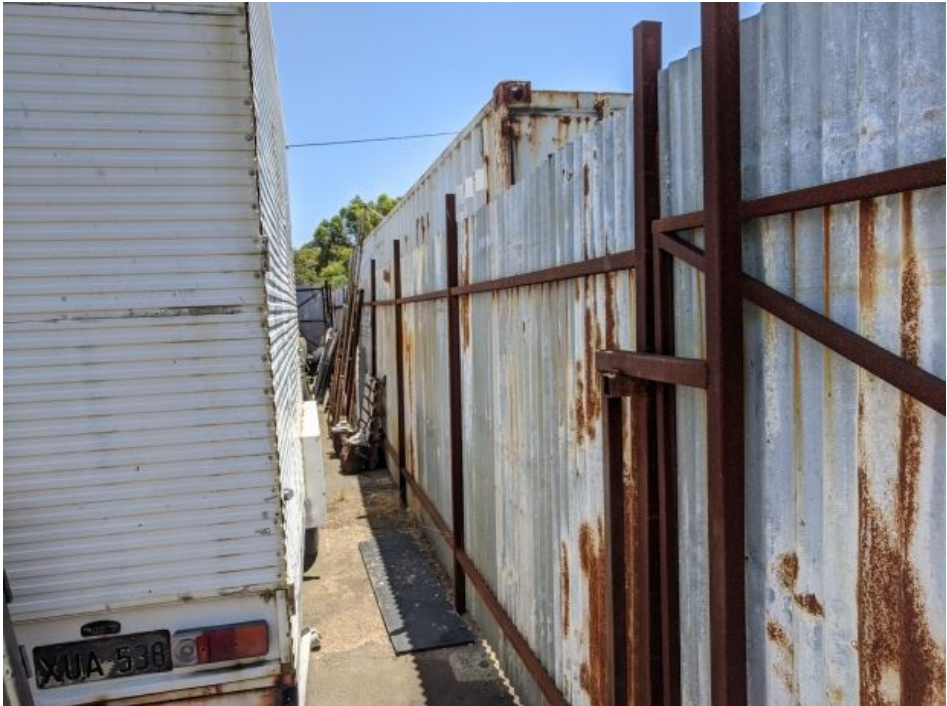
| 004-008 | The fence posts and rails were corroded; though did not appear to be structurally compromised at the time of inspection. | <ul style="list-style-type: none"> <li>These will have a limited life and may begin to fail in the intermediate term (2 to 5 years).</li> </ul> | |

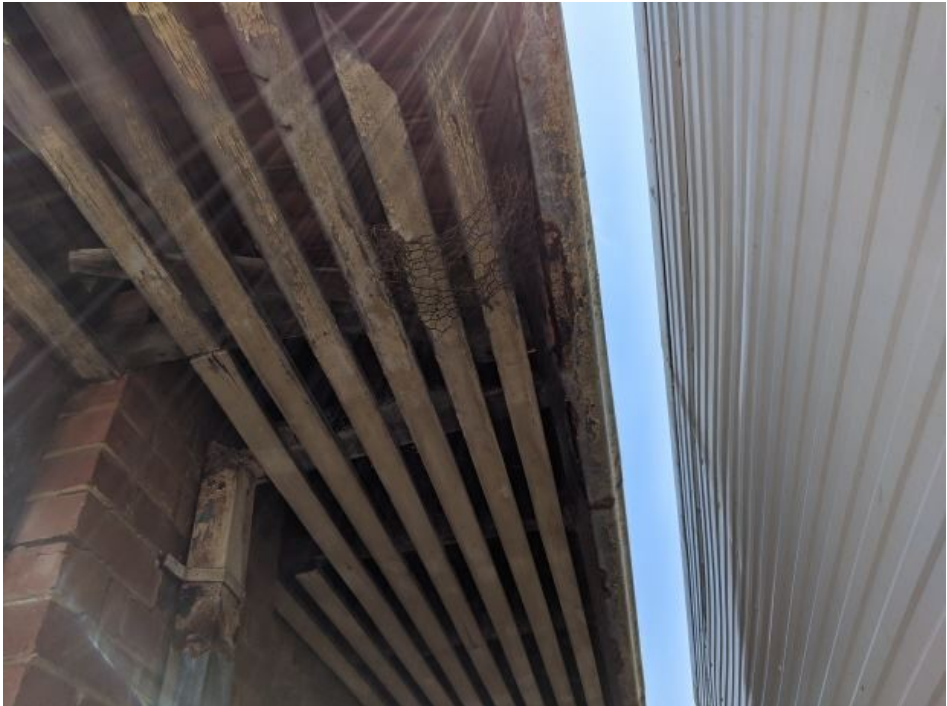
| ITEM: | PHOTO: |
|---|---|
| 004-009 | |

| 004-009 | The eaves gutter on the East side was corroded out. Some of the slat lining timbers were damaged, particularly near the North corner. Some windows were broken. | <ul style="list-style-type: none"> <li>The gutters require replacement.</li> <li>Eaves linings require repair or replacement of damaged areas. They should also be painted to provide protection to the timber.</li> </ul> | |

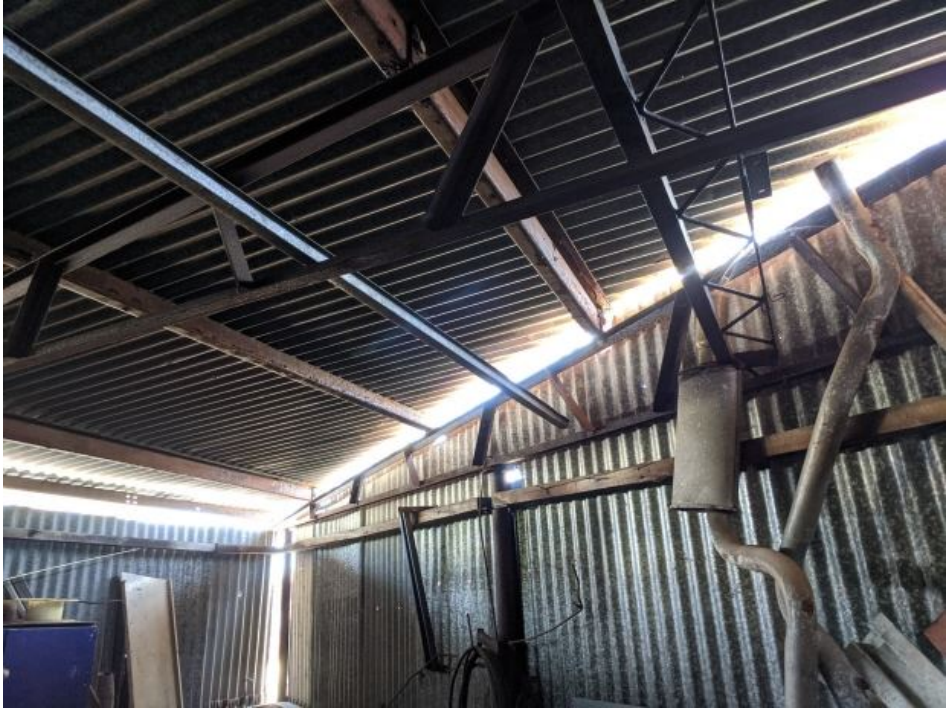
| ITEM: | PHOTO: |
|---|---|
| 004-010 | |

| 004-010 | The purlins for the shed were generally corroded; however, this was considerably worse along the West side. There was no flashing on the interface between wall and roof. | <ul style="list-style-type: none"> <li>Purlins will require replacement near the perimeter in the intermediate term. To extend the life, a flashing could be installed.</li> </ul> | |

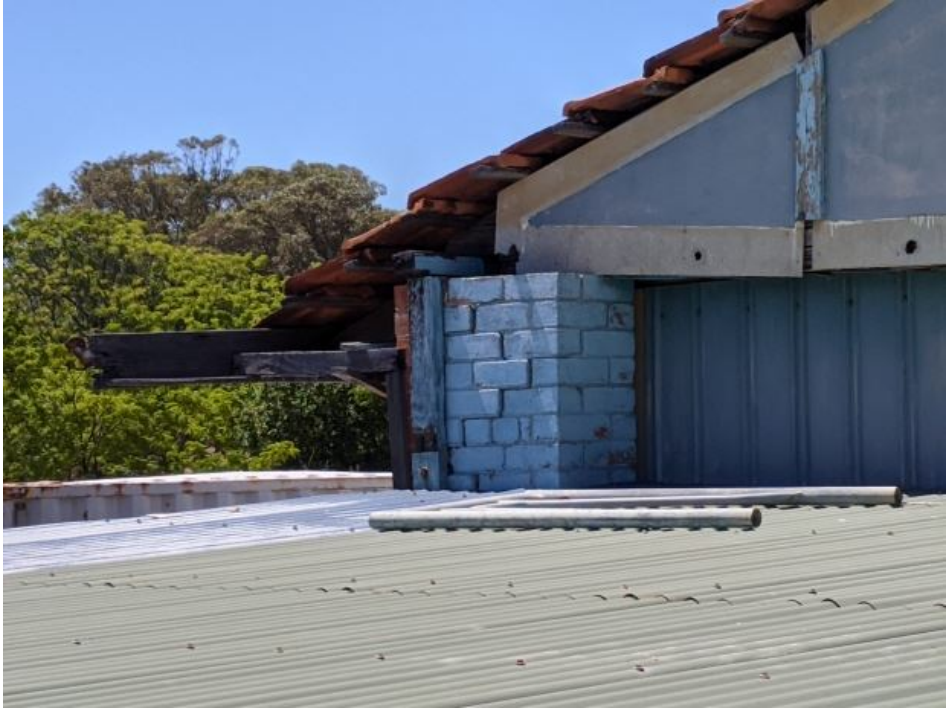
| ITEM: | PHOTO: |
|---|---|
| 004-012 | |

| 004-012 | The brick pier at the corner of the building appears to have some brick displacement. | <ul style="list-style-type: none"> <li>The top portion of the pier should be broken down and rebuilt.</li> </ul> | |
