1 Forrest Rd, Hamilton Hill

Structural Inspection Report

M15819

BPA Engineering were requested, by Dwayne Rowland of Kardan Construction, to undertake a structural audit of the existing buildings at 1 Forrest Rd, Hamilton Hill.

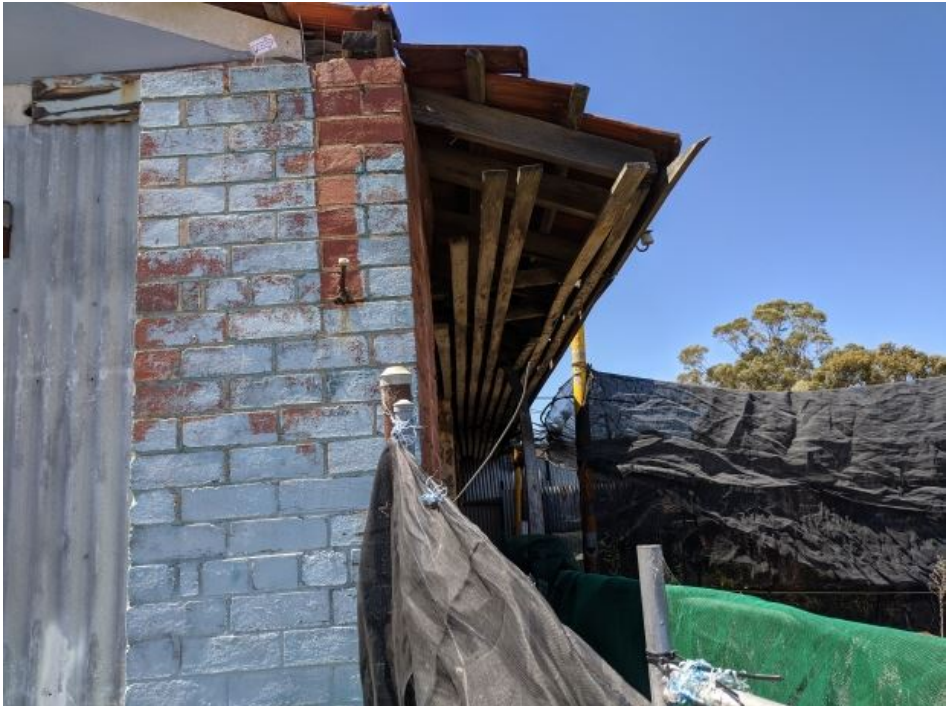
| ITEM: | PHOTO: |
|---|---|
| 004-013 | |

| 004-013 | The gutter appears to be missing on part of the West face. The remaining gutter is severely corroded. The eaves lining is badly weathered. | <ul style="list-style-type: none"> <li>The eaves lining and gutter require replacement.</li> <li>Note also that the facade cladding may be asbestos.</li> </ul> | |

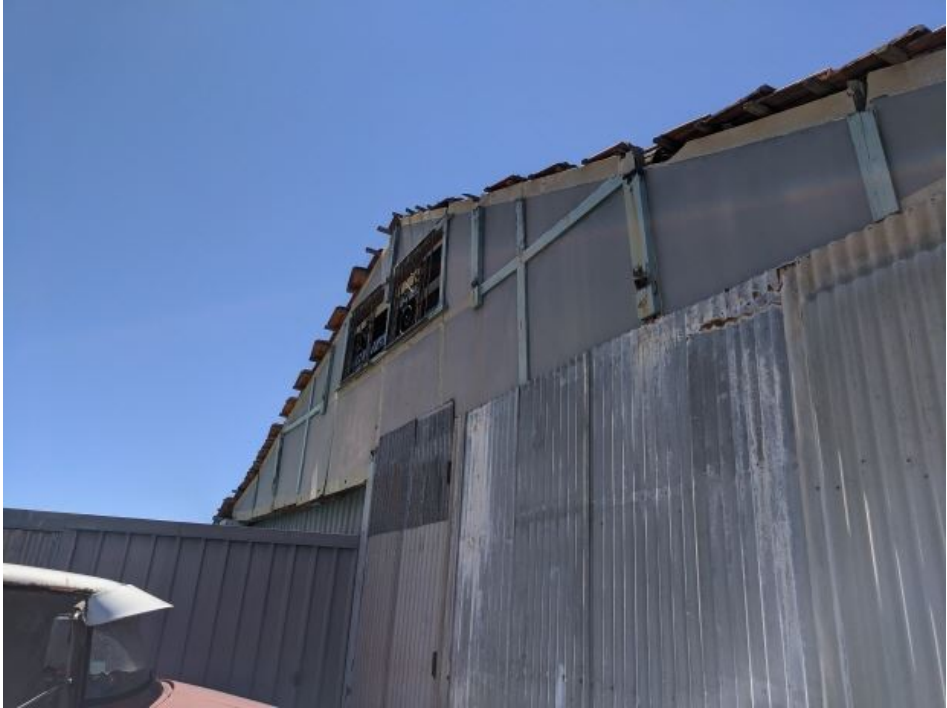
| ITEM: | PHOTO: |
|---|---|
| 004-014 | |

| 004-014 | The north face has no eaves overhang and there is no edge flashing. Windows appear to be broken. | <ul style="list-style-type: none"> <li>A flashing should be installed to seal the roof edge.</li> <li>Windows will require replacement with the timber framing.</li> <li>Note that the cladding may be asbestos.</li> </ul> | |

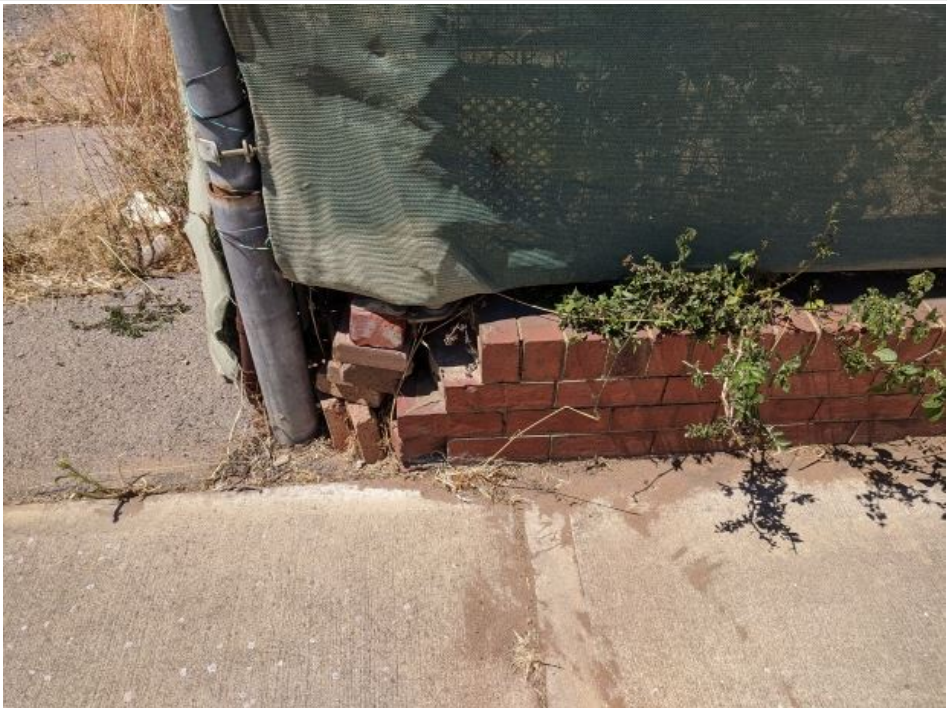
| ITEM: | PHOTO: |
|---|---|
| 004-015 | |

| 004-015 | <p>The fence around the yard adjacent building 4 and near building 1 has spalled around the fixings for the fence posts.</p> <p>The bottom rail at the return to building 1 is not connected to the post.</p> | <ul style="list-style-type: none"> <li>• Remove the fence and rebuild the brickwork where required.</li> <li>• Install a fence by core drilling and grouting the posts at least 400mm into the brickwork.</li> <li>• Connect the fence rails to the posts.</li> </ul> | |
