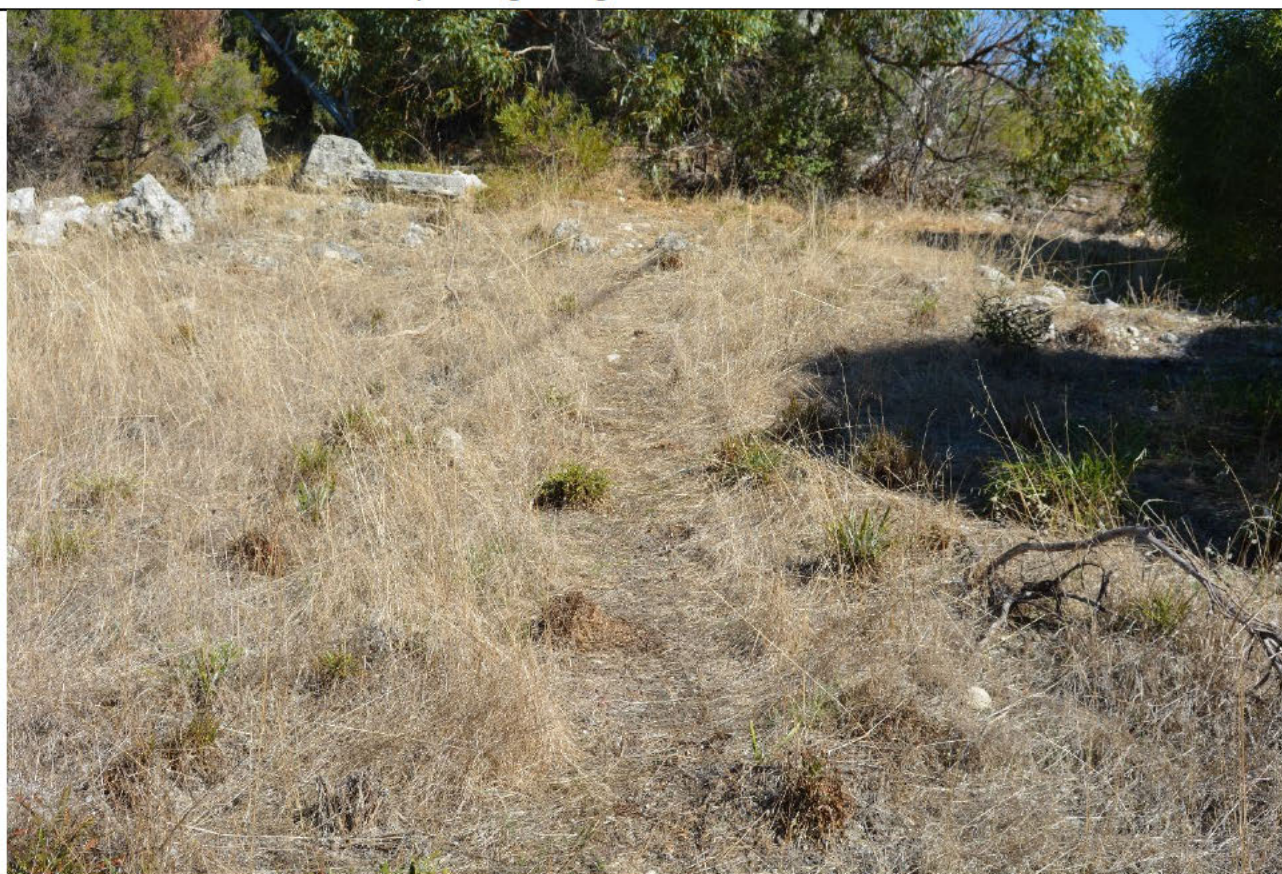
| Name: | Additional Trail 17 |
|---|---|
| Reference No.: | 61 |

| Name: | Additional Trail 17 |
|---|---|
| Condition: | Poor |
| Potential to Harm Heritage or Environmental Features: | Harm observed |
| Recommendation: | Close. Unauthorised entryways to trails 77 and 74. Entryway to trail 74 is close by so these trails are unnecessary. Erosion present and weeds spreading throughout the Tuart woodlands TEC. |

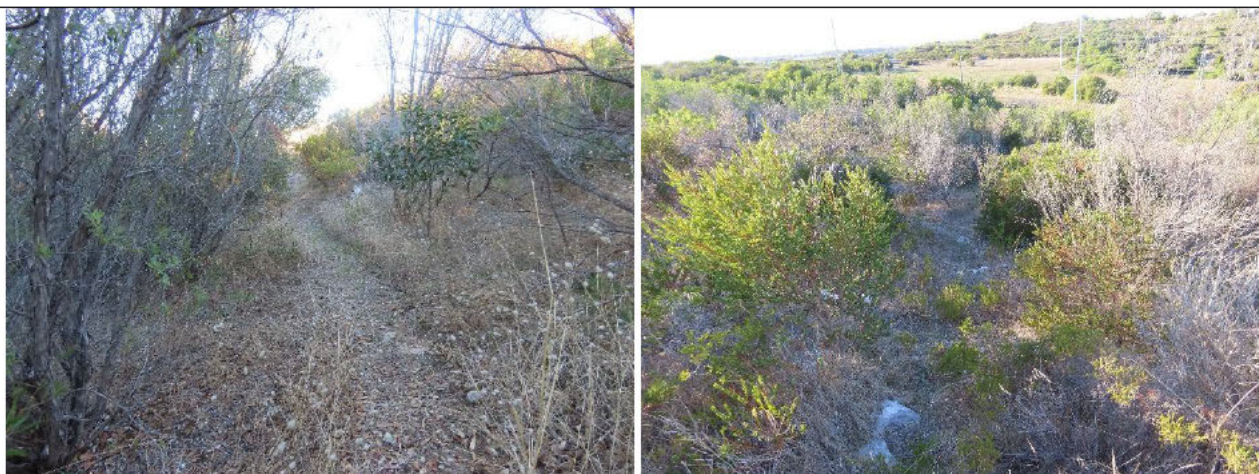
| Name: | Transmission Hill Ridgeline |
|---|---|
| Reference No.: | 62 |

| Name: | Transmission Hill Ridgeline |
|---|---|
| Condition: | Poor |
| Potential to Harm Heritage or Environmental Features: | Harm likely |
| Recommendation: | Close. [REDACTED]<br>Honeymyrtle shrublands TEC. Potential to facilitate weed spread into the surrounding environmental and heritage features. Poor condition trail not well used. |

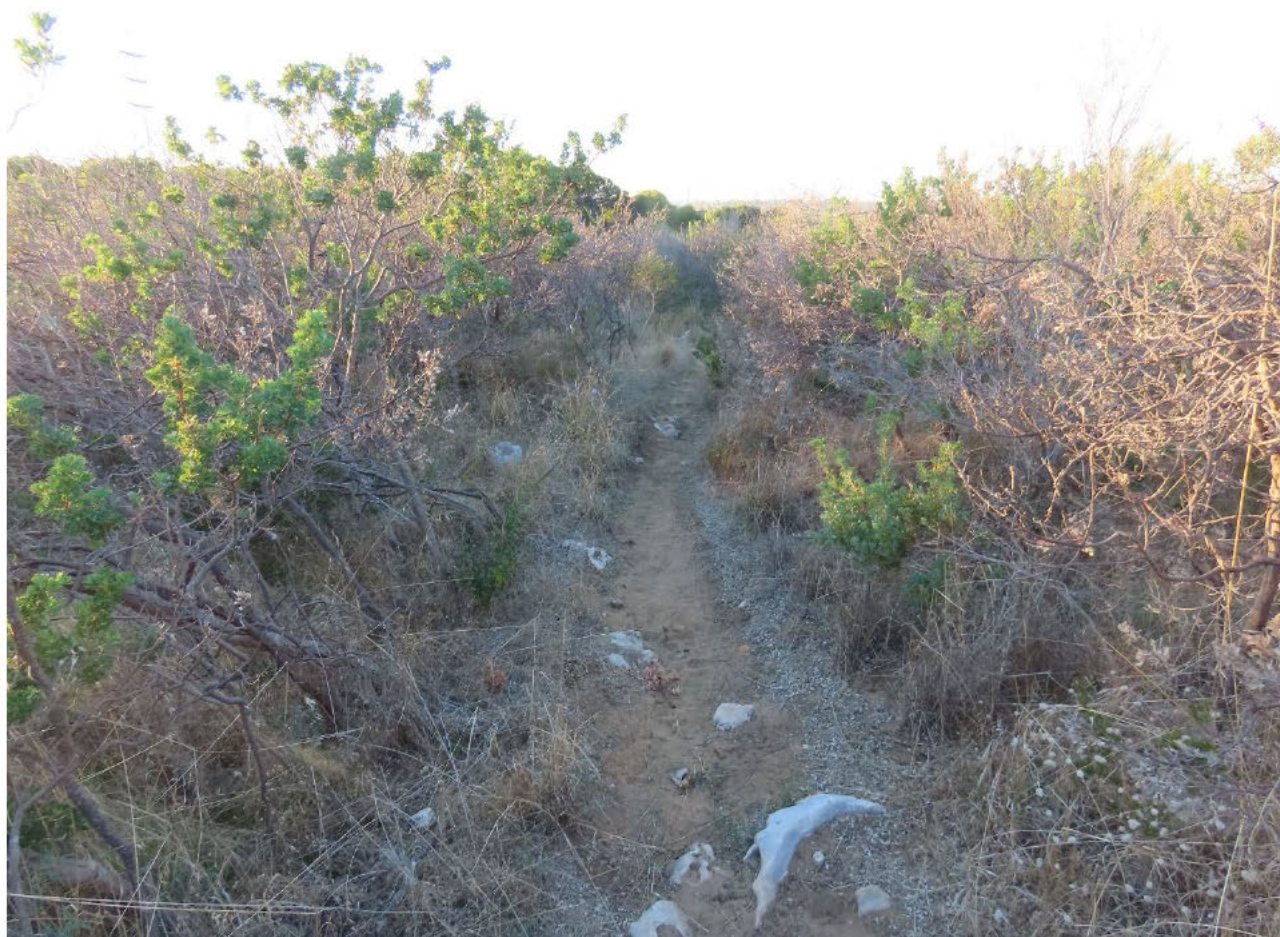
| Name: | Mid 2 |
|---|---|
| Reference No.: | 63 |

| Name: | Mid 2 |
|---|---|
| Condition: | Poor |
| Potential to Harm Heritage or Environmental Features: | Harm likely |
| Recommendation: | Close. Unnecessary shortcut between trails 75 and 93. Intersects with Honeymyrtle shrublands TEC. Potential to facilitate weed spread and trampling effects into the surrounding TEC. |

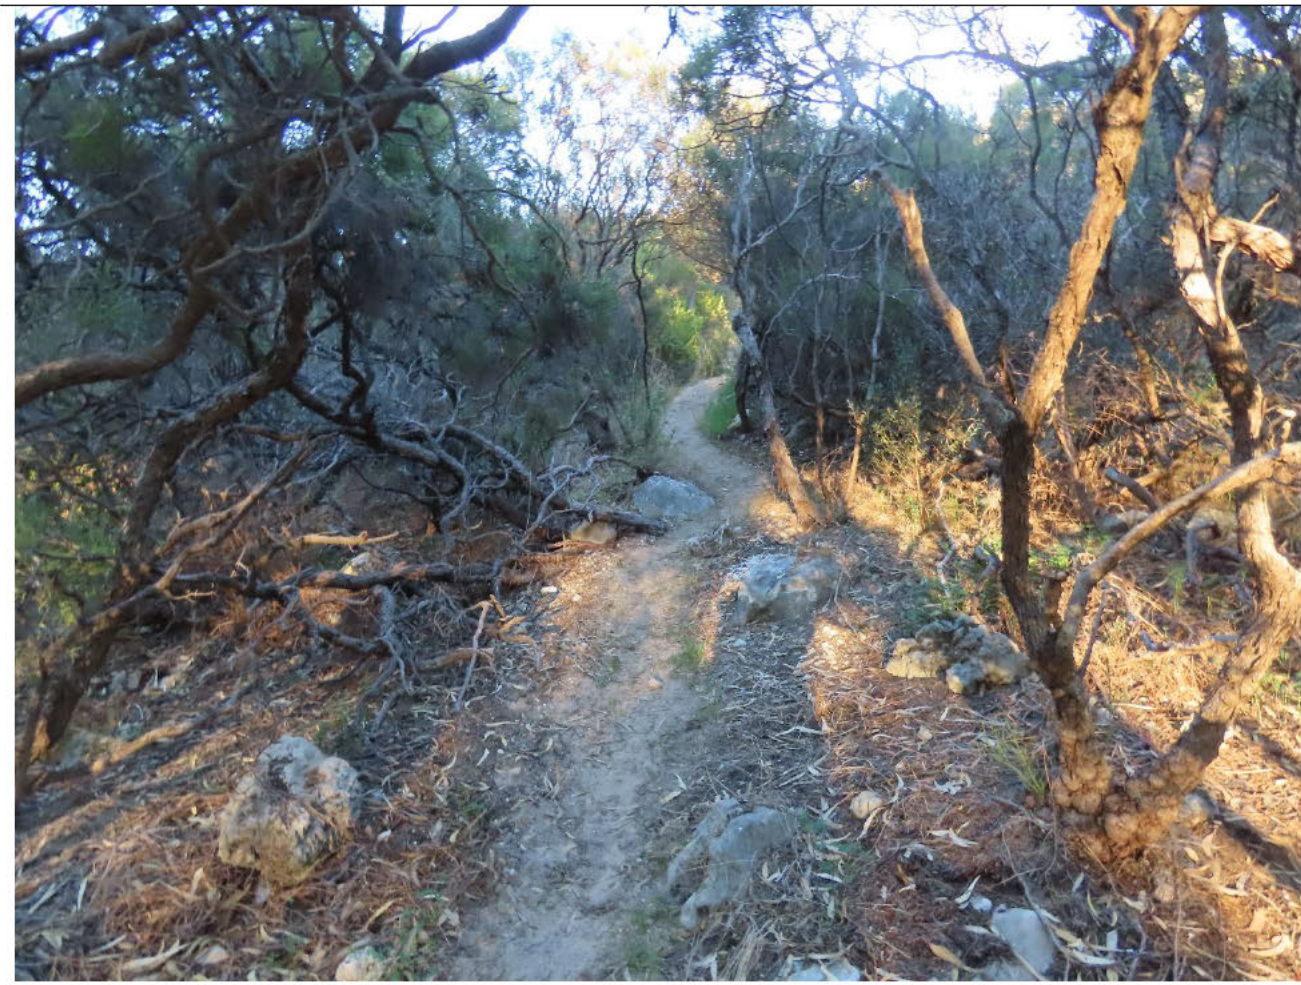
| Reference No.: | 64 |

| Condition: | Poor |
| Potential to Harm Heritage or Environmental Features: | Harm observed |
| Recommendation: | Close. Intersects with Tuart woodlands TEC, Honeymyrtle shrublands TEC<br>Currently facilitating weed spread and erosion to nearby environmental and heritage values. Poor condition trail. |

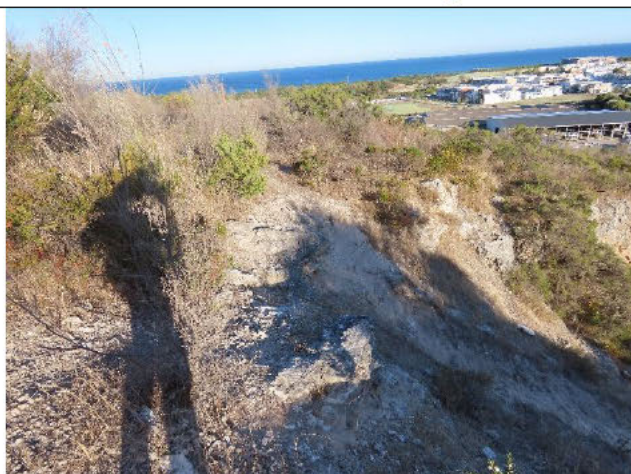
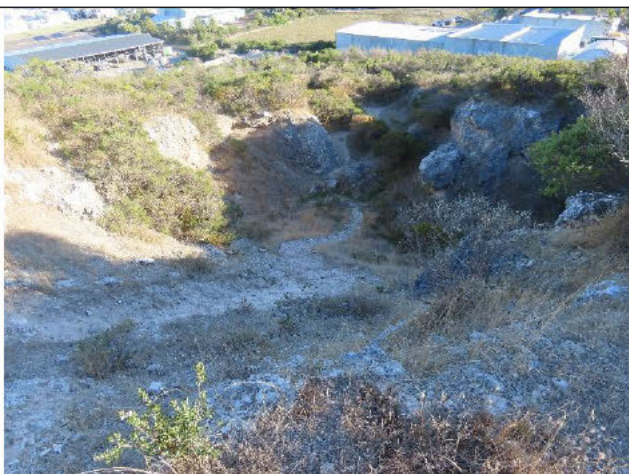
| Name: | Additional Trail 18 |
|---|---|
| Reference No.: | 65 |

| Name: | Additional Trail 18 |
|---|---|
| Condition: | Poor |
| Potential to Harm Heritage or Environmental Features: | Harm observed |
| Recommendation: | Close. Unnecessary meandering trails connecting trails 21, 22, 95 and 34. Intersects with the Honeymyrtle shrublands TEC. Erosion and vegetation trampling effects currently present. Poor condition, potentially dangerous trail. |

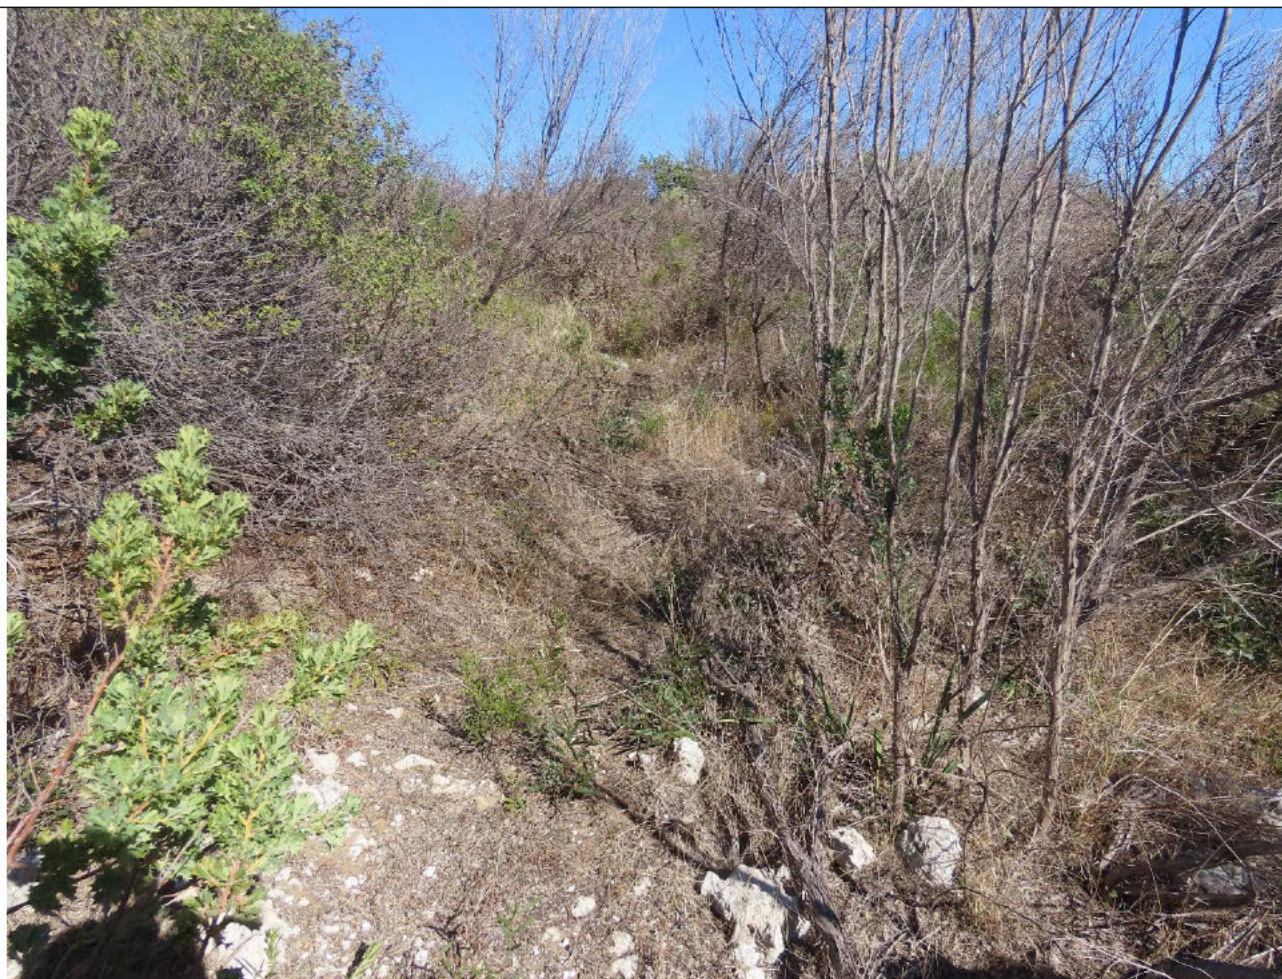
| Name: | Additional Trail 19 |
|---|---|
| Reference No.: | 66 |

| Name: | Additional Trail 19 |
|---|---|
| Condition: | Poor |
| Potential to Harm Heritage or Environmental Features: | Harm likely |
| Recommendation: | Close. Unnecessary shortcut connecting trails 95, 33 and 35. Intersects with the Honeymyrtle shrubland TEC. Potential to facilitate weed spread into the surrounding TEC. Poor condition trail, overgrown with vegetation. |

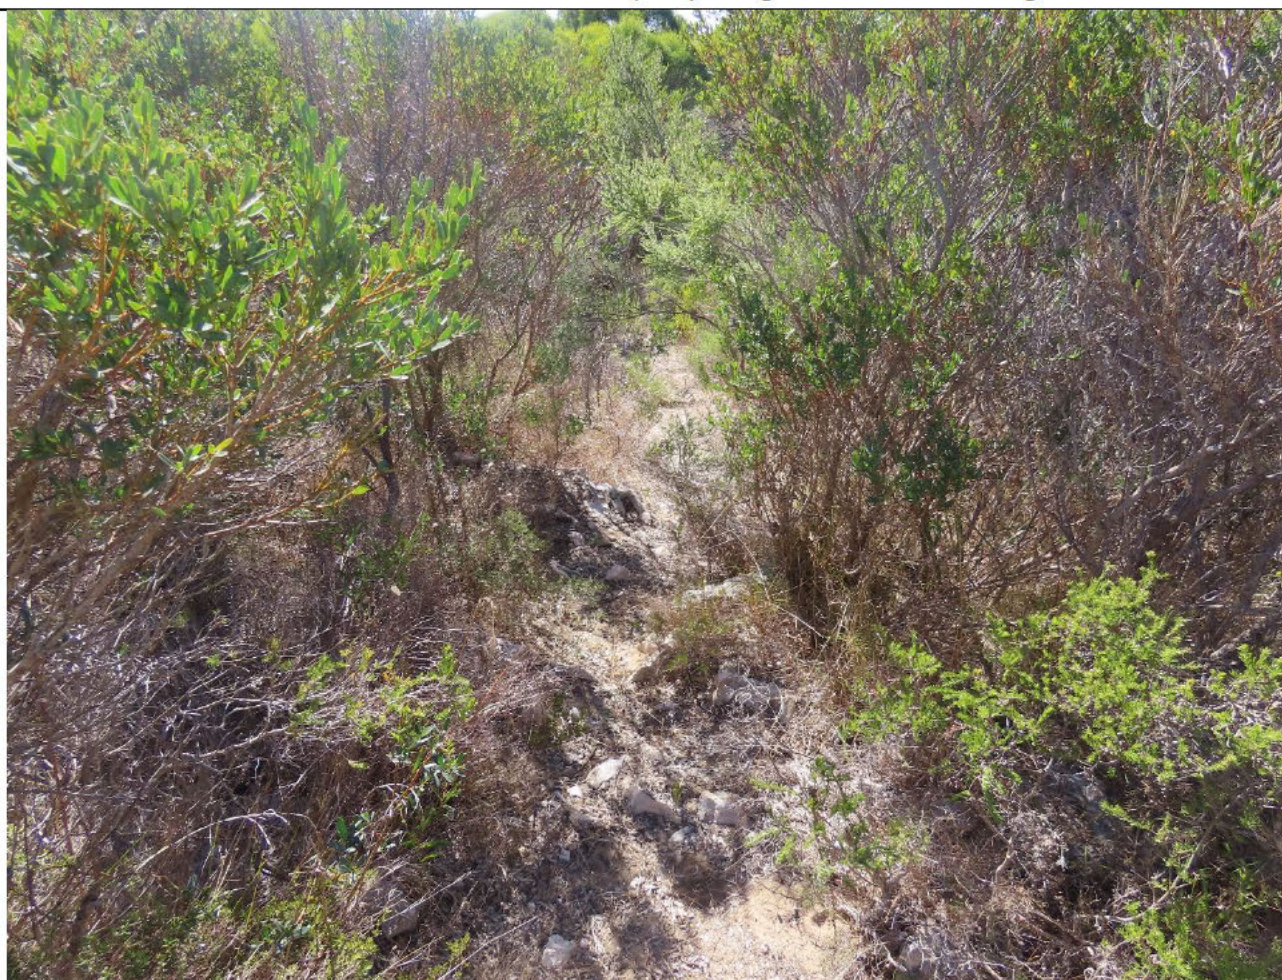
| Name: | Road to Nowhere |
|---|---|
| Reference No.: | 67 |

| Name: | Road to Nowhere |
|---|---|
| Condition: | Poor |
| Potential to Harm Heritage or Environmental Features: | Harm likely |
| Recommendation: | Close. Intersects with Honeymyrtle shrubland TEC and Tuart woodland TEC. Potential to introduce weeds into the surrounding TEC patches. Poor condition trail, very overgrown. With native vegetation. |

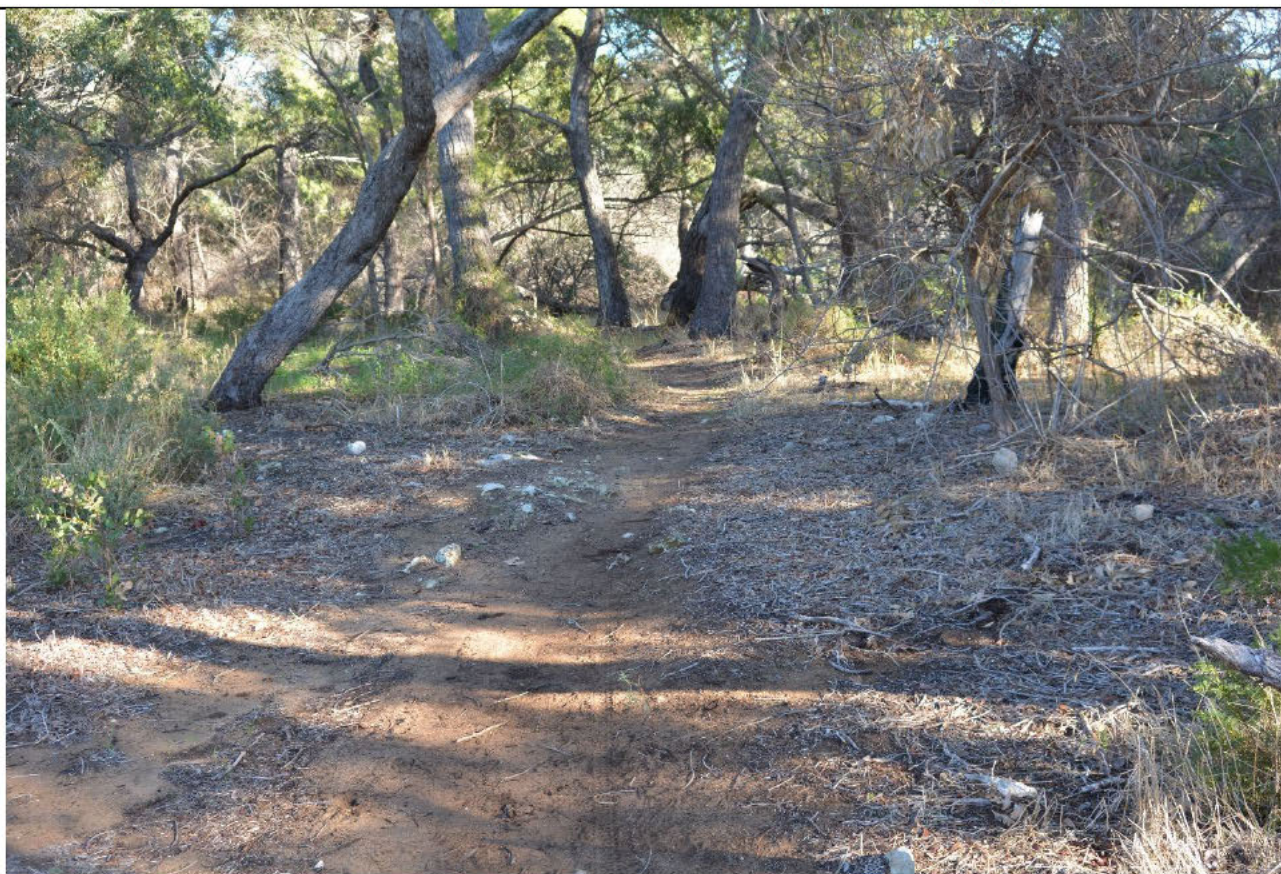
| Name: | Mid |
|---|---|
| Reference No.: | 68 |

| Name: | Mid |
|---|---|
| Condition: | Poor |
| Potential to Harm Heritage or Environmental Features: | Harm likely |
| Recommendation: | Close. Unnecessary shortcut. Intersects with the Tuart woodlands TEC.<br>Potential to introduce weeds into the surrounding TEC. |

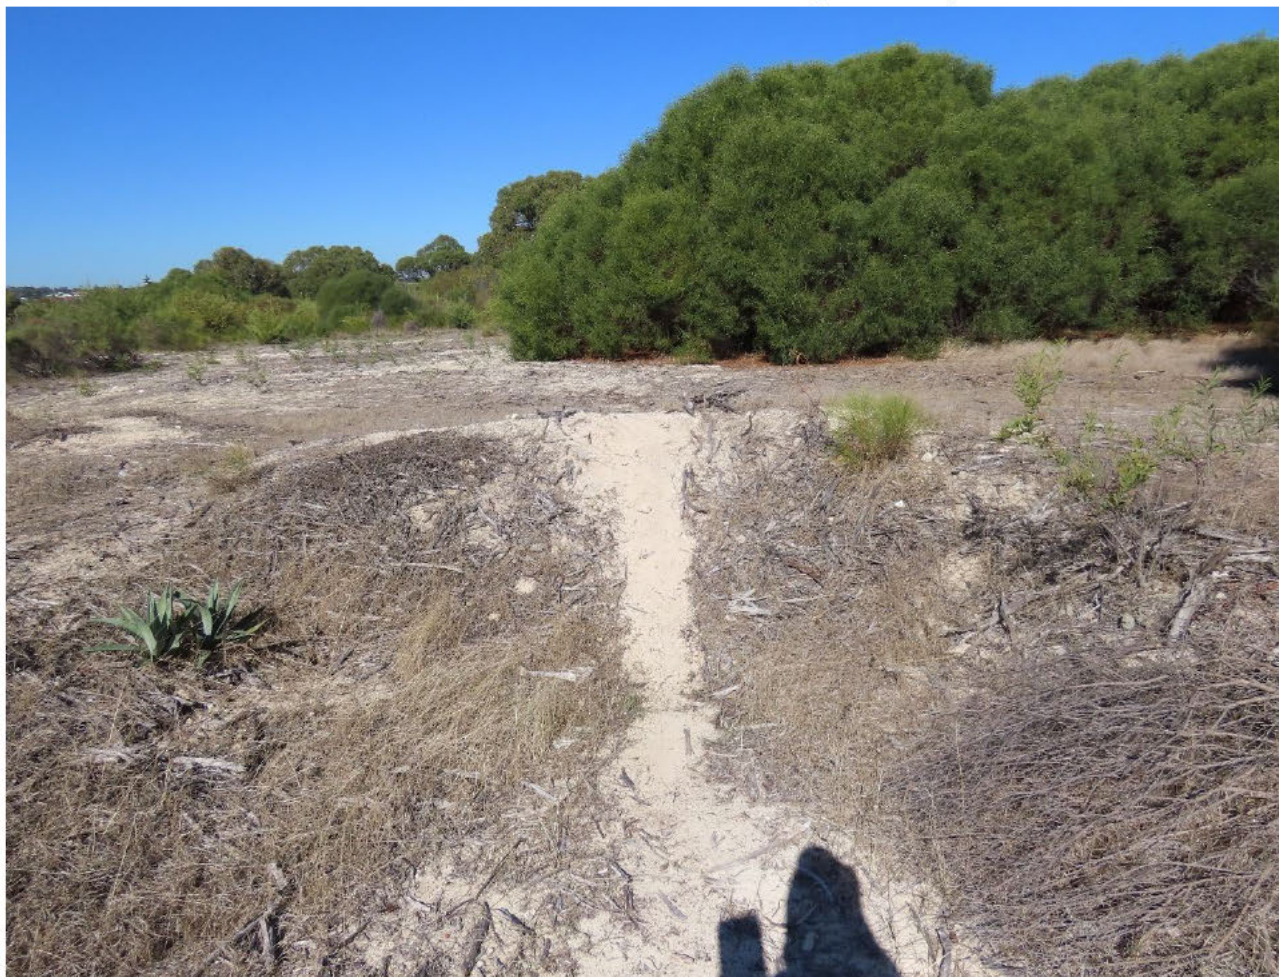
| Name: | Quarry Track |
|---|---|
| Condition: | Poor |
| Potential to Harm Heritage or Environmental Features: | Harm observed |
| Recommendation: | Close. Unauthorised mountain bike circuit including bike jumps. Erosion, trampling and weeds present. Intersects with Honeymyrtle shrublands TEC and Tuart woodlands TEC. Overgrown vegetation in sections. Poor condition trail. Not well used. Dangerous rocky sections of trail. |

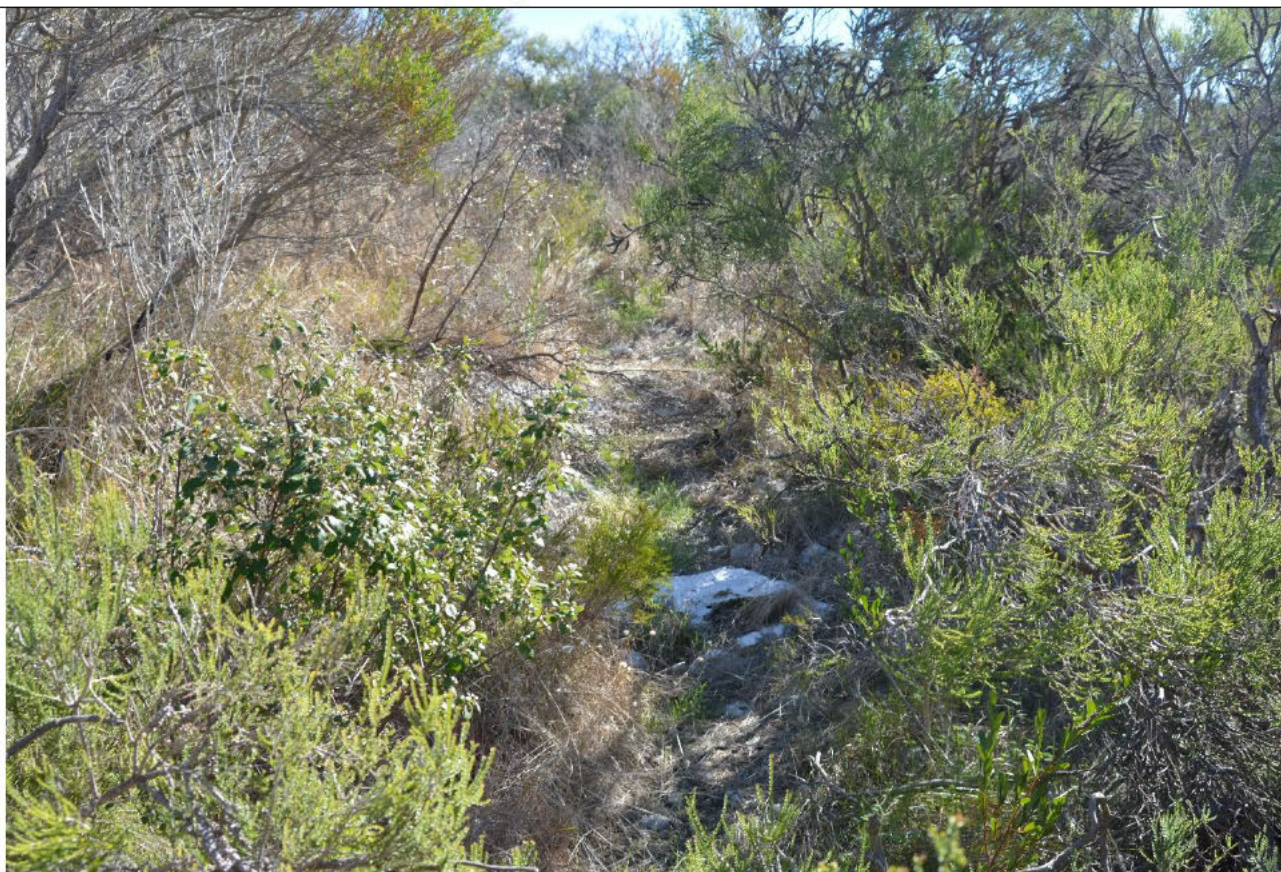
| Name: | Additional Trail 20 |
|---|---|
| Reference No.: | 70 |

| Name: | Additional Trail 20 |
|---|---|
| Condition: | Poor |
| Potential to Harm Heritage or Environmental Features: | Harm observed |
| Recommendation: | Close. Unnecessary shortcut connecting trails 124 and 37. Overgrown, trampling of native vegetation present. Potential to spread weeds into the adjacent Honeymyrtle shrubland TEC. Poor condition trail, not frequently used. |

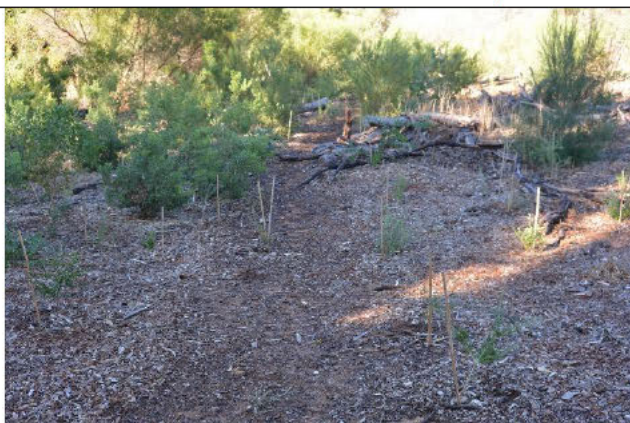
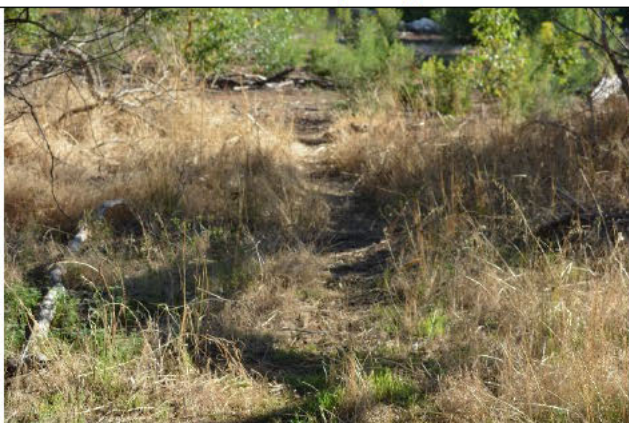
| Name: | Additional Trail 21 |
|---|---|
| Condition: | Poor |
| Potential to Harm Heritage or Environmental Features: | Harm likely |
| Recommendation: | Close. Intersects with Northern Spearwood shrublands PEC, Tuart woodlands TEC and revegetation area. Potential to spread weeds into the surrounding environmental features. Unnecessary trail connecting trails 28,45 and 105. Poor condition trail not frequently used. |

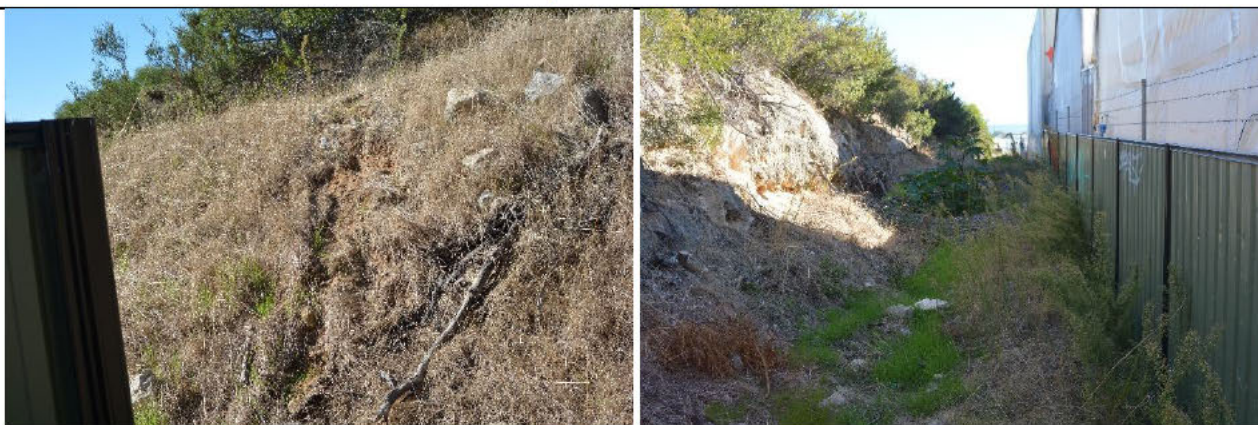
| Name: | Additional Trail 22 |
|---|---|
| Reference No.: | 72 |

| Name: | Additional Trail 22 |
|---|---|
| Condition: | Poor |
| Potential to Harm Heritage or Environmental Features: | Harm unlikely |
| Recommendation: | Close. Unnecessary trail parallel to trail 21. High weed load along trail and erosion present. |

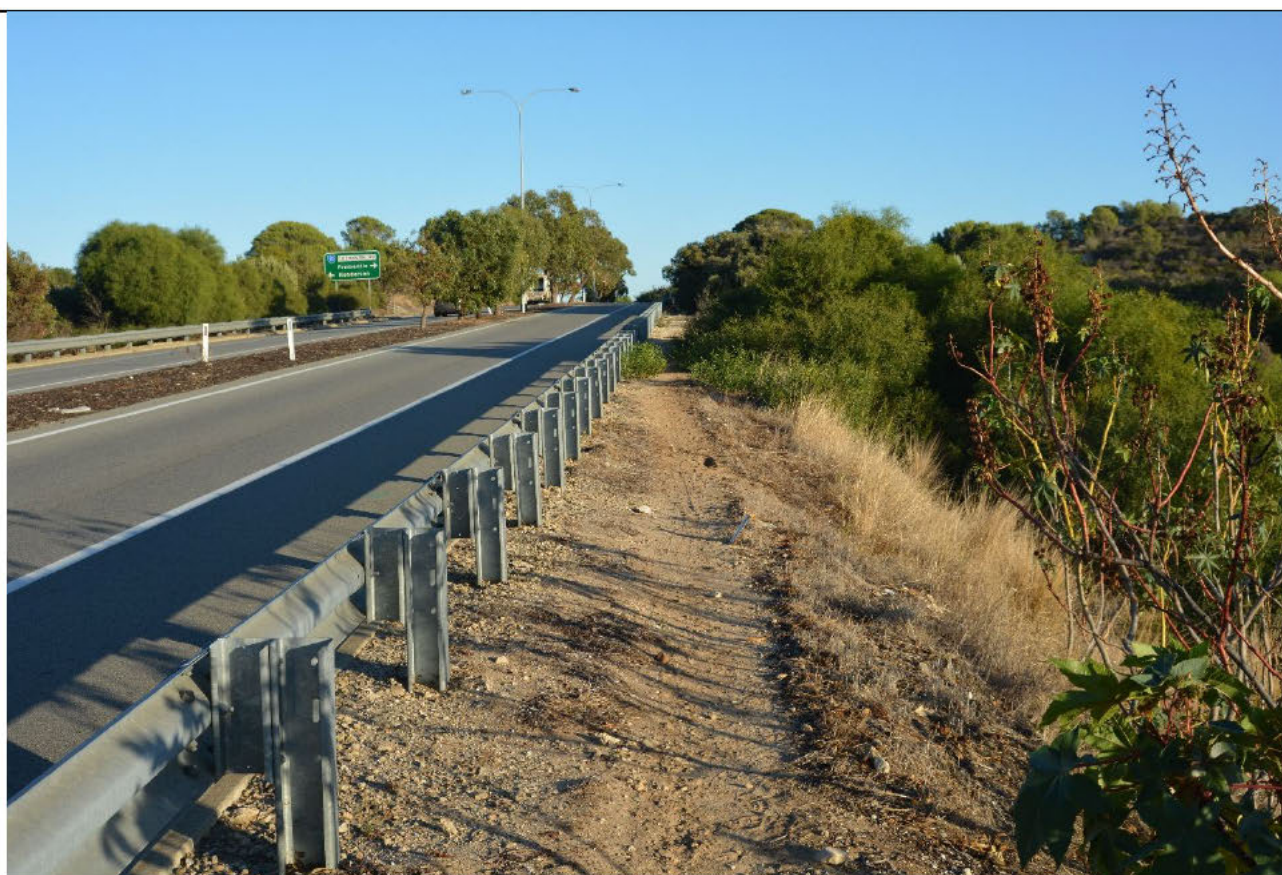
| Name: | Additional Trail 23 |
|---|---|
| Reference No.: | 73 |

| Name: | Additional Trail 23 |
|---|---|
| Condition: | Good |
| Potential to Harm Heritage or Environmental Features: | Harm unlikely |

| Name: | Additional Trail 23 |
|---|---|
| Recommendation: | Keep open - formalise. Trail used as bicycle access between Spearwood Avenue and trail 1. |

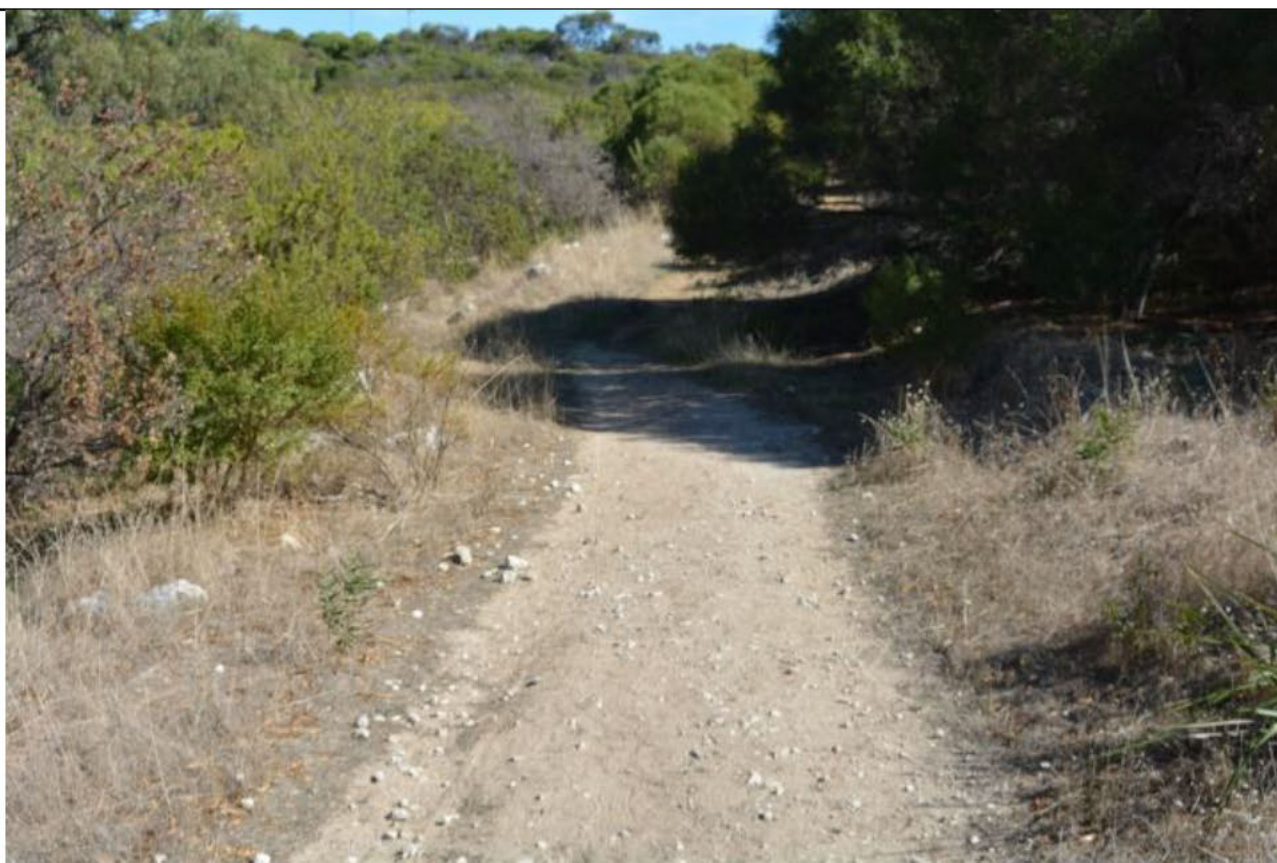
| Reference No.: | 74 |

| Condition: | Good |
| Potential to Harm Heritage or Environmental Features: | Harm unlikely |

| Recommendation: | Keep open - maintenance. Trail overgrown in sections, may require minor vegetation trimming. Formalisation recommended in trampled sections. |

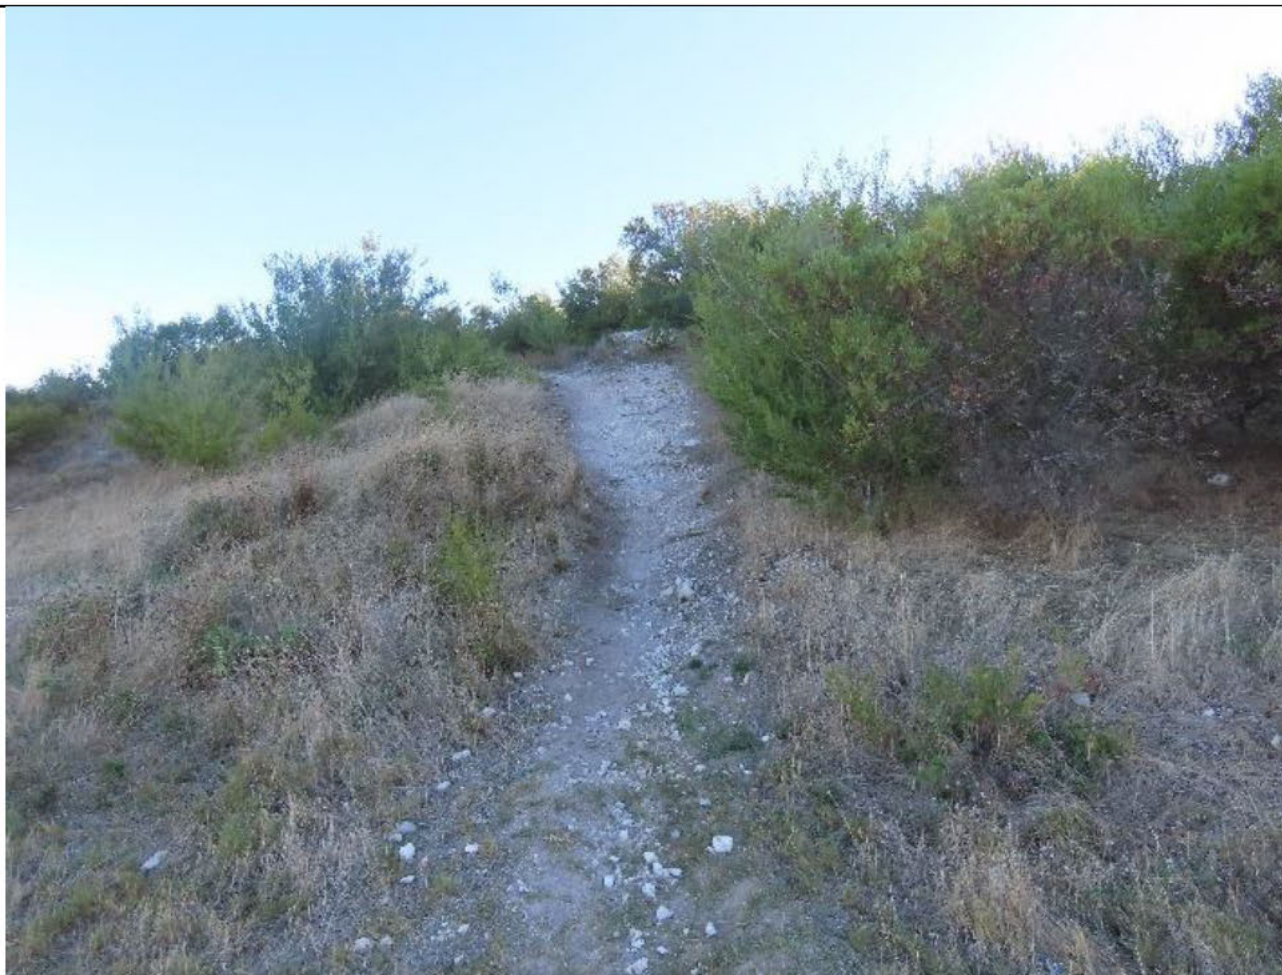
| Name: | Putins Fetish |
|---|---|
| Reference No.: | 75 |

| Name: | Putins Fetish |
|---|---|
| Condition: | Medium |
| Potential to Harm Heritage or Environmental Features: | Harm unlikely |

| Name: | Putins Fetish |
|---|---|
| Recommendation: | Close. High risk of harm to the environment through continued use of the trail. |

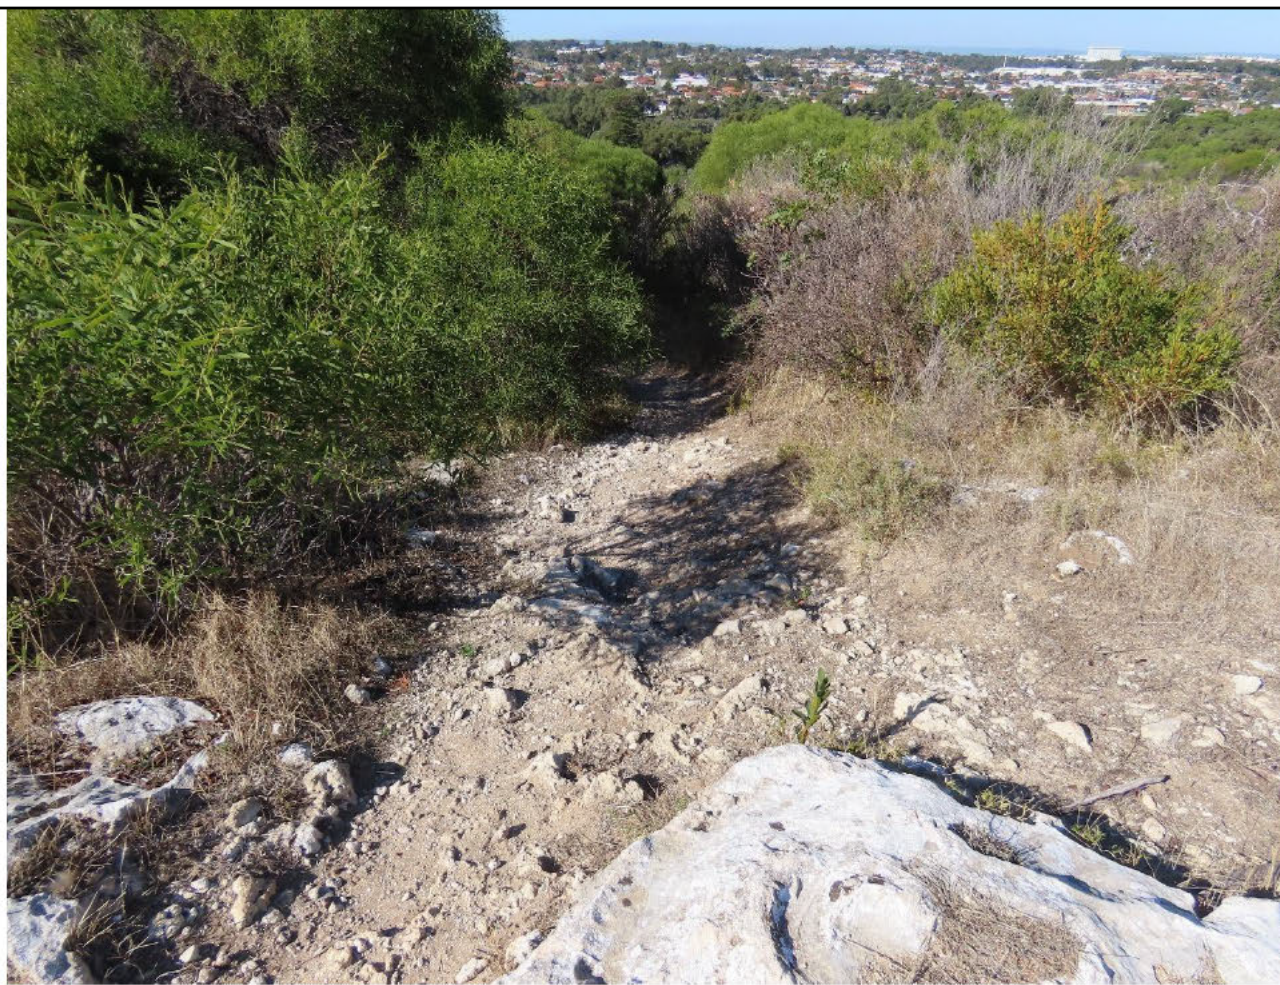
| Reference No.: | 76 |

| Condition: | Medium |
| Potential to Harm Heritage or Environmental Features: | Harm likely |

| Recommendations: | Keep open. Trail 76 is required to be kept open by the City, however [REDACTED] Fencing [REDACTED] should be installed to mitigate negative effects of foot traffic on this site by users of this section of trail 76. |

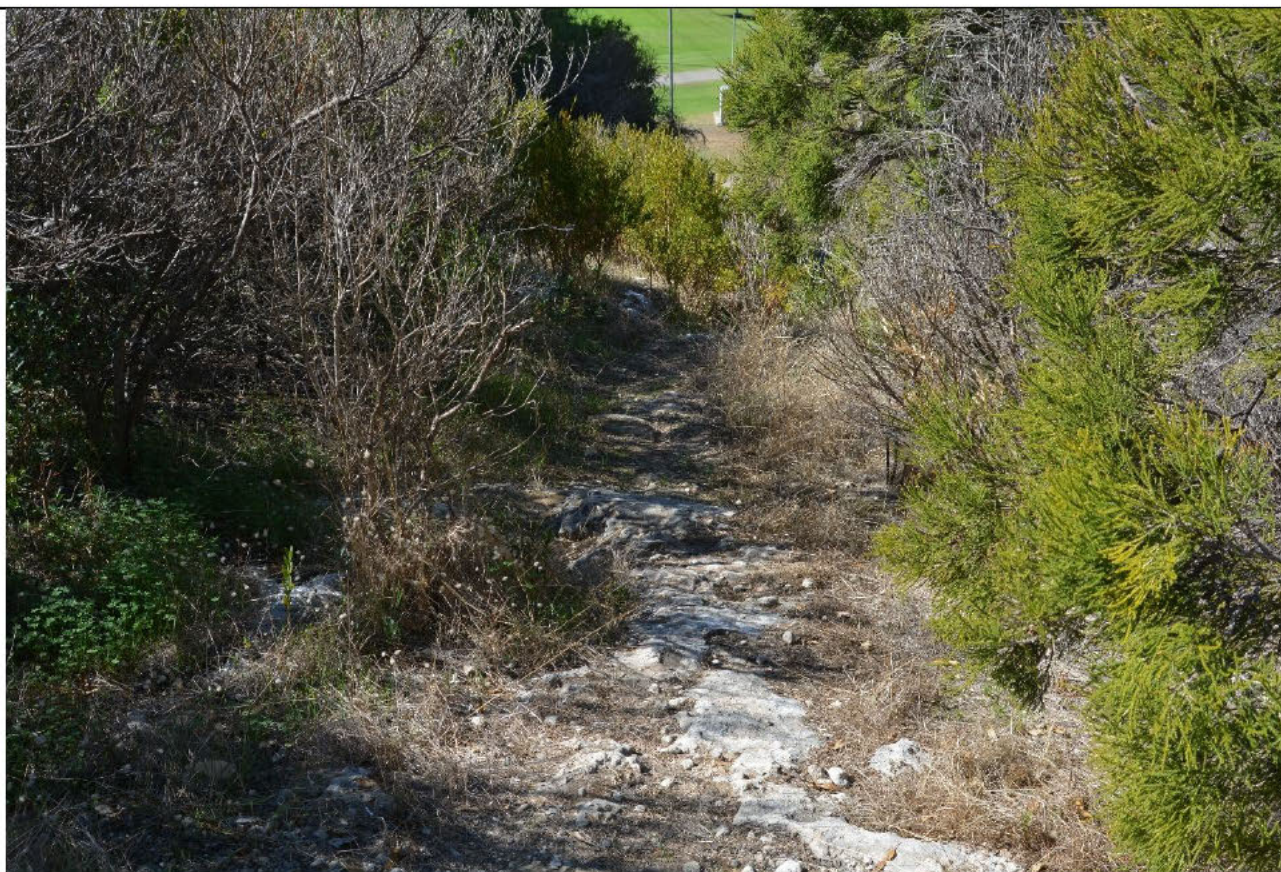
| Reference No.: | 77 |

| Condition: | Poor |
| Potential to Harm Heritage or Environmental Features: | Harm Observed |

| Recommendation: | Keep open. Maintenance should be undertaken to ensure track remains useable. |

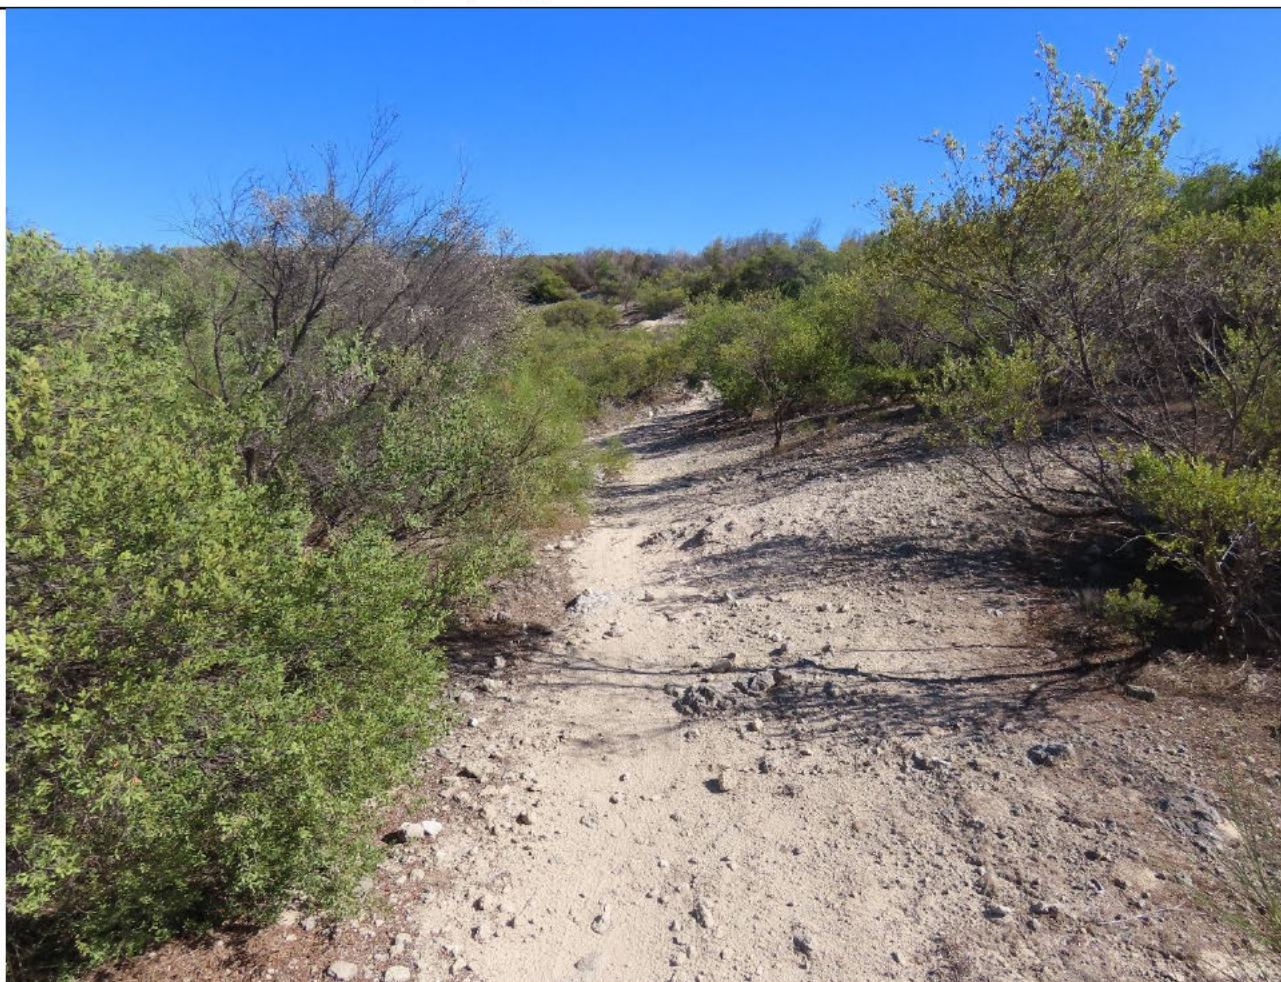
| Reference No.: | 78 |

| Condition: | Poor |
| Potential to Harm Heritage or Environmental Features: | Harm observed |

| Recommendation: | Keep open. Track 78 is required to be included as part of the proposed quarry loop, and will link to track 39. |

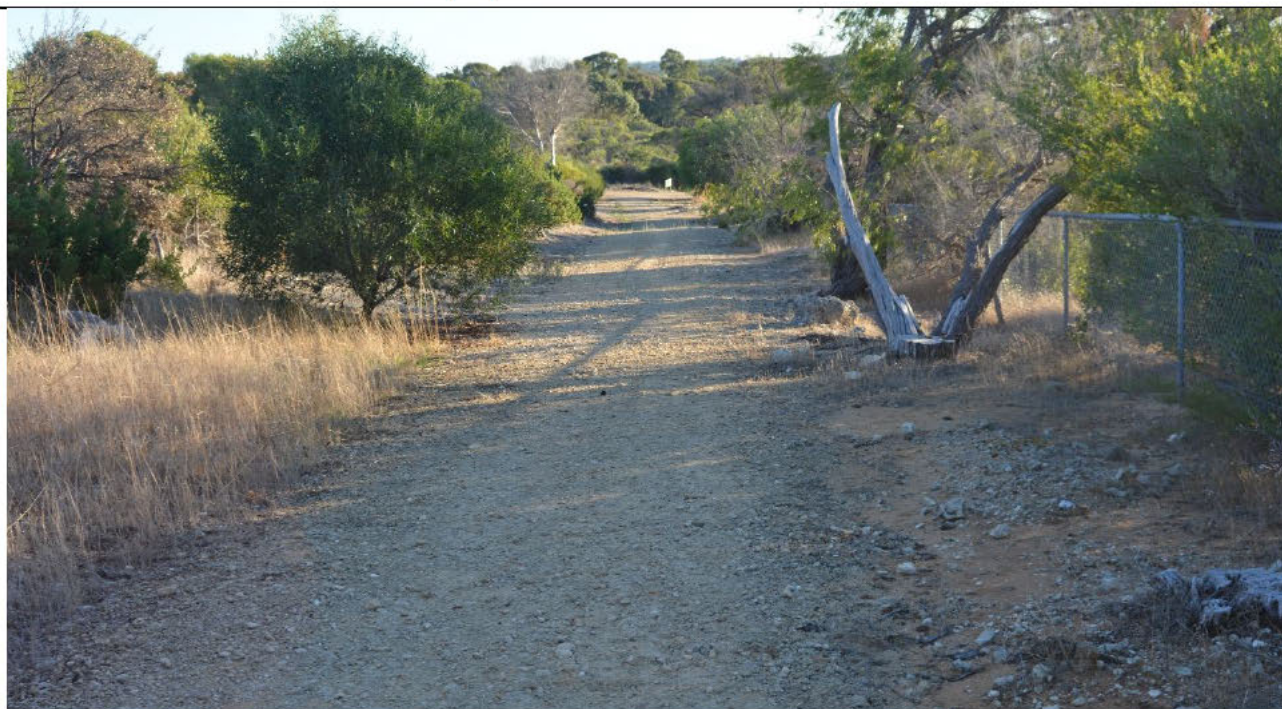
| Name: | Footway 3 |
|---|---|
| Condition: | Good |
| Required by City: | Yes |

| Name: | Footway 3 |
|---|---|
| Recommendation: | Keep open. |

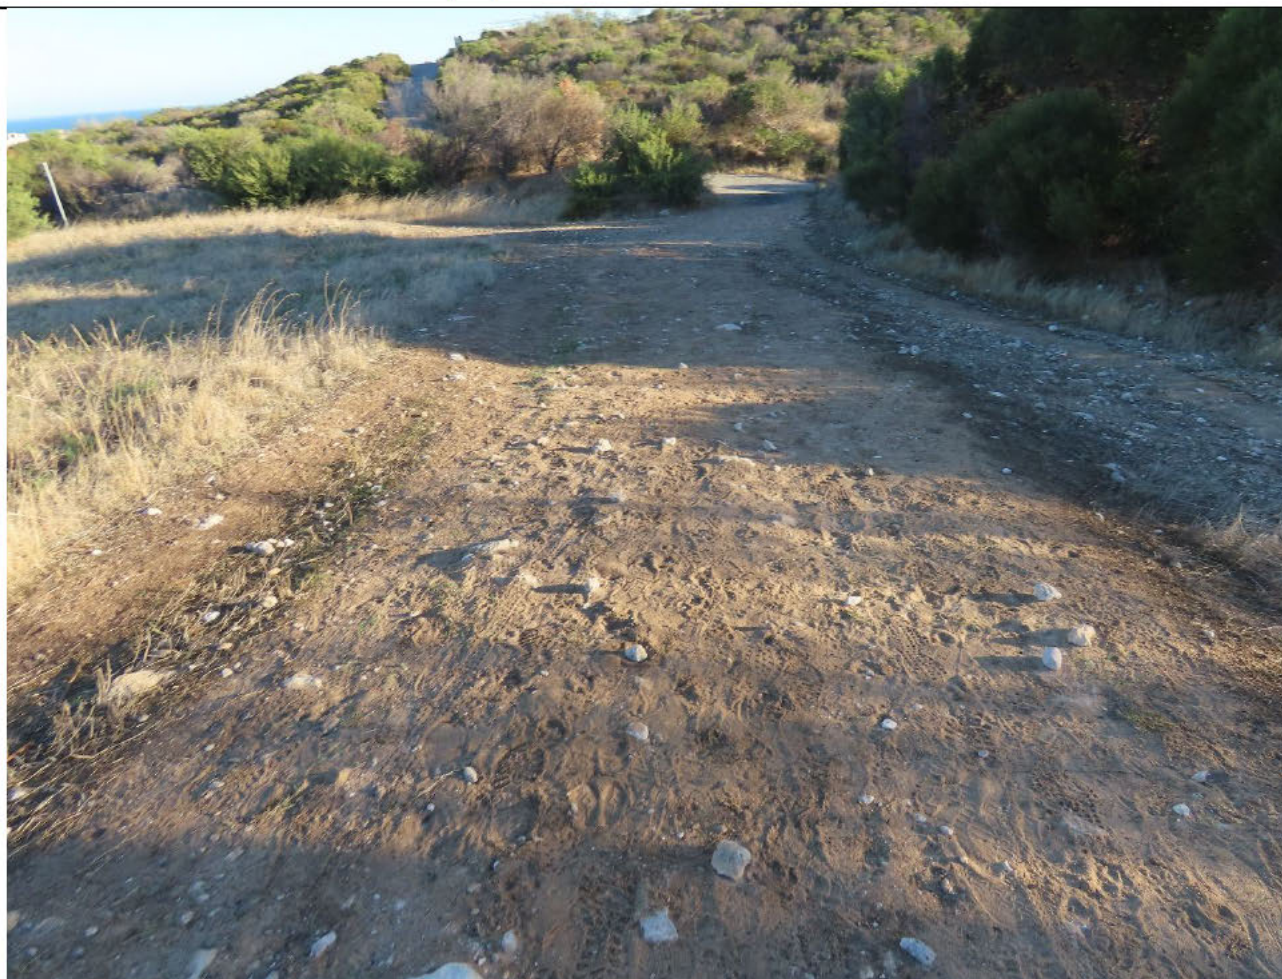
| Reference No.: | 80 |

| <b>Name:</b> | <b>Firebreak</b> |
| Condition: | Good |
| Required by City: | Yes |

| Recommendation: | Keep open. |
