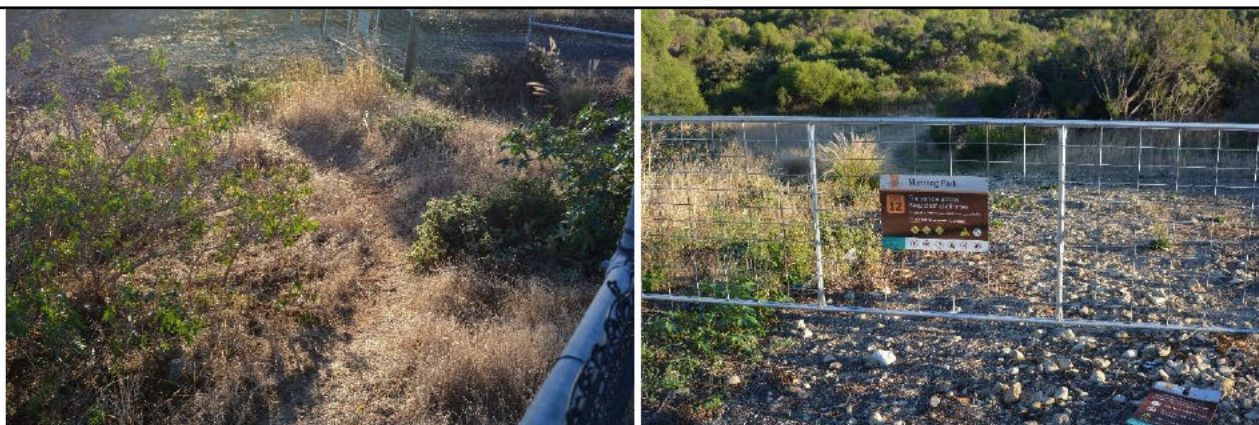
| Name: | Additional Trail 9 |
|---|---|
| Condition: | Poor |
| Potential to Harm Heritage or Environmental Features: | Harm likely |

| Name: | Additional Trail 9 |
|---|---|
| Recommendation: | Keep open - Formalise. Potential for erosion to occur. Gate 12 is inaccessible by bicycles, with no other suitable access point along the western portion of Spearwood Avenue. Recommendations include formalisation to allow bicycles access off Spearwood Avenue, and to mitigate erosion risk. If the City wishes to close this trail it is recommended to modify gate 12 to allow bicycle access into Manning Park from Spearwood Avenue. |

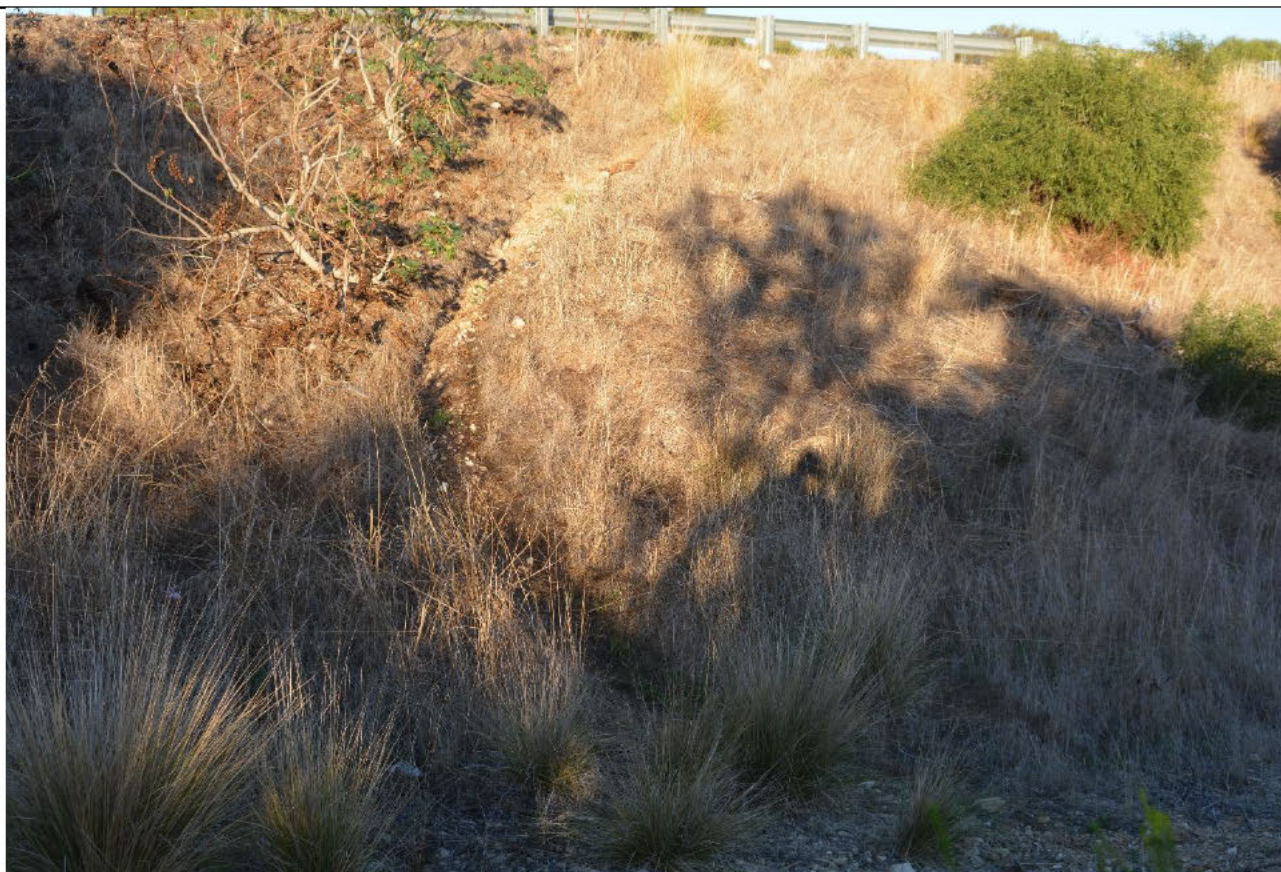
| Name: | Additional Trail 10 |
|---|---|
| Reference No.: | 42 |

| Name: | Additional Trail 10 |
|---|---|
| Condition: | Poor |
| Potential to Harm Heritage or Environmental Features: | Harm likely |

| Name: | Additional Trail 10 |
|---|---|
| Recommendation: | Close. Second point of access for bicycles off Spearwood Avenue. Not required if trail 41 remains open, or gate 12 is modified. Potential for erosion to occur. |

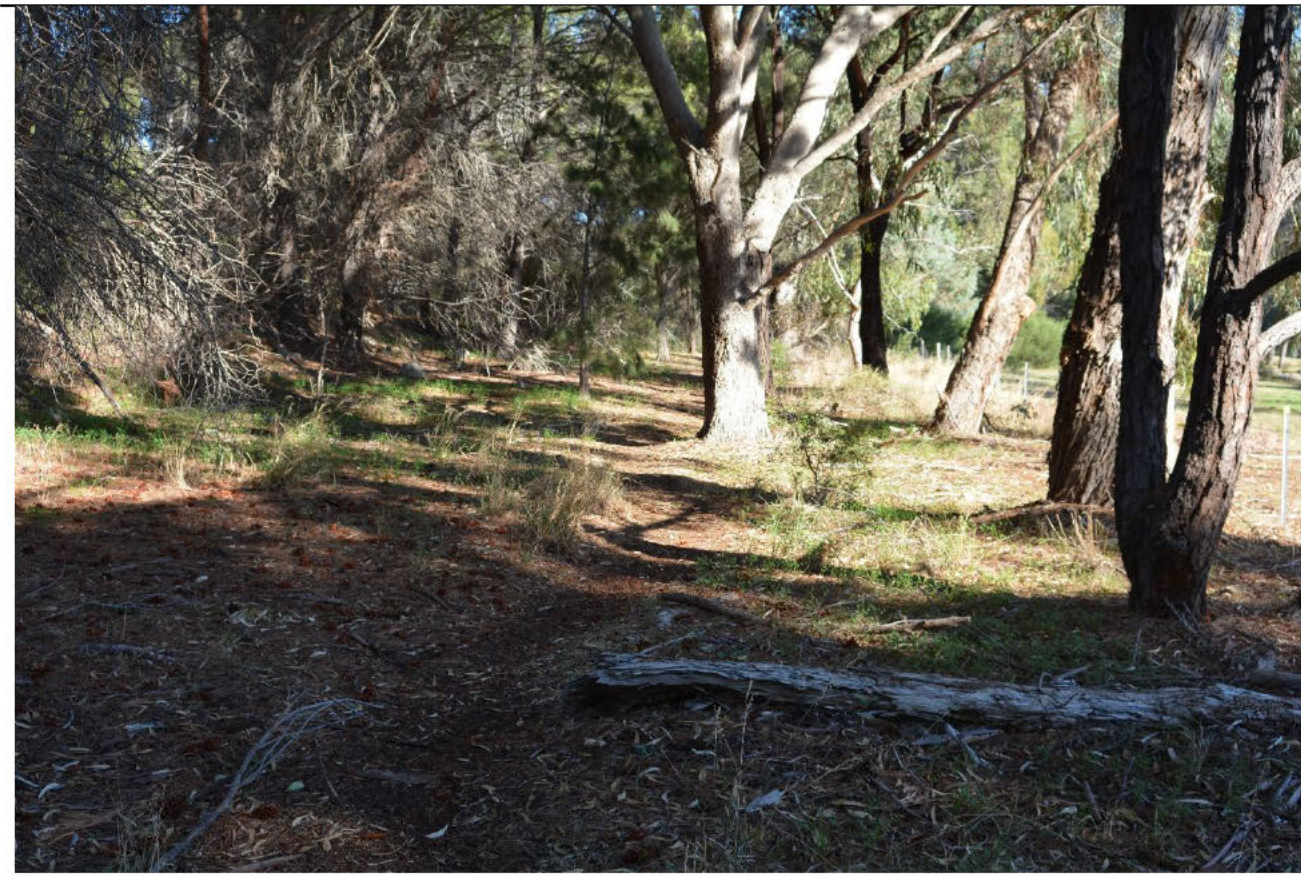
| Name: | Additional Trail 11 |
|---|---|
| Reference No.: | 43 |

| Name: | Additional Trail 11 |
|---|---|
| Condition: | Medium |
| Potential to Harm Heritage or Environmental Features: | Harm likely. |

| Name: | Additional Trail 11 |
|---|---|
| Recommendation: | Close. Potential to cause weed spread through Tuart woodlands TEC, Northern Spearwood shrublands PEC and revegetated areas. Is not required for trail connectivity. |

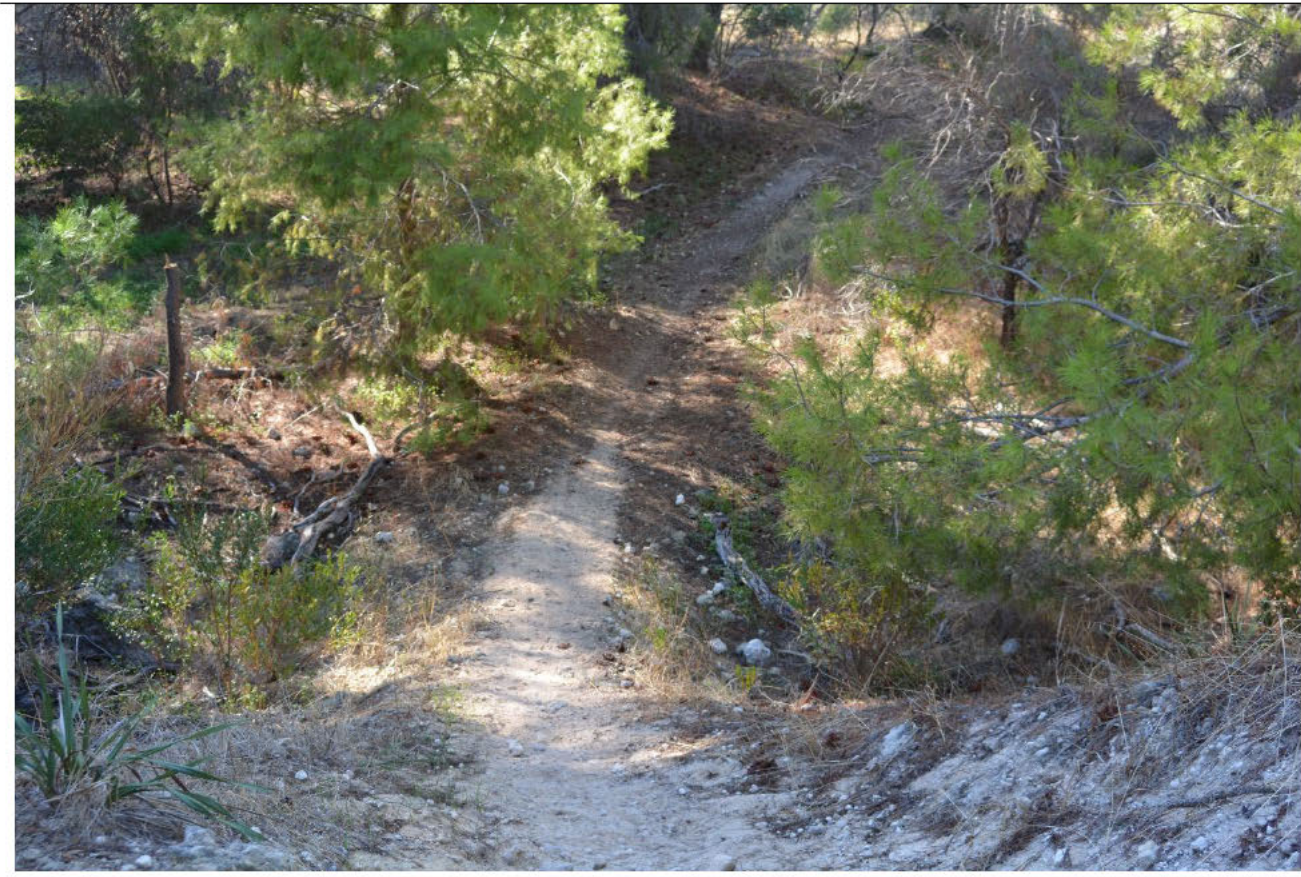
| Condition: | Medium |
| Potential to Harm Heritage or Environmental Features: | Harm likely |

| Recommendation: | Close. Is not required for trail connectivity, forms a loop off trail 3. Intersects with revegetation area, Northern Spearwood shrublands PEC and Tuart woodlands TEC. Potential to spread weeds into revegetated area, Tuart woodlands TEC and Northern Spearwood shrublands PEC. |

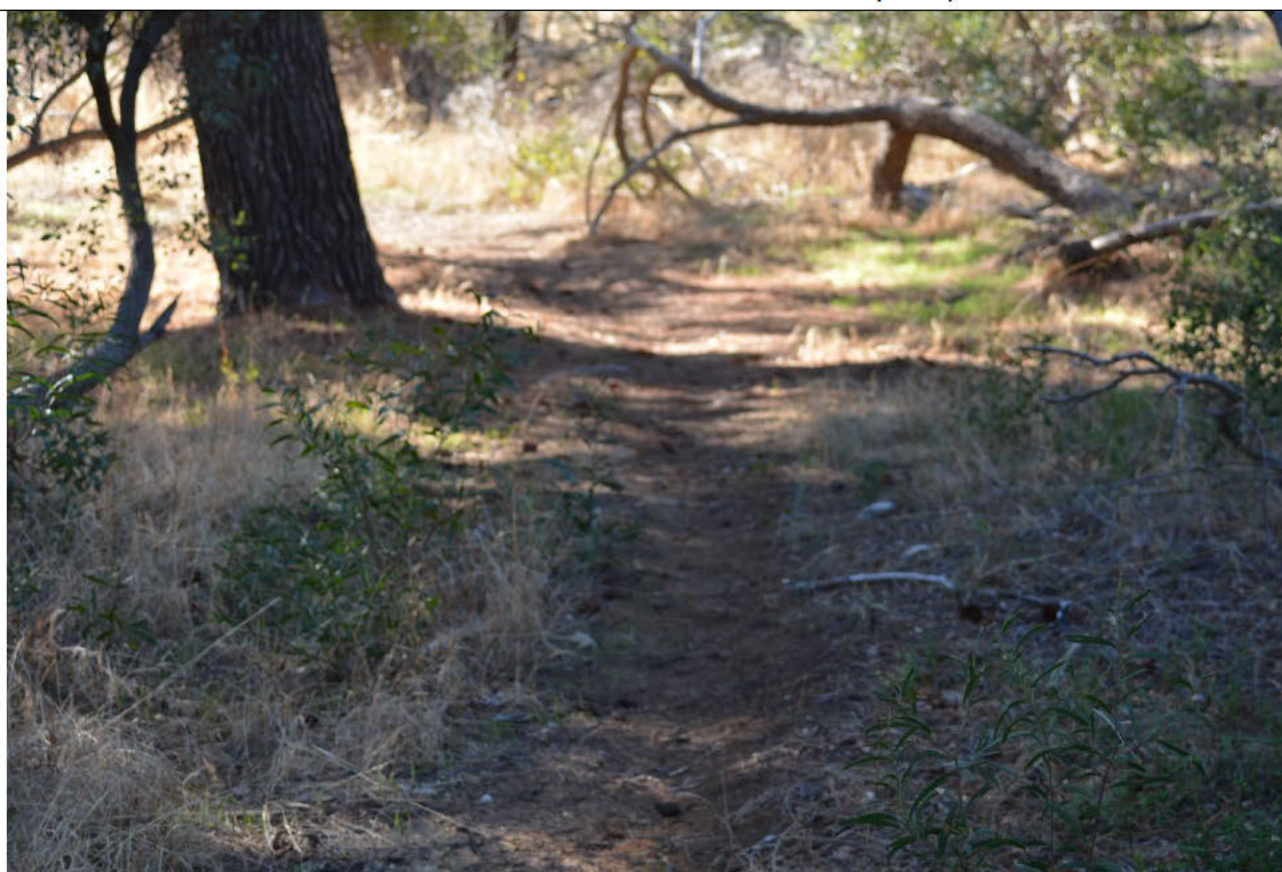
| Condition: | Medium |
| Potential to Harm Heritage or Environmental Features: | Harm likely |

| Recommendation: | Close. Intersects with Tuart woodlands TEC, Northern Spearwood shrublands PEC and revegetation area. Potential to spread weeds into all three areas. Connect trails 3 and 7. Not required for connectivity as trails 6 also connects trails 3 and 7. Not a frequently used trail. |

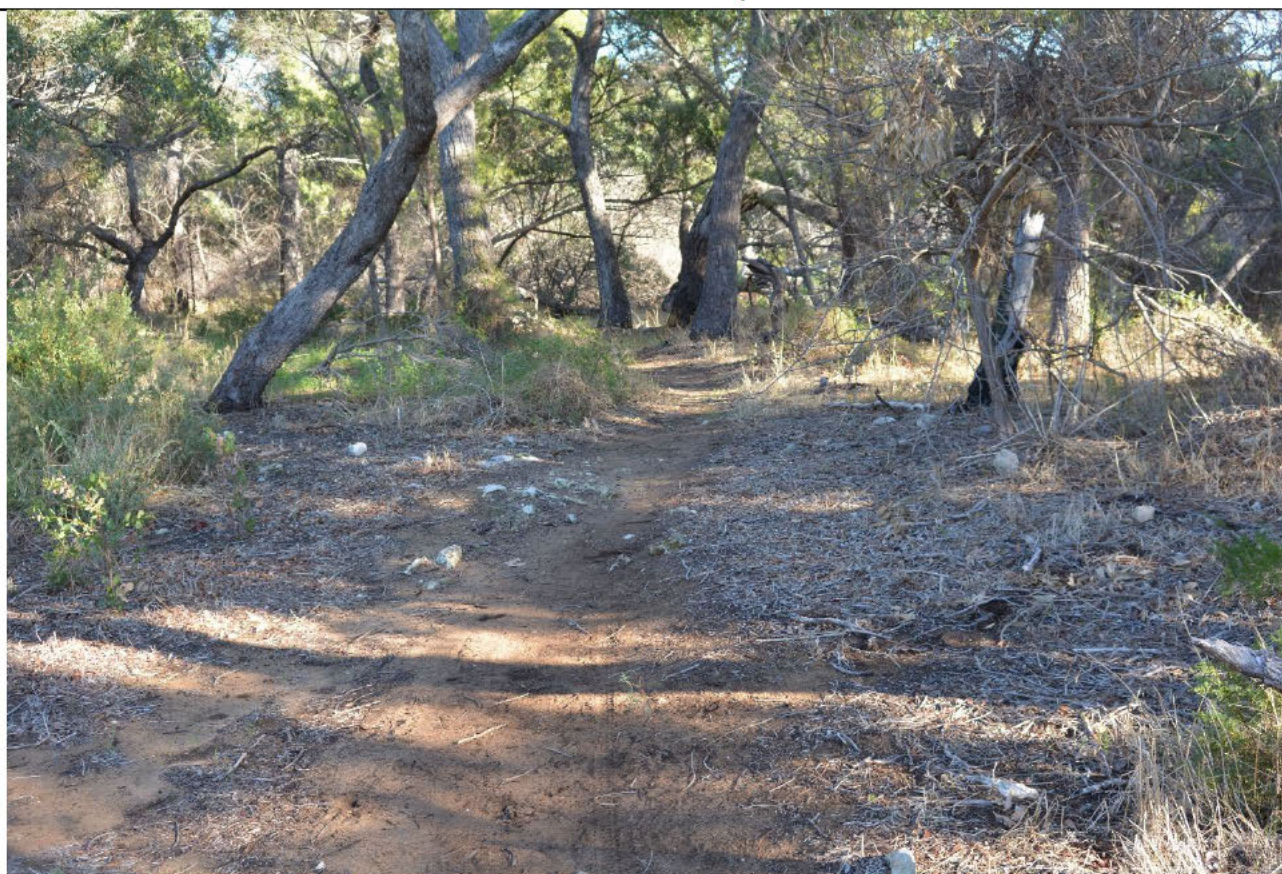
| Reference No.: | 46 |

| Condition: | Medium |
| Potential to Harm Heritage or Environmental Features: | Harm likely |

| Recommendation: | Close. Not required, leads to other trails to be closed. Close to avoid dead ends. Intersects with revegetation area and Northern Spearwood shrublands PEC and has the potential to introduce weeds. |

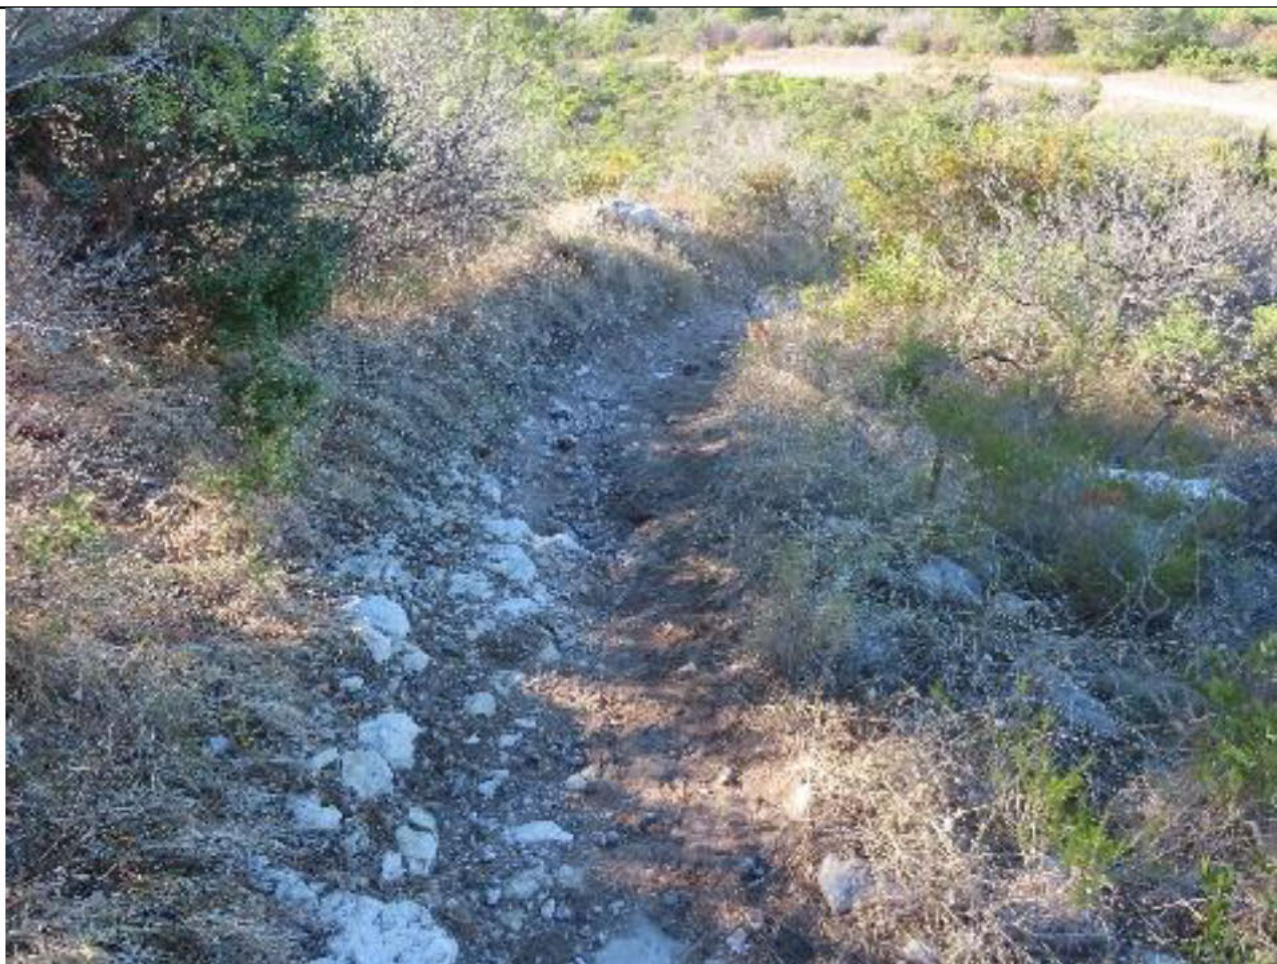
| Name: | Alt Route |
|---|---|
| Reference No.: | 47 |

| Name: | Alt Route |
|---|---|
| Condition: | Poor |
| Potential to Harm Heritage or Environmental Features: | Harm observed |

| Name: | Alt Route |
|---|---|
| Recommendation: | Close. Currently spreading weeds into adjacent vegetation. Risk of erosion. Intersects with Honeymyrtle shrubland TEC and Northern Spearwood shrubland PEC. Intersects with Davilak Ruins. |

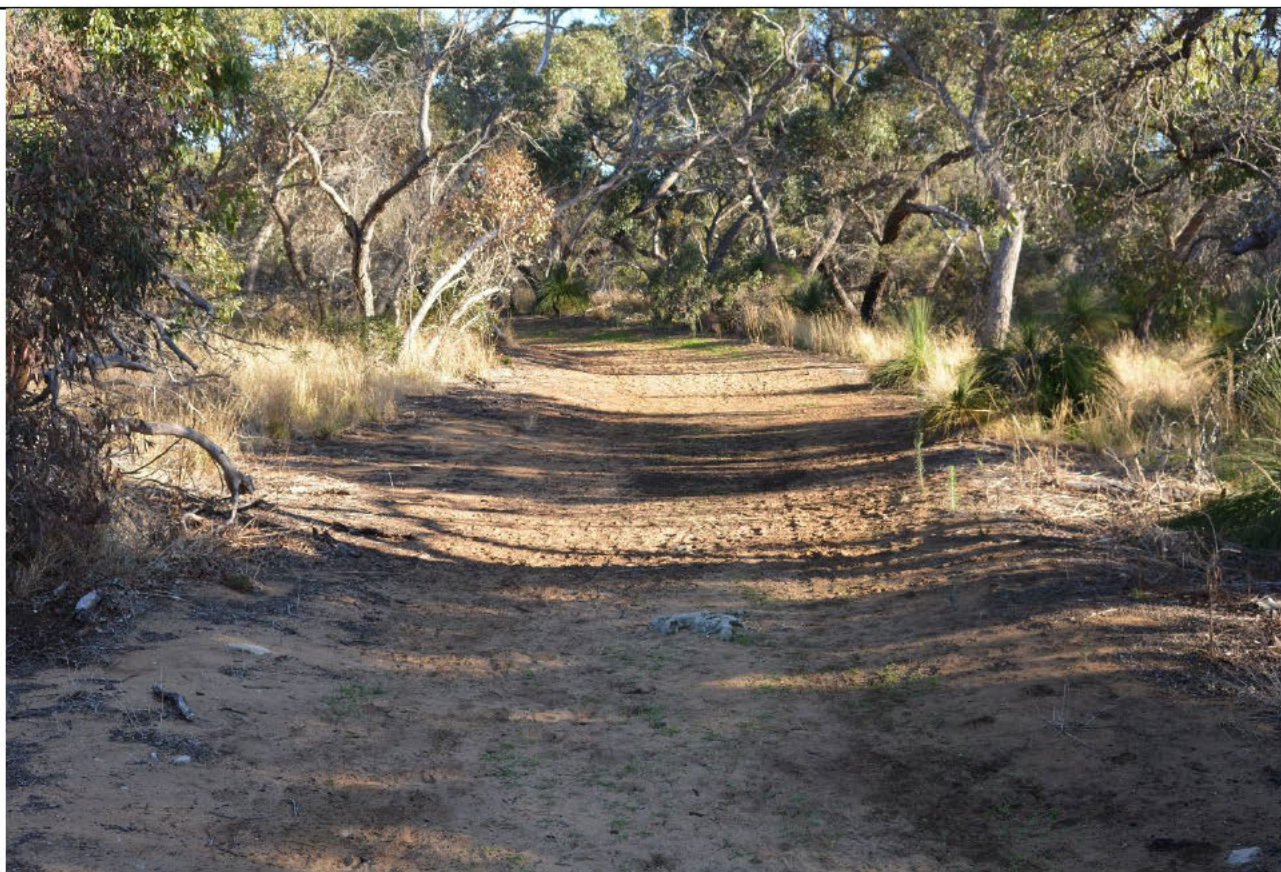
| Reference No.: | 48 |

| Condition: | Poor |
| Potential to Harm Heritage or Environmental Features: | Harm observed |

| Recommendation: | Close. Poor condition trail not frequently used. Vegetation trampling occurring. |

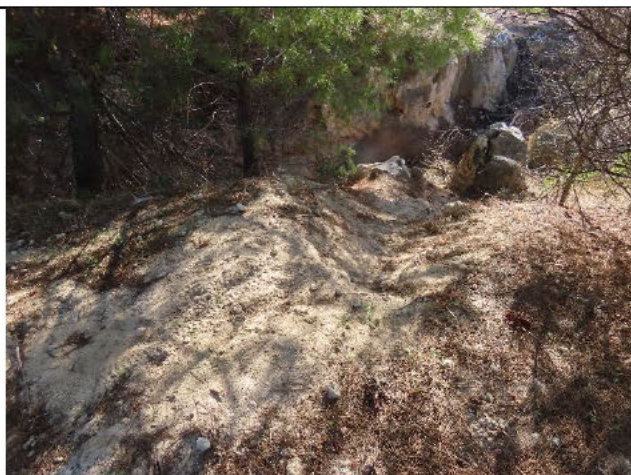
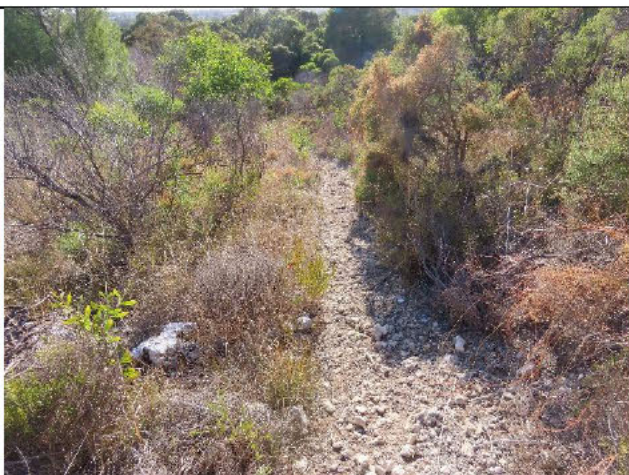
| Reference No.: | 49 |

| Condition: | Poor |
| Potential to Harm Heritage or Environmental Features: | Harm observed |

| Recommendation: | Close. Unnecessary shortcuts. Intersect with the Northern Spearwood shrublands PEC. Risk of erosion moving into surrounding vegetation. Leads to Davilak Ruins. |

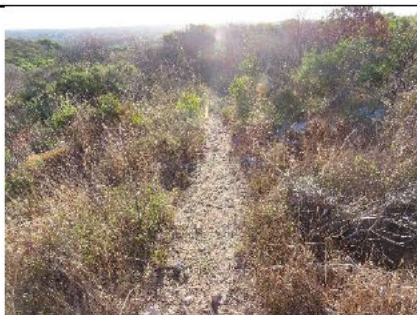
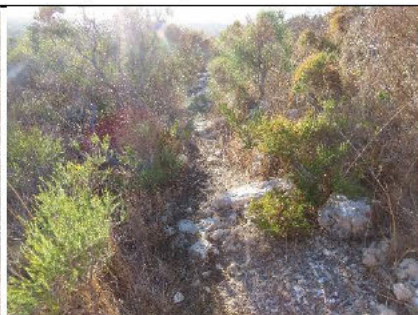
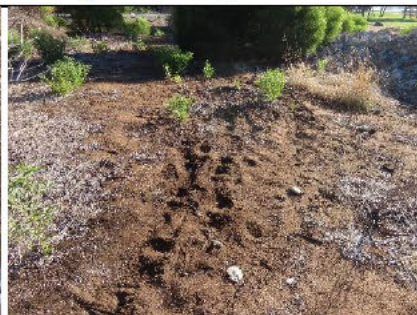
| Name: | Castle Face |
|---|---|
| Reference No.: | 50 |

| Name: | Castle Face |
|---|---|
| Condition: | Poor |
| Potential to Harm Heritage or Environmental Features: | Harm observed |

| Name: | Castle Face |
|---|---|
| Recommendation: | Close. Rubbish along the trail. Leads to Davilak Ruins. Trail is not necessary as it is parallel to trail 10. Not a high frequency use trail. |

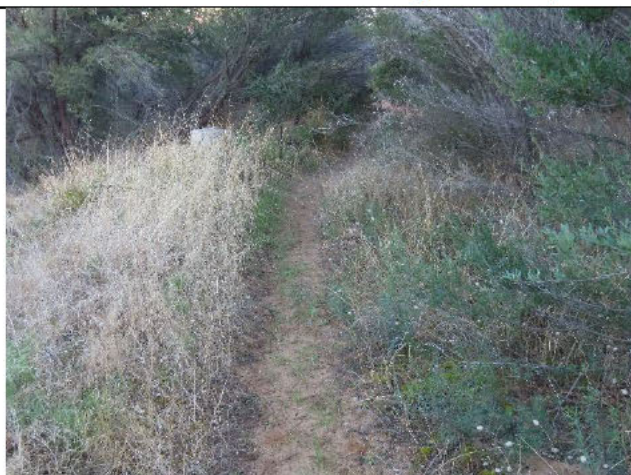
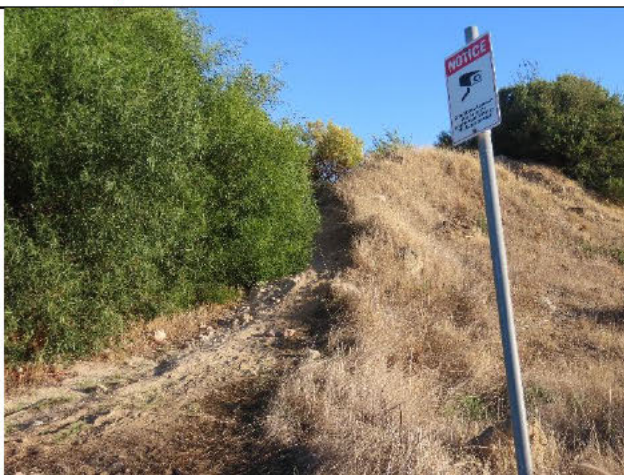
| Name: | Additional Trail 12 |
|---|---|
| Reference No.: | 51 |

| Name: | Additional Trail 12 |
|---|---|
| Condition: | Poor |
| Potential to Harm Heritage or Environmental Features: | Harm observed |

| Name: | Additional Trail 12 |
|---|---|
| Recommendation: | Close. Erosion present. Trail not necessary, links trails 5, 9 and 12. Trails 5, 9 and 12 are already linked. Poor condition trail would require significant inputs from the City to formalise. |

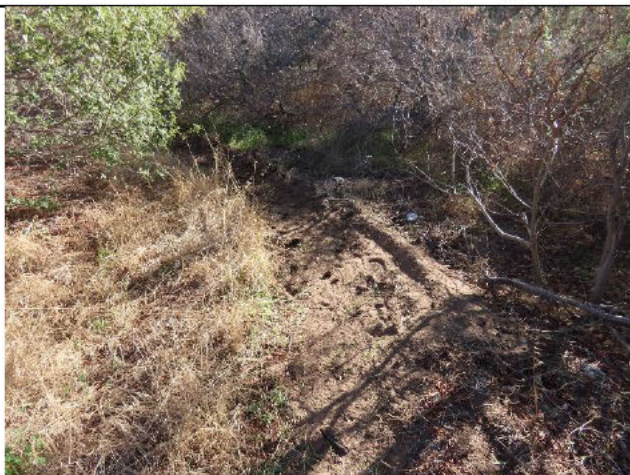
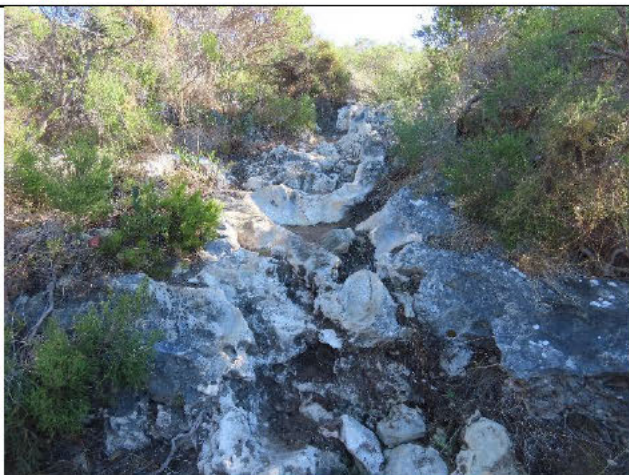
| Reference No.: | 52 |

| Condition: | Poor |
| Potential to Harm Heritage or Environmental Features: | Harm likely |

| Recommendation: | Close. Unnecessary shortcut through trail 10. Has the potential to negatively affect nearby priority flora. Poor condition trail. |

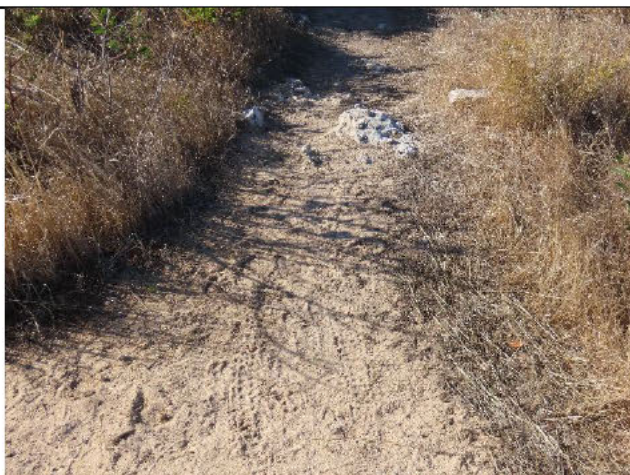
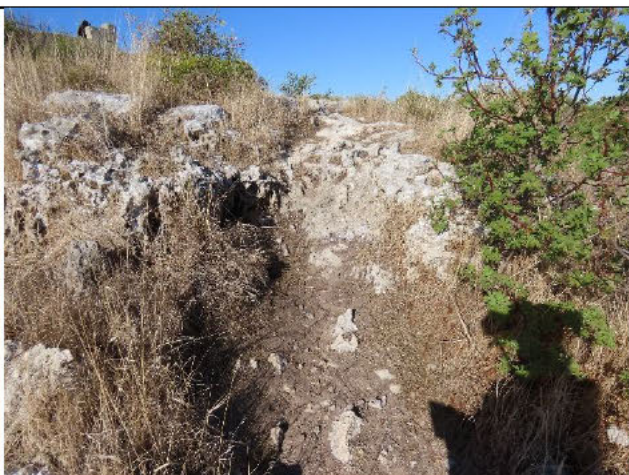
| Name: | Switchback Singletrack |
|---|---|
| Reference No.: | 53 |

| Name: | Switchback Singletrack |
|---|---|
| Condition: | Poor |
| Potential to Harm Heritage or Environmental Features: | Harm Likely |

| Name: | Switchback Singletrack |
|---|---|
| Recommendation: | Close. Unnecessary shortcut between trails 10 and 11. Potential to introduce weeds and erosion effects into the adjacent Honeymyrtle shrublands TEC. |

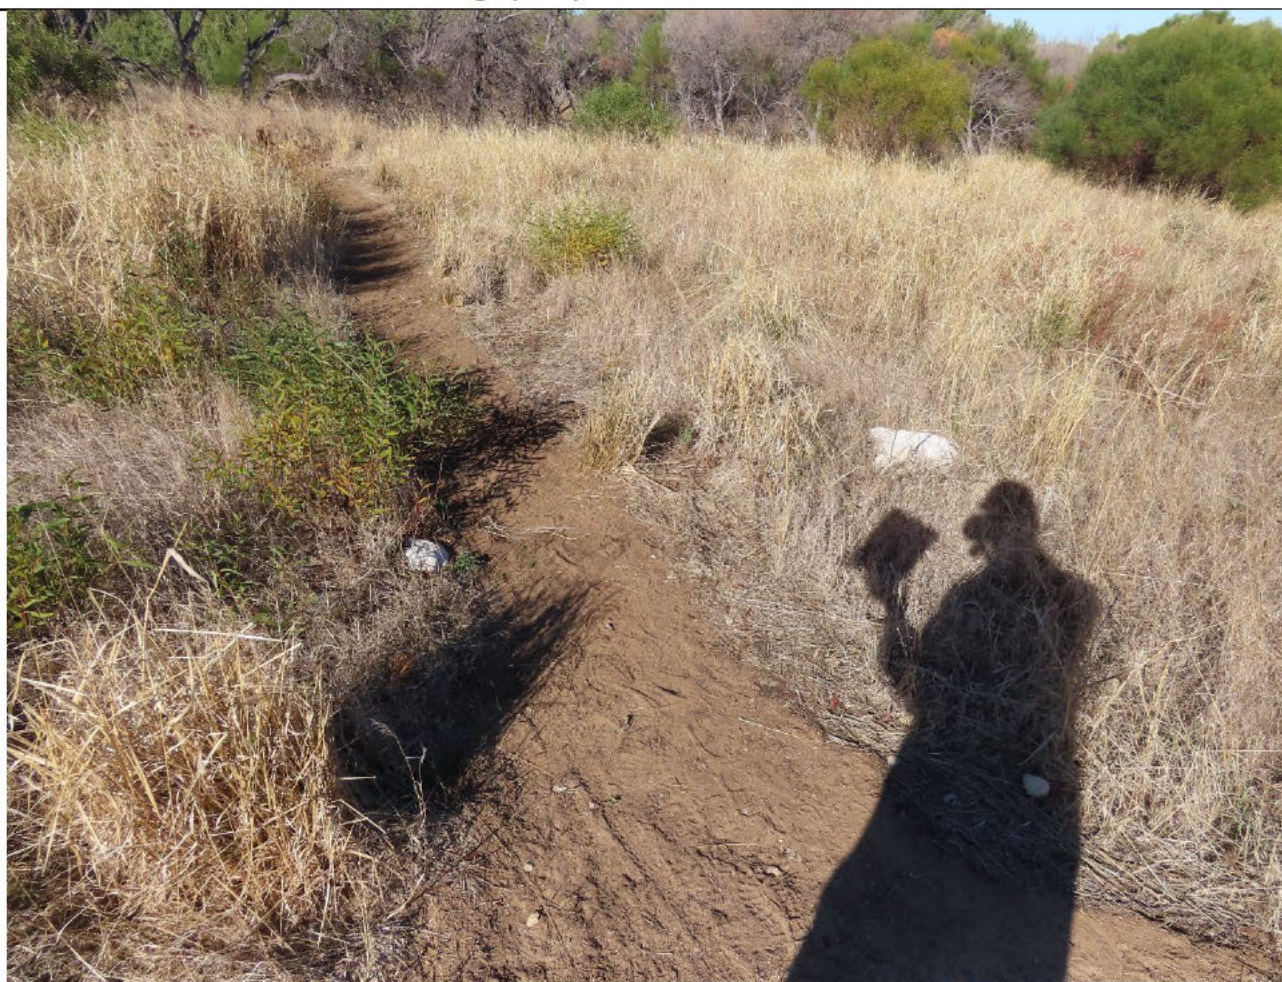
| Name: | Additional Trail 13 |
|---|---|
| Reference No.: | 54 |

| Name: | Additional Trail 13 |
|---|---|
| Condition: | Poor |
| Potential to Harm Heritage or Environmental Features: | Harm likely |

| Name: | Additional Trail 13 |
|---|---|
| Recommendation: | Close. Unauthorised shortcut trail connecting trails 10 and 82. Potential to facilitate weed spread throughout the park. Poor condition trail and not highly frequented. |

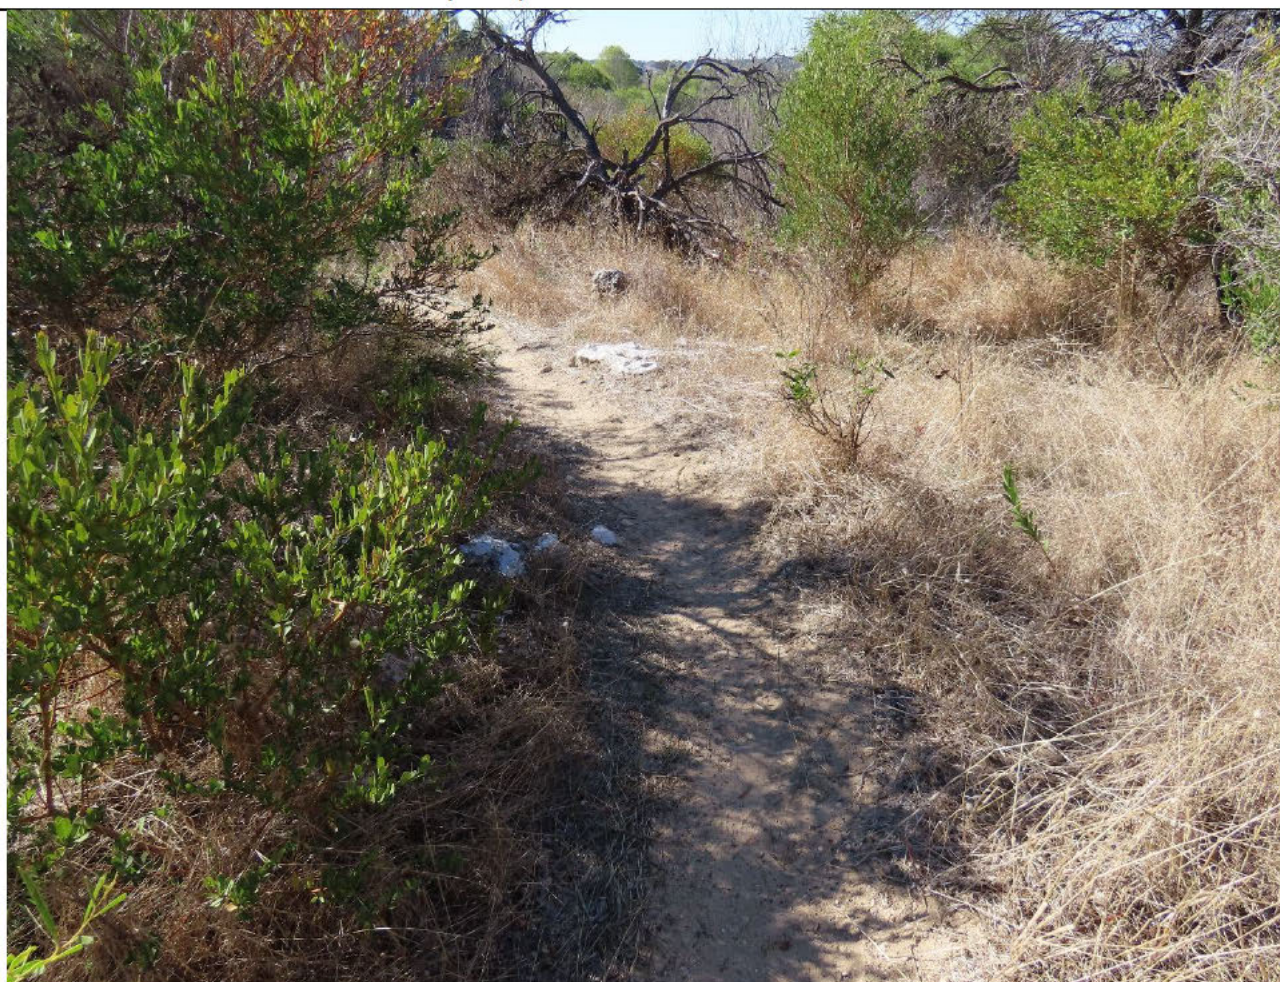
| Reference No.: | 55 |

| Condition: | Medium |
| Potential to Harm Heritage or Environmental Features: | Harm likely |

| Recommendation: | Close. Potential to facilitate weed spread through Honeymyrtle shrublands TEC, Tuart woodlands TEC and revegetation areas. Not frequently used. |

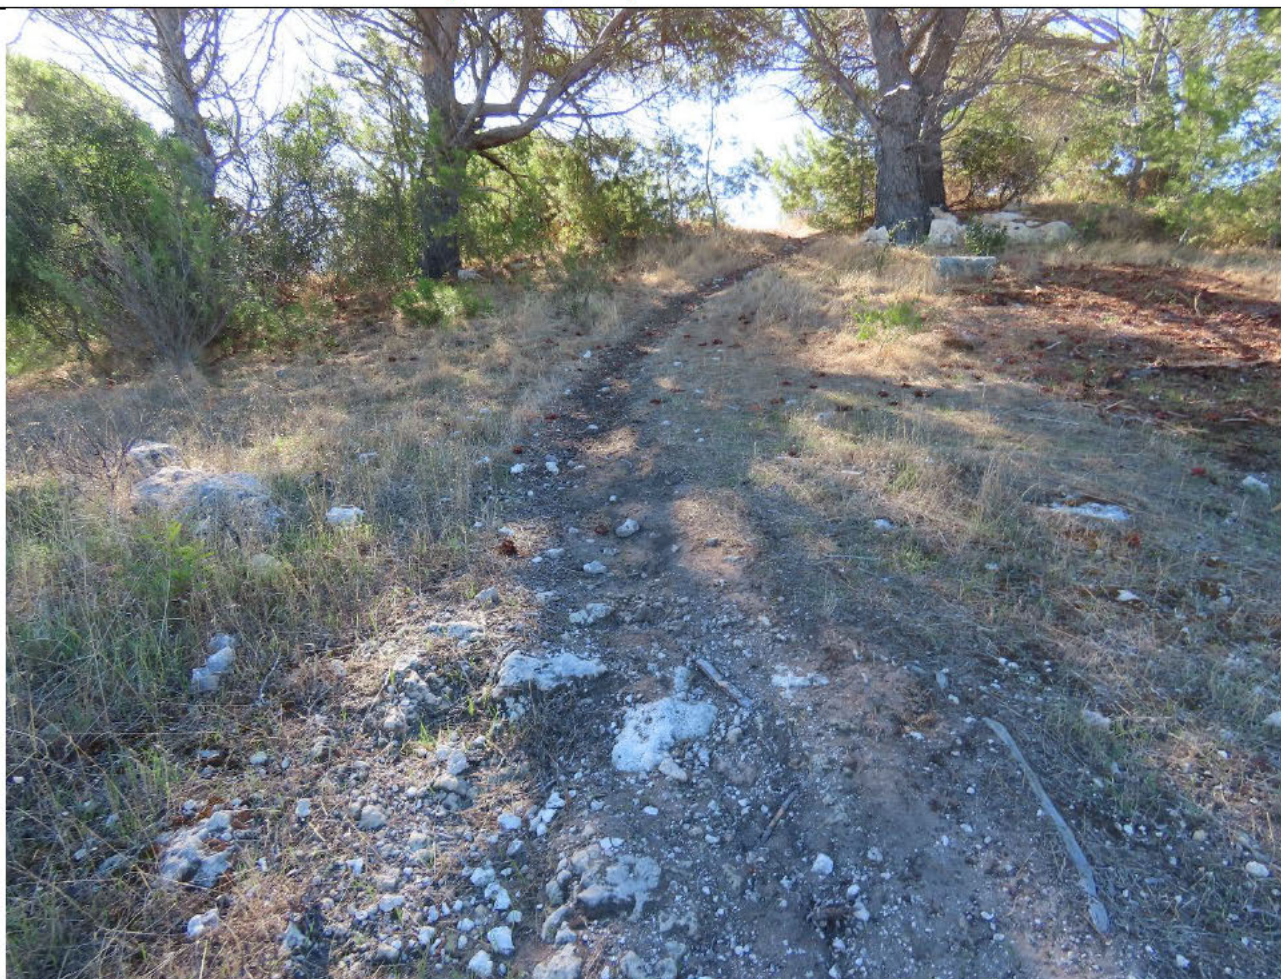
| Name: | Additional Trail 14 |
|---|---|
| Reference No.: | 56 |

| Name: | Additional Trail 14 |
|---|---|
| Condition: | Poor |
| Potential to Harm Heritage or Environmental Features: | Harm unlikely |

| Name: | Additional Trail 14 |
|---|---|
| Recommendation: | Close. Unnecessary shortcut between trail 82 and 85. Poor condition trail, not frequently used. |

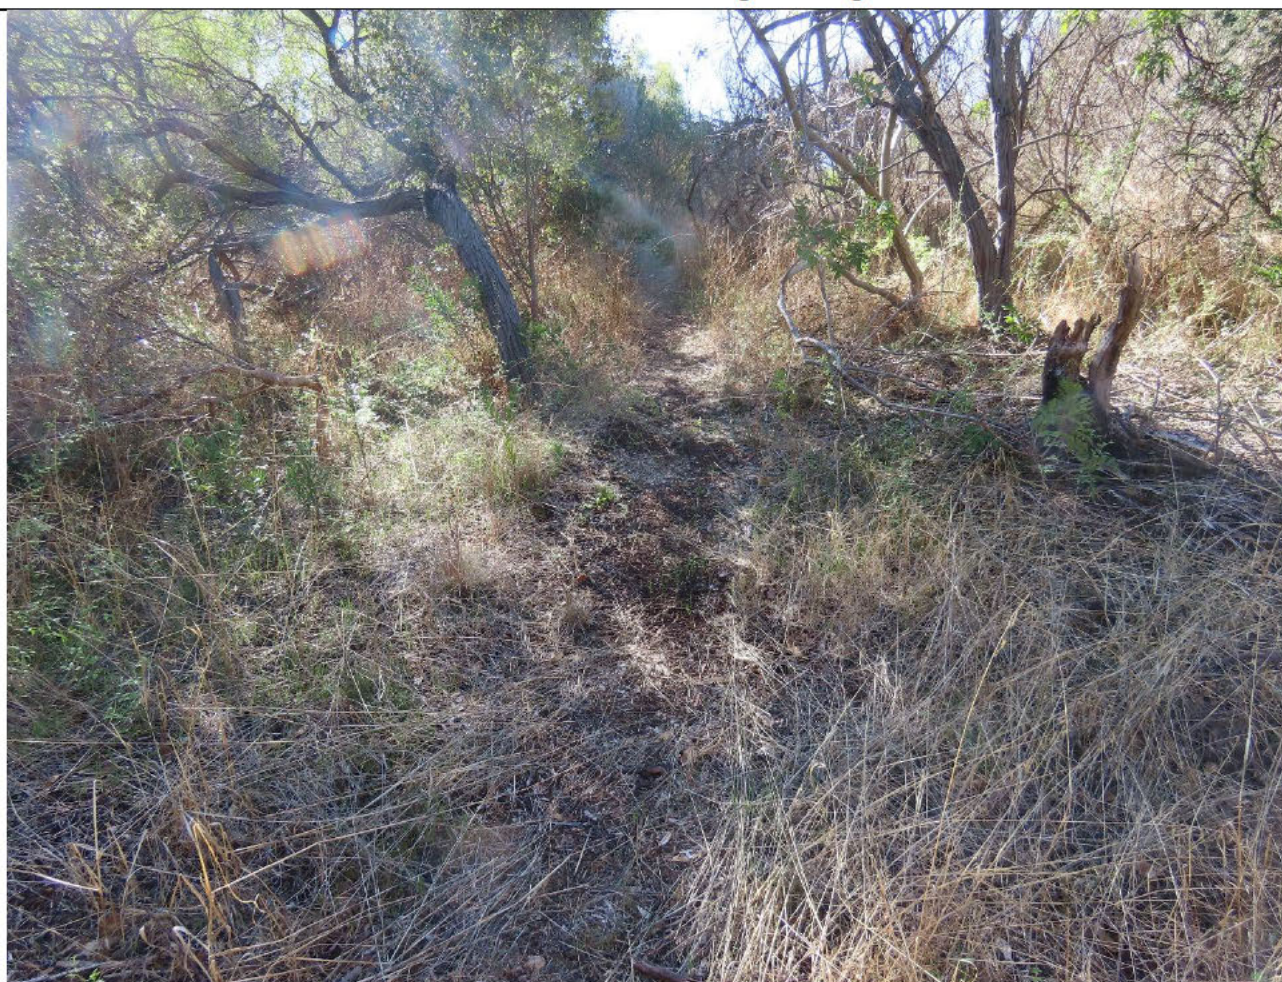
| Name: | Additional Trail 15 |
|---|---|
| Reference No.: | 57 |

| Name: | Additional Trail 15 |
|---|---|
| Condition: | Poor |
| Potential to Harm Heritage or Environmental Features: | Harm observed |

| Name: | Additional Trail 15 |
|---|---|
| Recommendation: | Close. Intersects with Tuart woodland TEC and revegetation area. Trampling effects present. Poor condition trail not frequently used. Does not connect with the existing Manning Park trails network. |

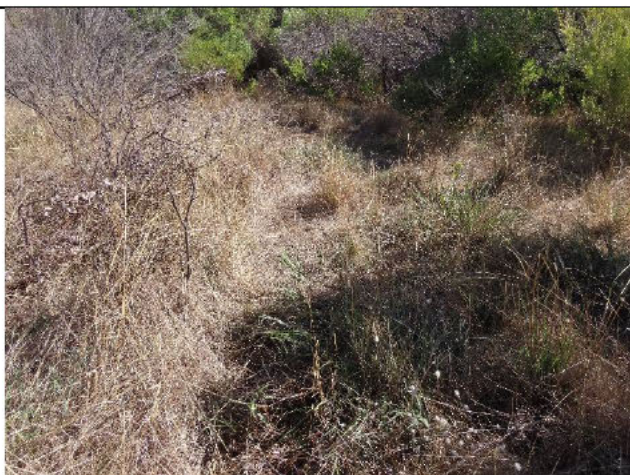
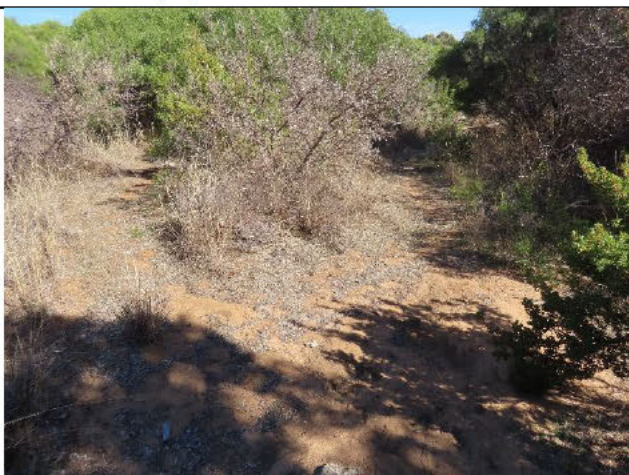
| Name: | Firebreak 1 |
|---|---|
| Reference No.: | 58 |

| Name: | Firebreak 1 |
|---|---|
| Condition: | Poor |
| Potential to Harm Heritage or Environmental Features: | Harm observed |

| Name: | Firebreak 1 |
|---|---|
| Recommendation: | Close. Trail is currently facilitating weed spread. Trampling effects present on existing vegetation. Meandering trail off trail 13. Connects to a trail recommended for closure (29). |

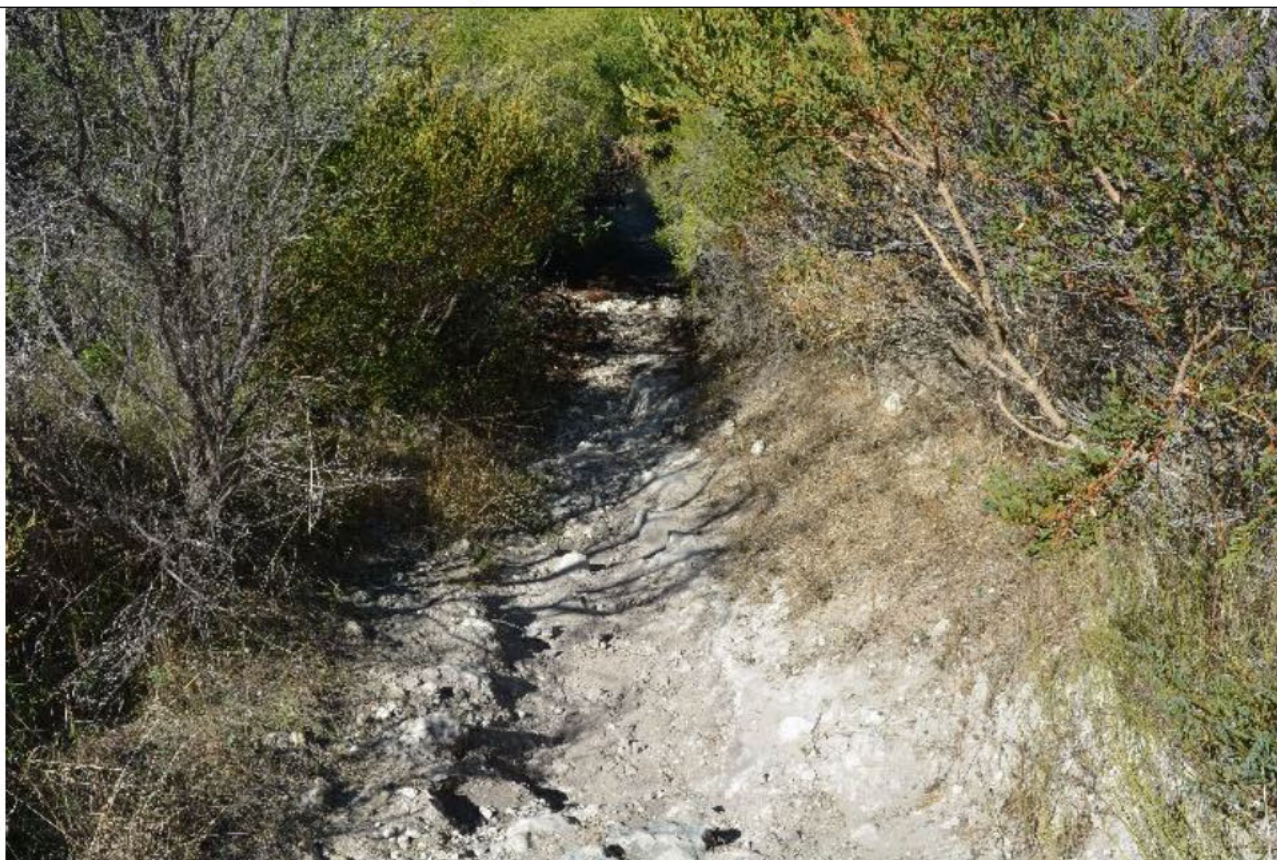
| Reference No.: | 59 |

| Condition: | Medium |
| Potential to Harm Heritage or Environmental Features: | Harm likely |

| Recommendation: | Close. Intersects with the Tuart woodland TEC and adjacent to the Honeymyrtle shrublands TEC. Medium condition trail with the potential to facilitate weed spread and erosion effects into environmental and heritage areas. |

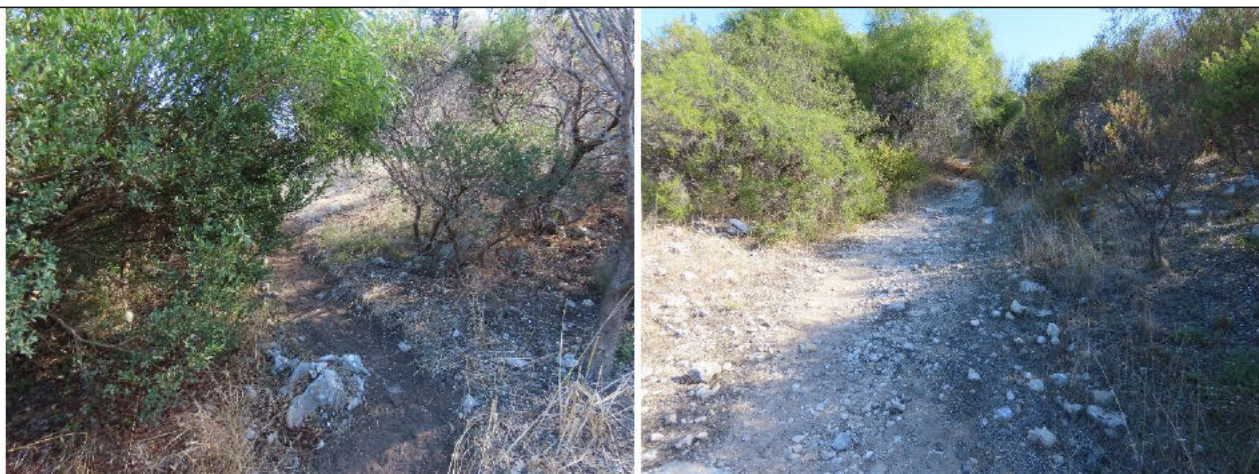
| Name: | Payment Advice (South) |
|---|---|
| Reference No.: | 60 |

| Name: | Payment Advice (South) |
|---|---|
| Condition: | Poor |
| Potential to Harm Heritage or Environmental Features: | Harm likely |

| Name: | Payment Advice (South) |
|---|---|
| Recommendation: | Close. [REDACTED]<br>Honeymyrtle shrublands TEC. Potential to spread weeds and erosion effects to nearby features. Connects two trails recommended to close (30 and 107). Poor condition trail that is not well used. |
